# VKJA 5756

Technical Bulletin – December 2010

Technical Information: VKJA 5756 Replacement guidelines

This bulletin describes the replacement guidelines of a wheel side CVjoint on a Renault LAGUNA Grandtour (K56\_) 2.0 (K56C/H).

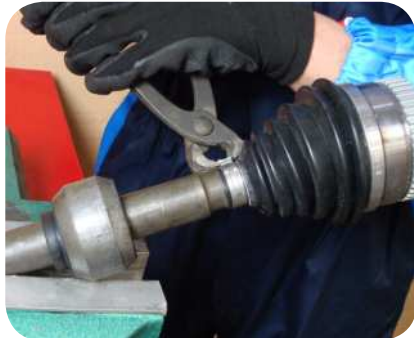
1. Remove the driveshaft in accordance with the vehicle manufactures' workshop manual.

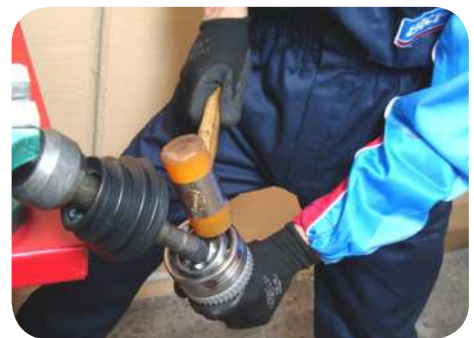
2. Place the driveshaft in a vice (with aluminum or protective jaws).  
Remove both the inner and the outer clips.  
Cut the boot and remove it.

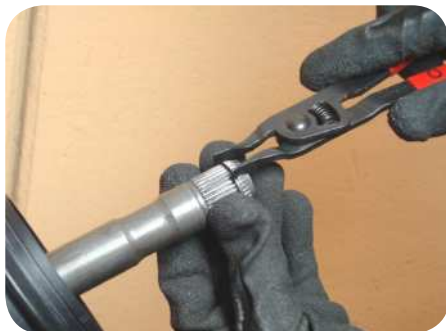
3. Hold the CV-Joint and pull it off the shaft by tapping with a hammer

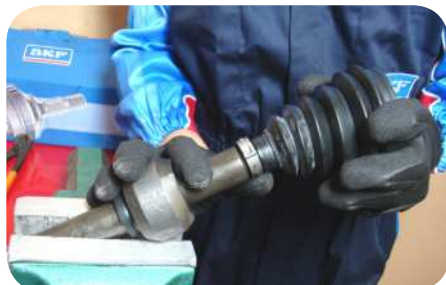
4. Expand and remove the circlip with circlip removal pliers.

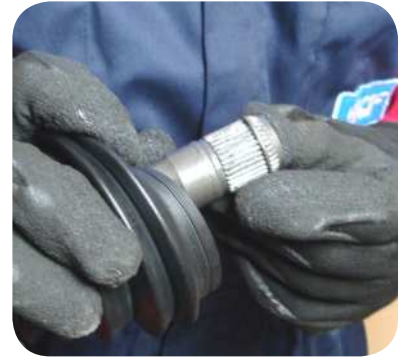
1. Put the short boot clamp on the shaft.  
Slide the boot on the shaft.

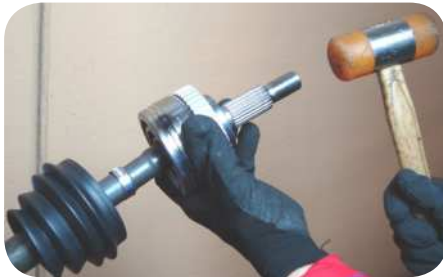
2. Fix the new circlip into the groove.  
Tip: To keep it into the groove use a hose clip (do not over tighten!)

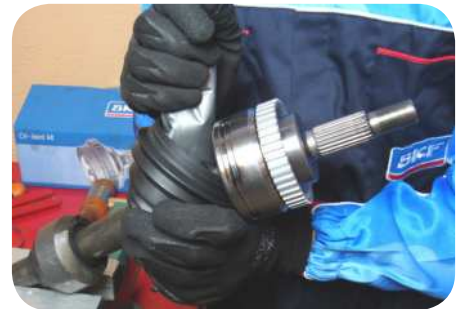
3. Press the new CV-joint onto the shaft.  
Tap with a rubber hammer until the circlip locks into its groove in the inner race of the CV-joint.  
Remove the hose clip.

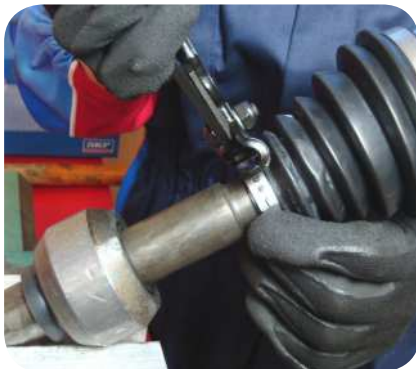
4. Slide the boot into position ready for mounting and fill with all of the supplied grease.

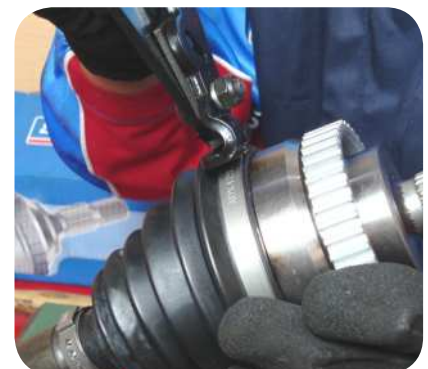
5. Fit the short clamp onto the CV-boot and tighten it with a suitable tool.  
Pull the boot onto the CV-joint.

6. Fit the long clamp and tighten it with the same tool.
