SKF Pulp & Paper Practices

SKF Global Pulp & Paper Segment | No. 16 | December 2015

“What’s the correct fit for this bearing?”

Fretting corrosion and wear in the bearing seat due to ring creep or micro movement

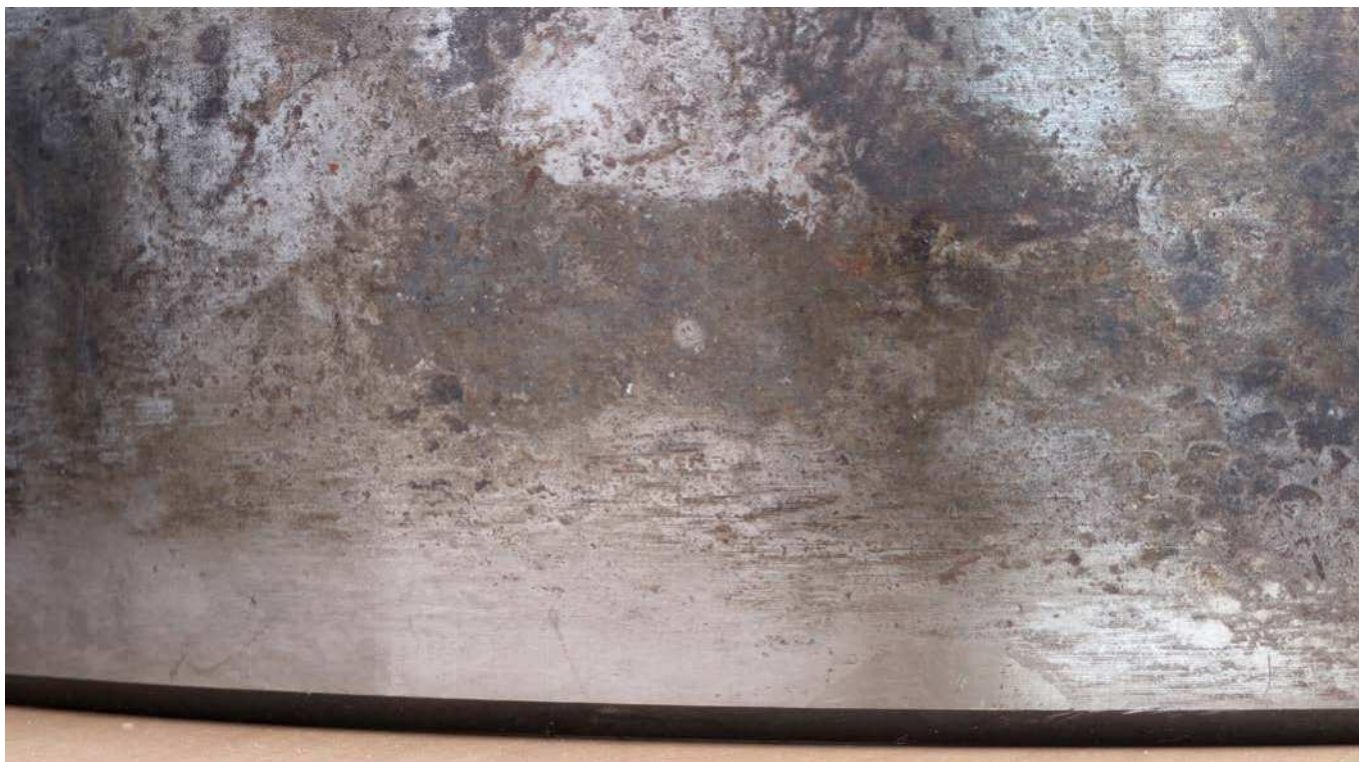
Fretting corrosion on the outside surface of a bearing outer ring due to a damaged raceway

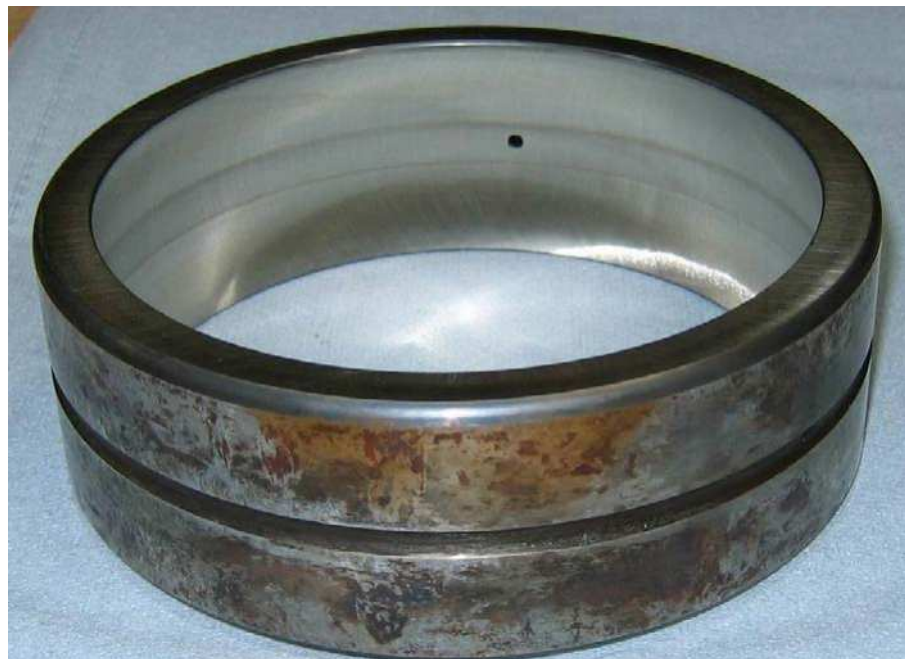
Fig. 1 Fretting corrosion on the outer diameter of a spherical roller bearing

Fretting corrosion occurs when there is relative movement between a bearing ring and its seat on a shaft or in the housing. This relative movement can be very small and occur due to the unique elastic deformation of the rings under load, for example (→ figure 1).

Fretting corrosion appears as areas of rust on the outside surface of the outer ring (→ figure 1) or in the bore of the inner ring. The raceway path pattern could be heavily marked at corresponding positions. In some cases, fretting corrosion can be actually secondary damage due to heavy spalling on the raceway.

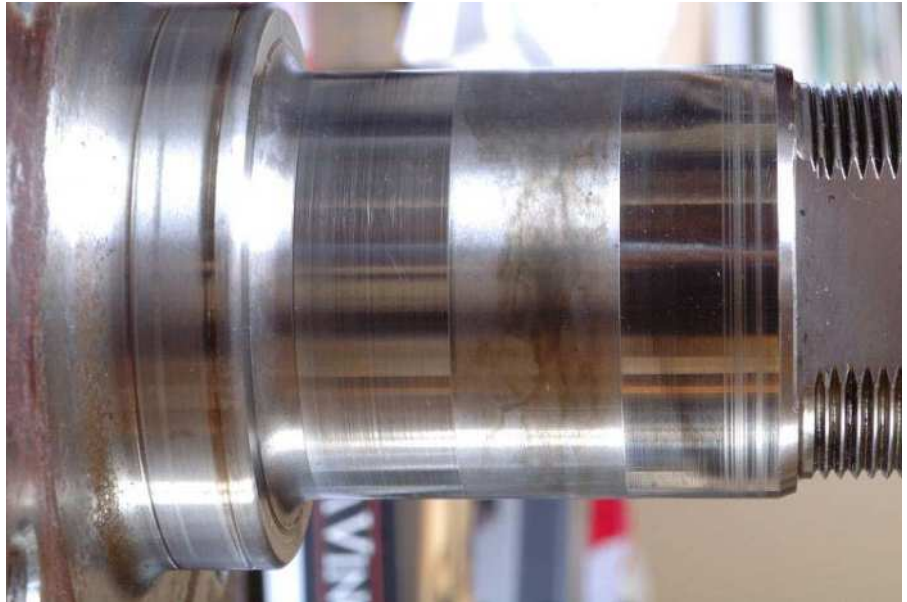
Fig. 4 Wheel bearing stub axle showing wear in the contact surface with the tapered roller bearings due to a loose fit and changing load direction after 200 000 km

etc. The inner rings roll back and forwards on the stub creating wear (→ **figure 4**).

Is this loose fit leading to acceptable wear? I would definitely say yes. After 200 000 km, there was just minor surface wear creating a mirror-like surface with some slight fretting corrosion. After 400 000 km, the wear could be felt with your fingernail, but it was not severe enough to make me decide to change the stub.

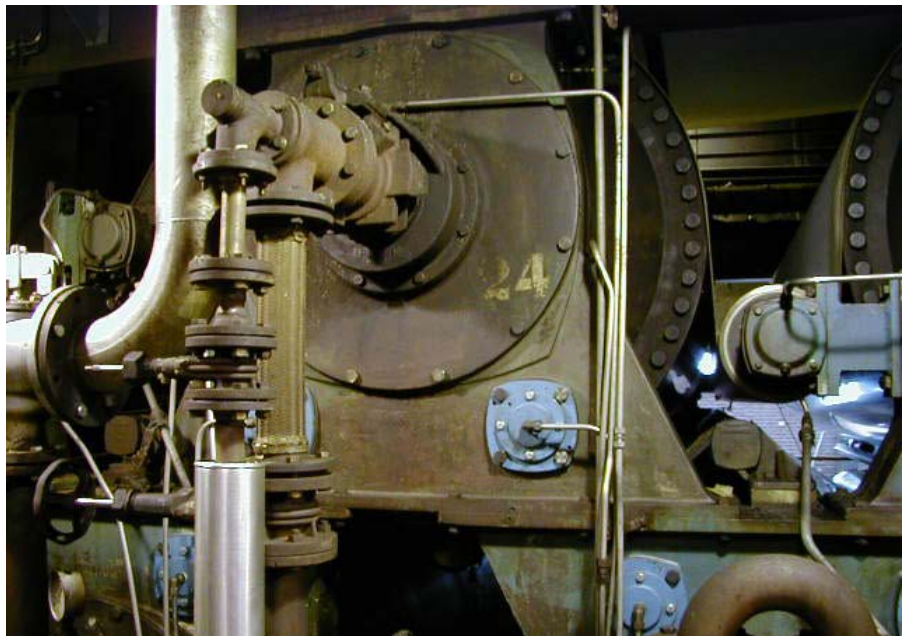
Fig. 5 Intermediate gears on a drying cylinder drive. Note that the blue covers show their position

My second example is the intermediate gears used to drive groups of drying cylinders in some paper machines (→ **figures 5 and 6**). The typical bearing arrangement has two cross-located spherical roller bearings mounted with a tight fit on the inner rings and a loose fit on the outer rings. The outer rings are mounted like this to facilitate mounting and dismounting, for cost reasons, and to allow the bearings to find their position in operation. I've got a case in which there was on one side a double row tapered roller bearing and on the other side a cylindrical roller bearing, with tight fit for the inner rings and loose fit for the outer rings.

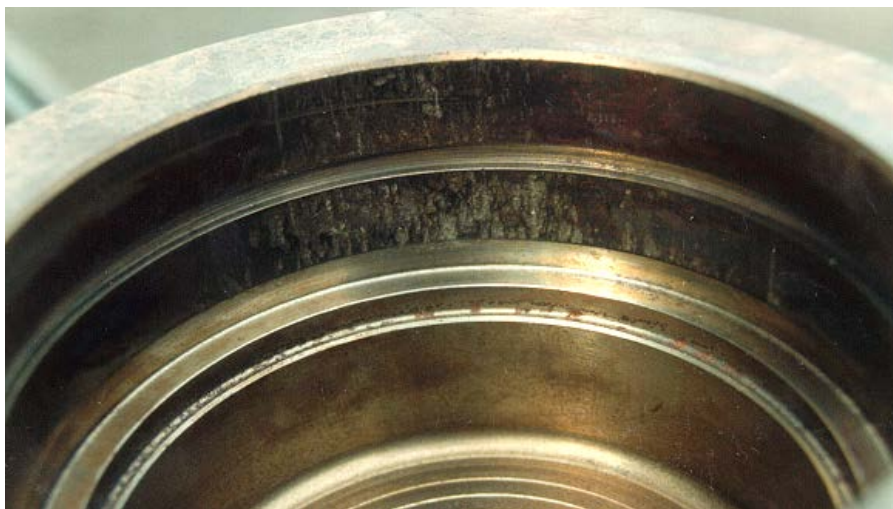
Fig. 7 Fretting corrosion in the housing

Depending on the radial run out of the drying cylinders, the felt tension and so on, the drying cylinders can be partly or fully driven by the paper and felt for short periods. When this happens, the load on the gears is modified and can sometimes even change direction. Load variation and load direction variation on the gear teeth when the gears drive or are driven make the bearings move in their housings creating heavy wear (→ **figures 7 and 8**).

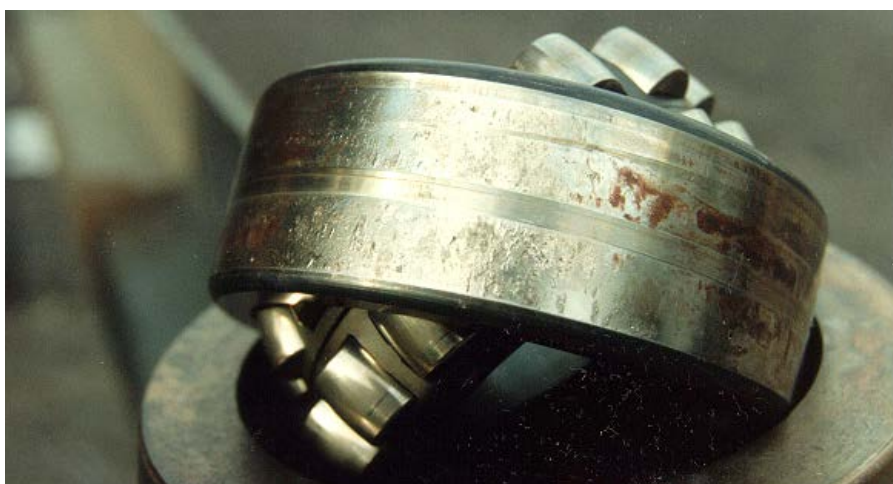
Fig. 8 Fretting corrosion on the bearing outer diameter

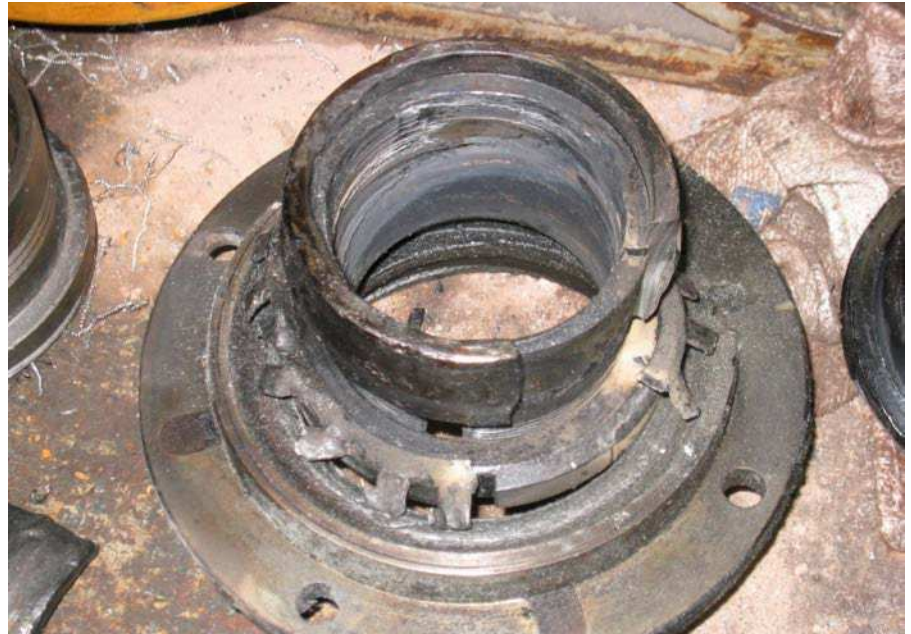
Fig. 11 Part of a bearing inner ring on an adapter sleeve following heavy damage

A few years later, felt roll bearings started to fail (→ **figure 11**) while others exhibited heavy fretting corrosion in the bore, the sleeve bore and on the shaft (→ **figure 12**).

Analysis of the bearings, sleeves and shafts indicated that the fit wasn't tight enough for the application. The failed bearings would, in fact, have been heavily preloaded and inadequately lubricated as the result of significant sliding of adapter sleeves on shafts leading to high friction and inner rings heating up.

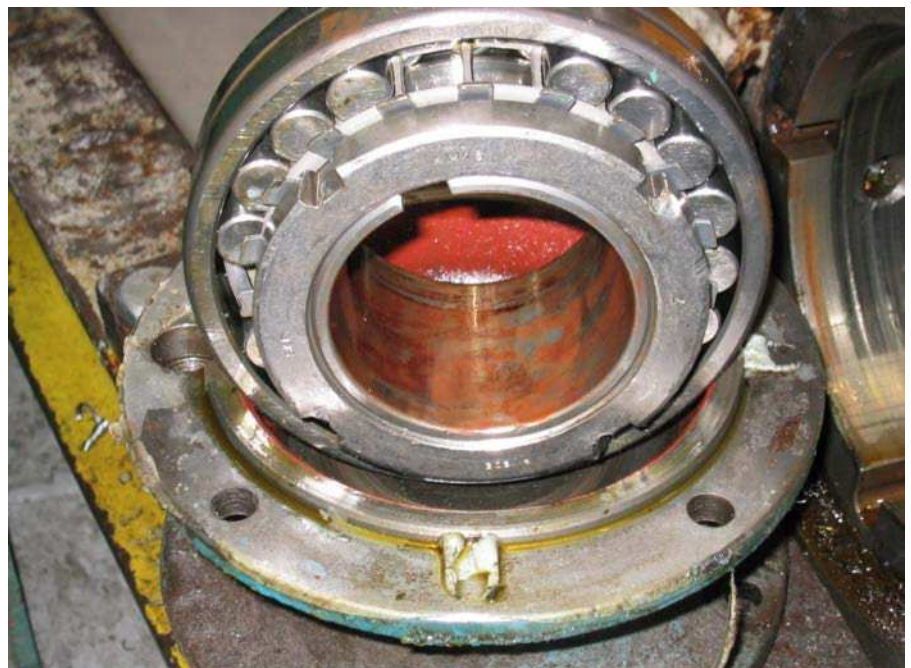
Fig. 12 Heavy fretting corrosion in an adapter sleeve bore, but the bearing raceway is in quite good condition which gives a clue about the root cause

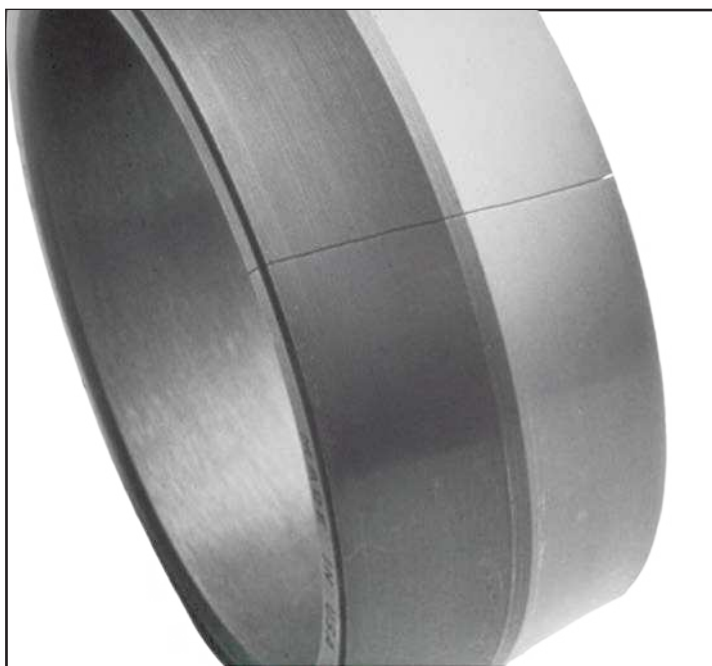
Fig. 16 The fractured inner ring of a spherical roller bearing resulting from excessive drive-up

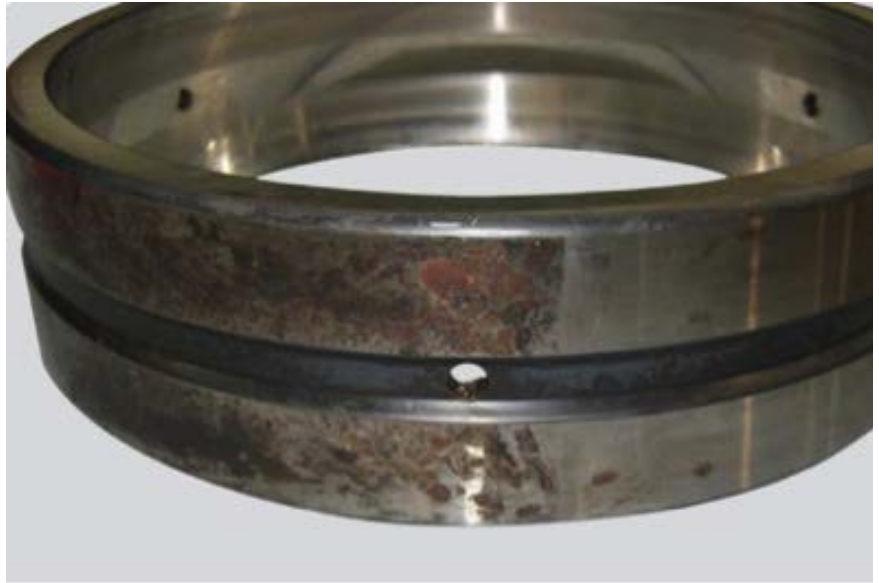
Fig. 18 Oval clamping due to mismatched cap and base on a split plummer block housing

A common error is that caps and bases are exchanged during bearing mounting. → **Figure 18** shows a bearing outer ring where this has happened. The photograph shows part of the ring with fretting corrosion and thus contact, and one part without fretting corrosion and therefore no contact. On the opposite side of the ring, fretting corrosion is on the right and there's an undamaged surface on the left. When this happens, it creates oval clamping of the outer ring and can block the bearing creating axial overload in non-locating bearings that need to move in their housings and/or create premature fatigue.

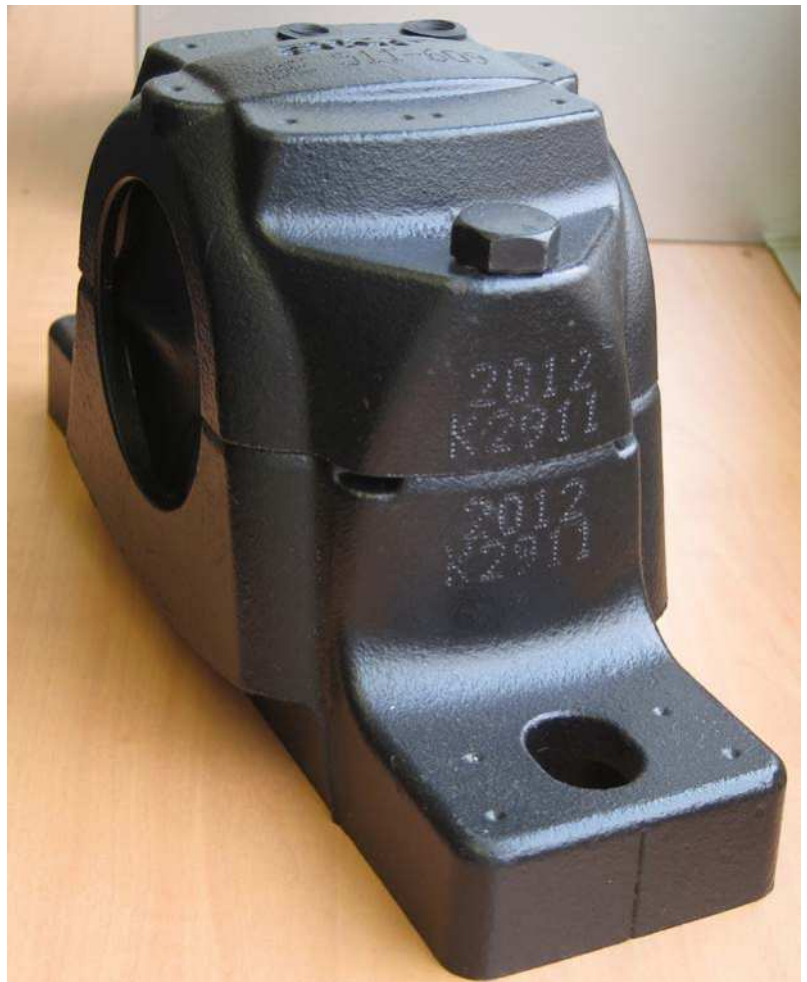
Fig. 19 Cap and base marking on a SKF SE Housing

To help prevent such problems, SKF SNL and SE housing have matching cap and base markings (→ **figure 19**). The markings are horizontal on SE housings and vertical on SNL ones. When mounting, care should be taken to ensure that the matching caps and bases are used.
