SKF Pulp & Paper Practices

SKF Global Pulp & Paper Segment | No. 19 | December 2016

Monitoring slow rotating equipment with vibration analysis?

Low speed bearing monitoring – Challenges and solutions

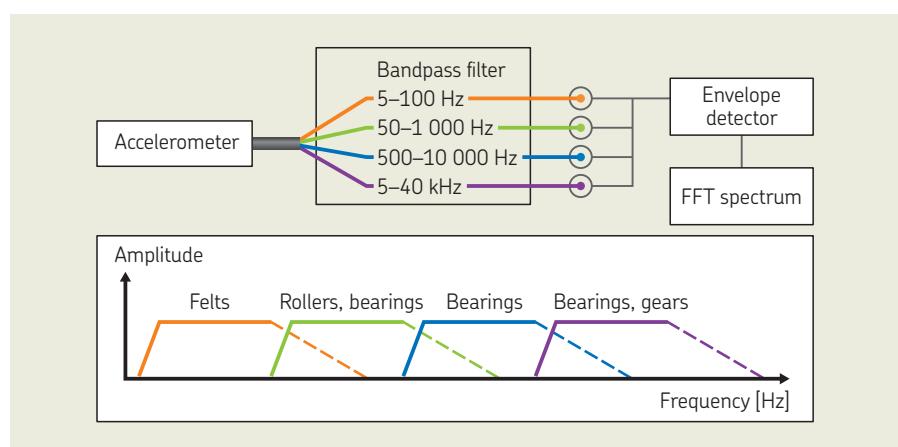
Fig. 1: Example of acceleration enveloping filters (SKF method)

For very low speed applications, the use of high frequency techniques such as acceleration enveloping has proven successful, but a common pitfall is the incorrect selection of enveloping filter. Most commercial instruments, in addition to standard vibration measurements, have selectable enveloping filter bands that focus feature extraction on a specific frequency range, both to minimize noise as well as collect signals from impacts (→ **fig. 1, page 2**). A common misconception is that the proper filters to use for low speed bearings are the lower frequency ones. In reality that is not the case as other factors such as damage size and shape, impact energy propagation to high frequencies, system resonances and noise sources in lower frequencies can (and do) mean that higher filters produce better results. Hence, when establishing a measurement strategy for a specific application, we start with several measurement types (and enveloping filters) then later trim down to the essentials based on actual results. This is part of an approach that we refer to as multi-parameter monitoring.

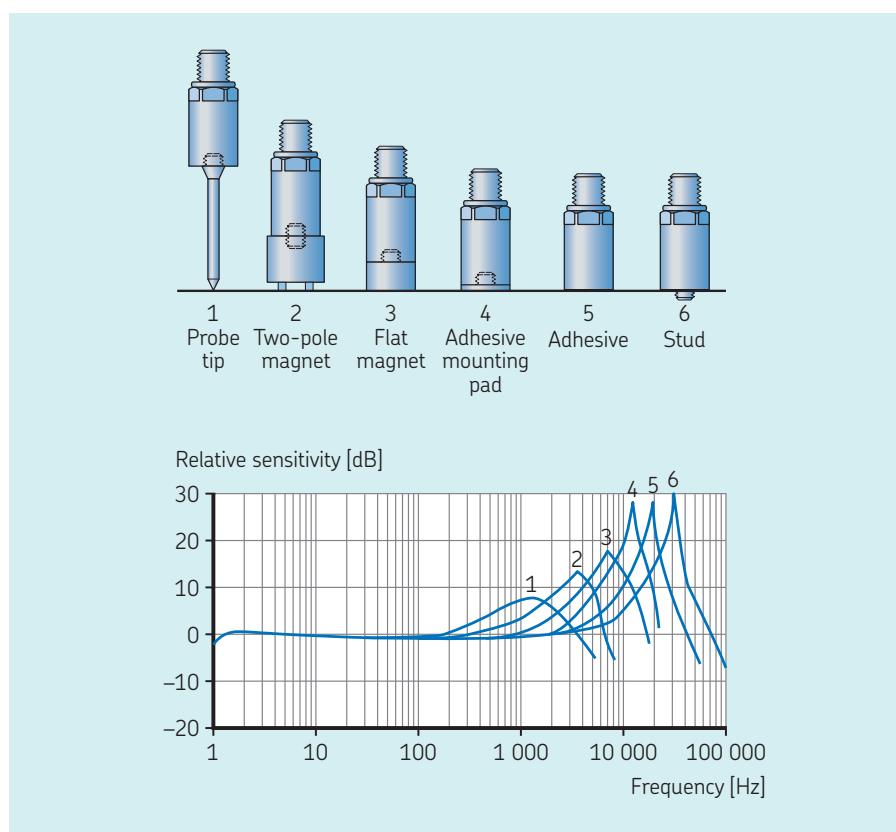
Fig. 2: Frequency response with different mounting methods

The sensor mounting method has a crucial impact especially when using high frequency feature extraction techniques (higher enveloping filters). The full frequency response of accelerometers can only be achieved with proper mounting (e.g. stud mounting). Using a magnet, for example, will drastically reduce the maximum frequency that the accelerometer can measure e.g. from 15–20 kHz down to about 3–5 kHz (→ **fig. 2**). Permanent mounting is the only way to get consistent higher frequency

response, so we recommend stud mounting for best results.

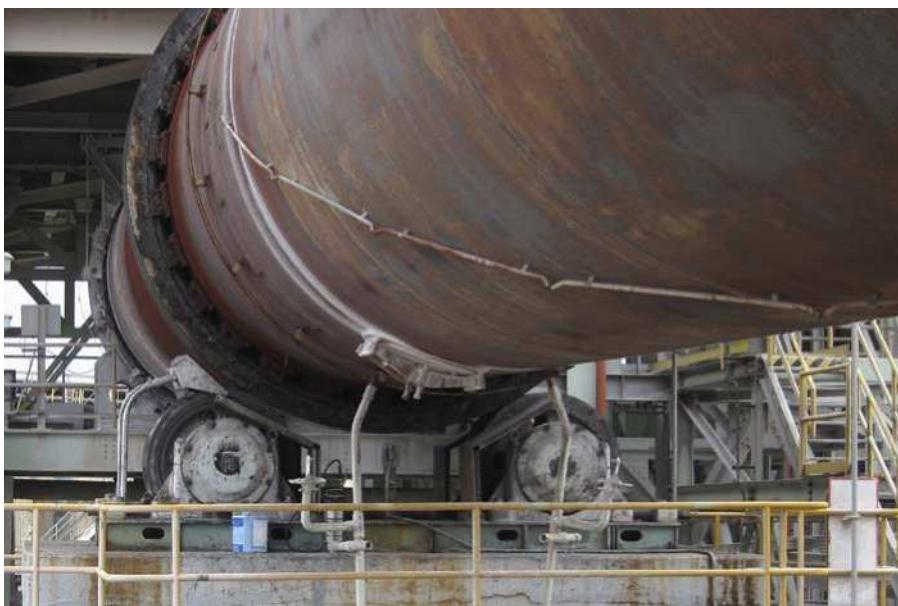
Fig. 3: Lime kiln support rollers

To illustrate the effectiveness of our low speed monitoring techniques, let us consider the example of a kiln support roller bearing turning at around 6 r/min (→ fig. 3). The key measurement specifications were as follows:

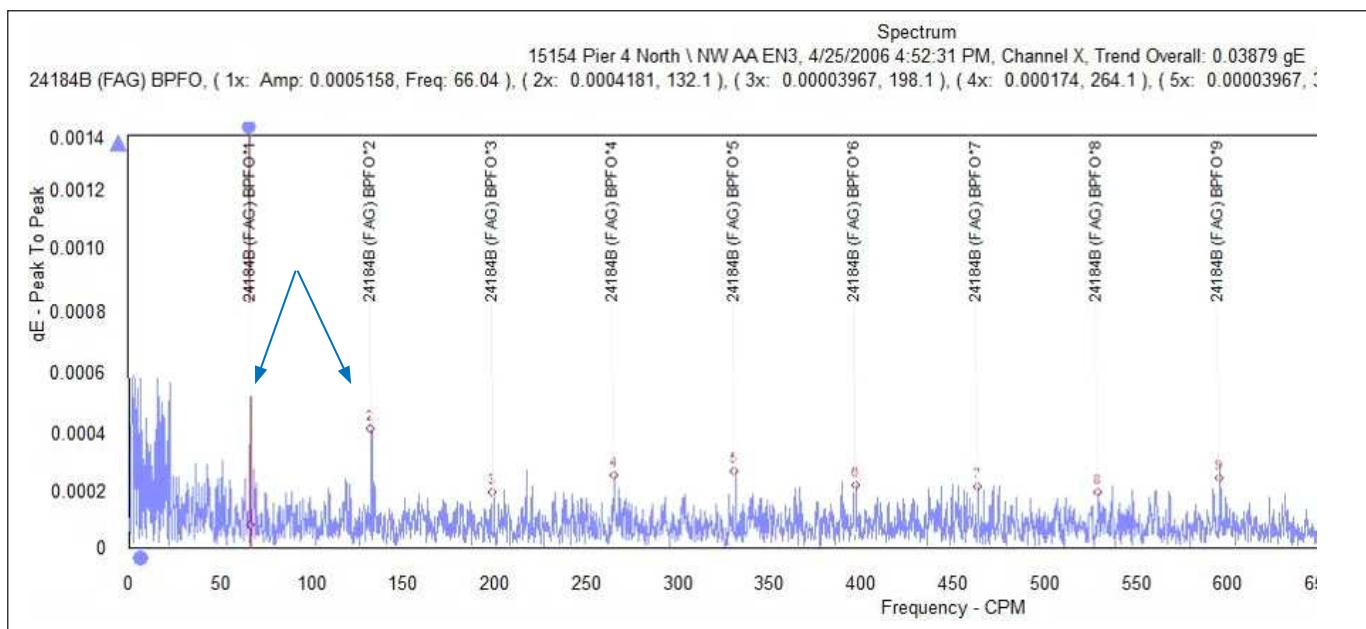
Damage to the outer ring was first detected in April, 2006. The spectrum peaks from the acceleration enveloping measurement precisely match the expected defect frequency of the bearing, leaving no doubt that damage has occurred (→ fig. 4).

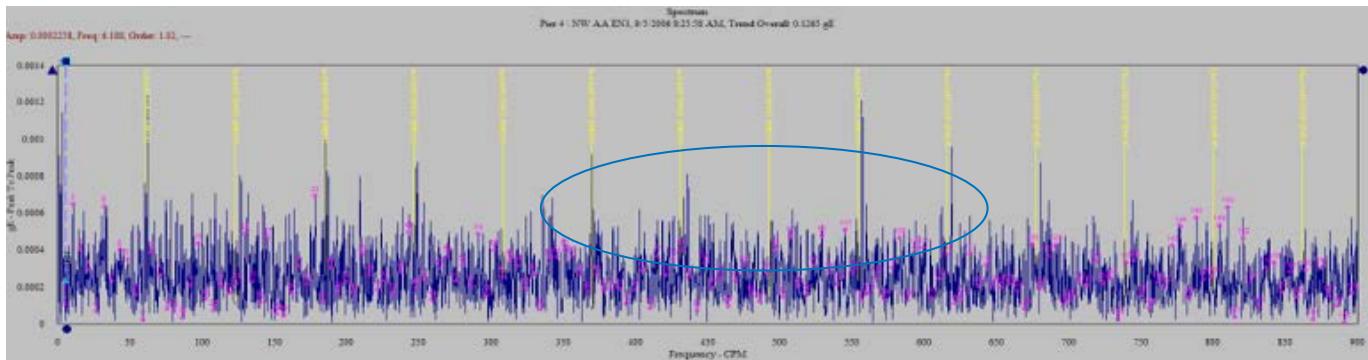
Fig. 5: Spectrum taken five months later showing less distinct peaks

As a bearing deteriorates, it is not unusual for peaks in the spectrum to change patterns or lose their distinctness due to potential growth of the damage area and/or potential multiple impact points. **Fig. 5** shows the spectrum five months later. Note that the peaks (particularly the first and second harmonics) are less dominant, but higher order harmonics are slightly visible.

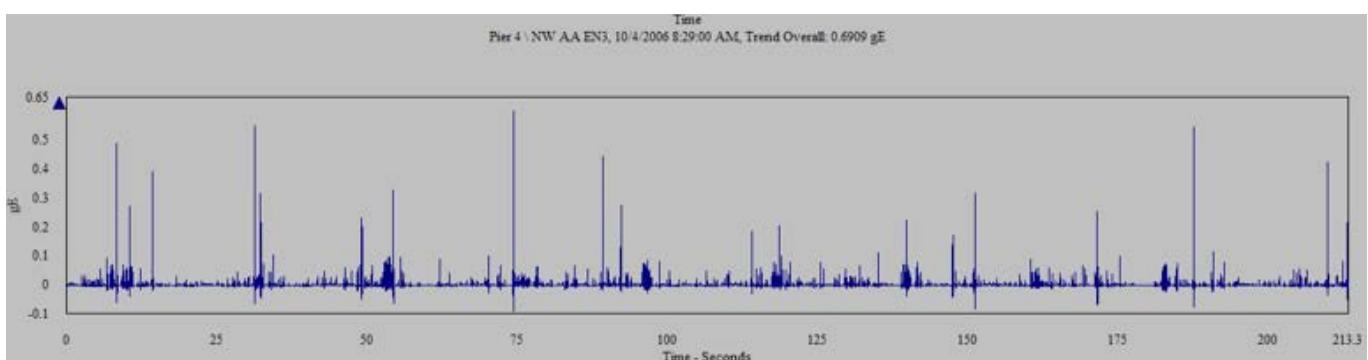
Fig. 6: Time waveform showing multiple high energy impacts from bearing damage

At this point the damage had grown quite significantly and the bearing needed to be replaced soon. The time waveform display taken just before the bearing was replaced in October (→ **fig. 6**) shows multiple roller impacts on the raceways indicating severe damage. This was verified when the bearing was replaced (→ **fig. 7**). As can be seen from the damage pattern, the bearing was subjected to large axial forces.

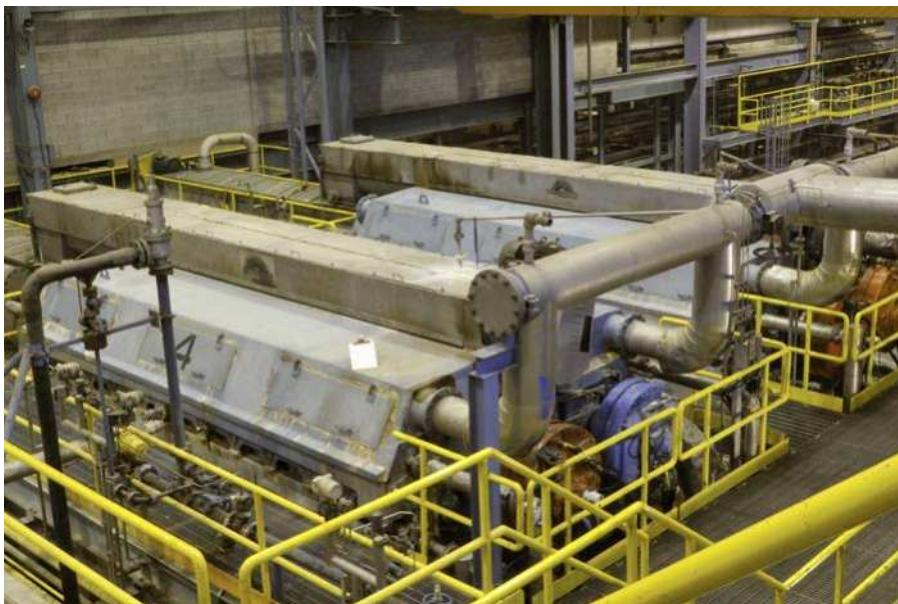
Fig. 8: Twin roll press

The situation changes, however, in cases where the rotational speed is not steady. A good example of this is a twin roll press which typically runs from about 6 to 12 r/min (→ fig. 8).

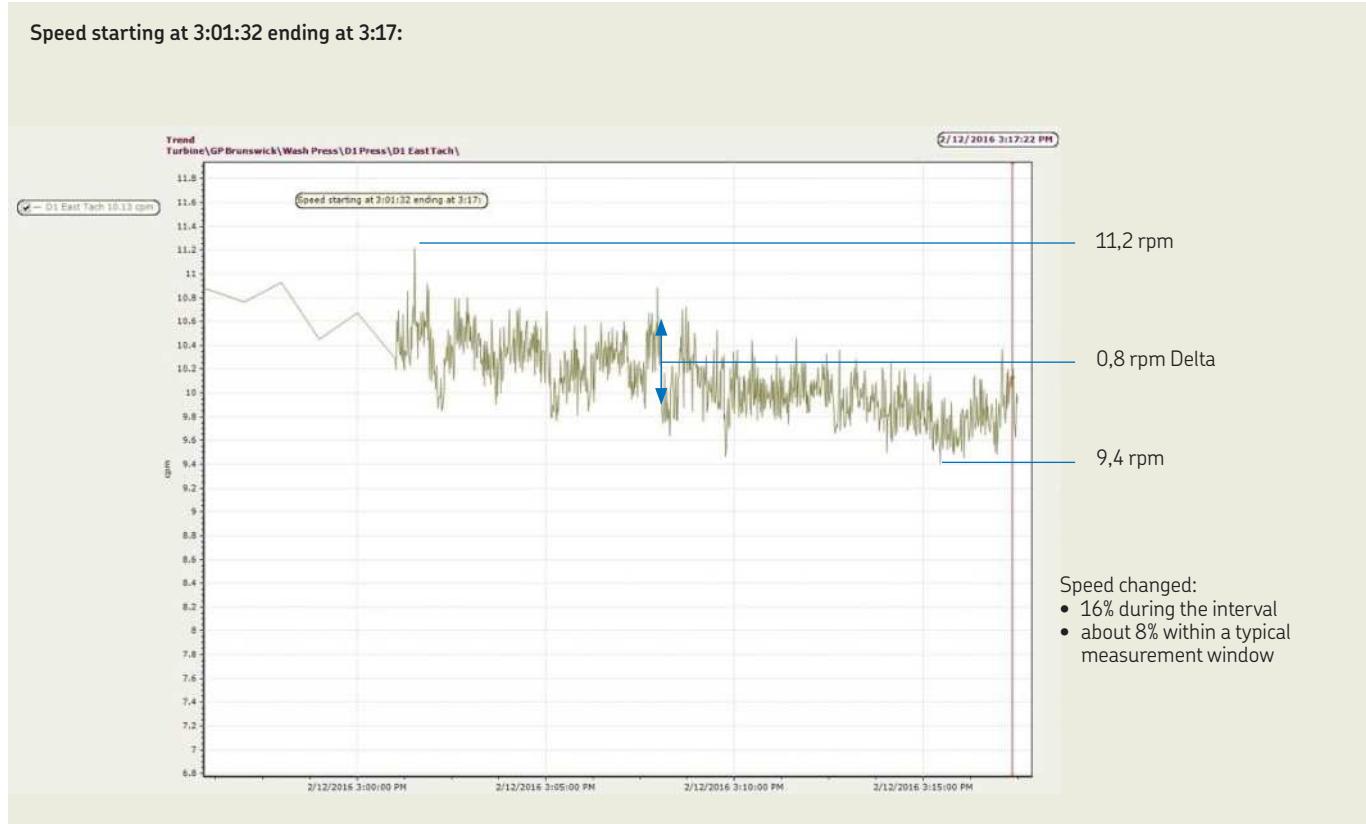
Fig. 9: Example of non-steady speed during operation

The press rolls, which are driven by hydraulic drives, constantly change speed due to loading conditions. Fig. 9 shows the typical scale of speed changes during normal operation.

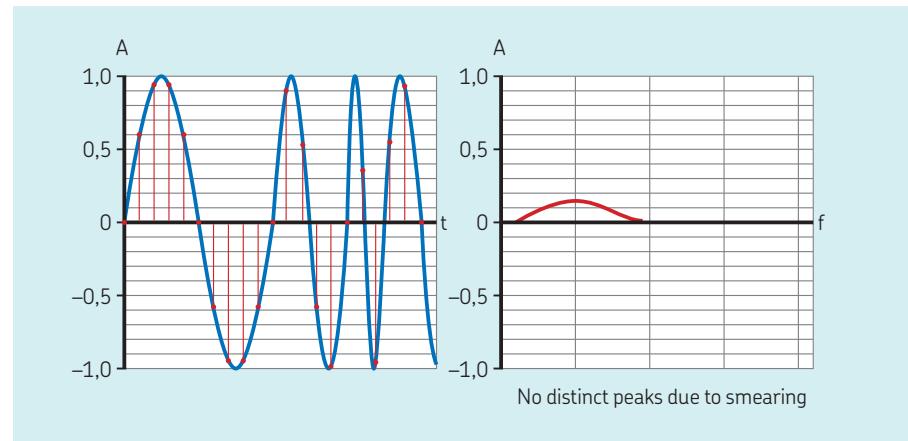
Fig. 10: Fixed sampling during non-steady speed operation results in smearing

referred to as "smearing". The effect of smearing is shown in **fig. 10**.

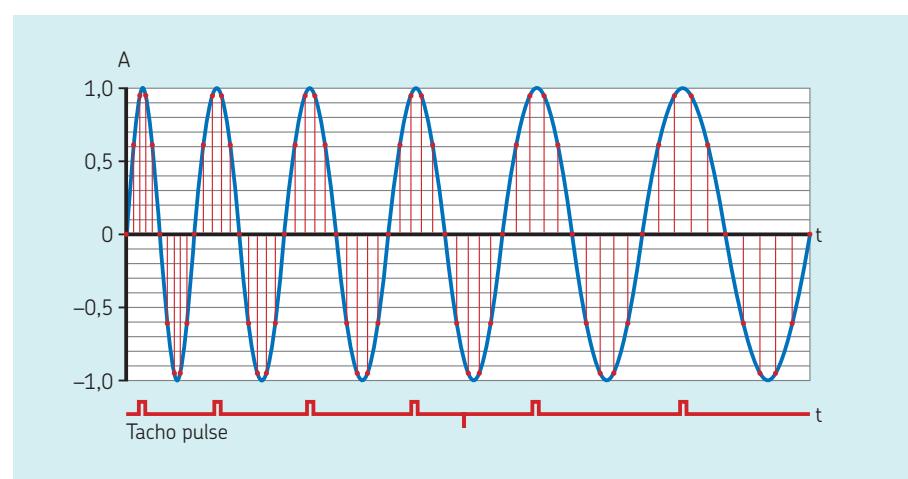
Fig. 11: Order tracking

Order tracking uses a speed reference (e.g. tachometer pulse) to compensate for non-steady speed (→ **fig. 11**). The result is a time waveform with samples in the "right" places (even though the speed is changing during measurement).

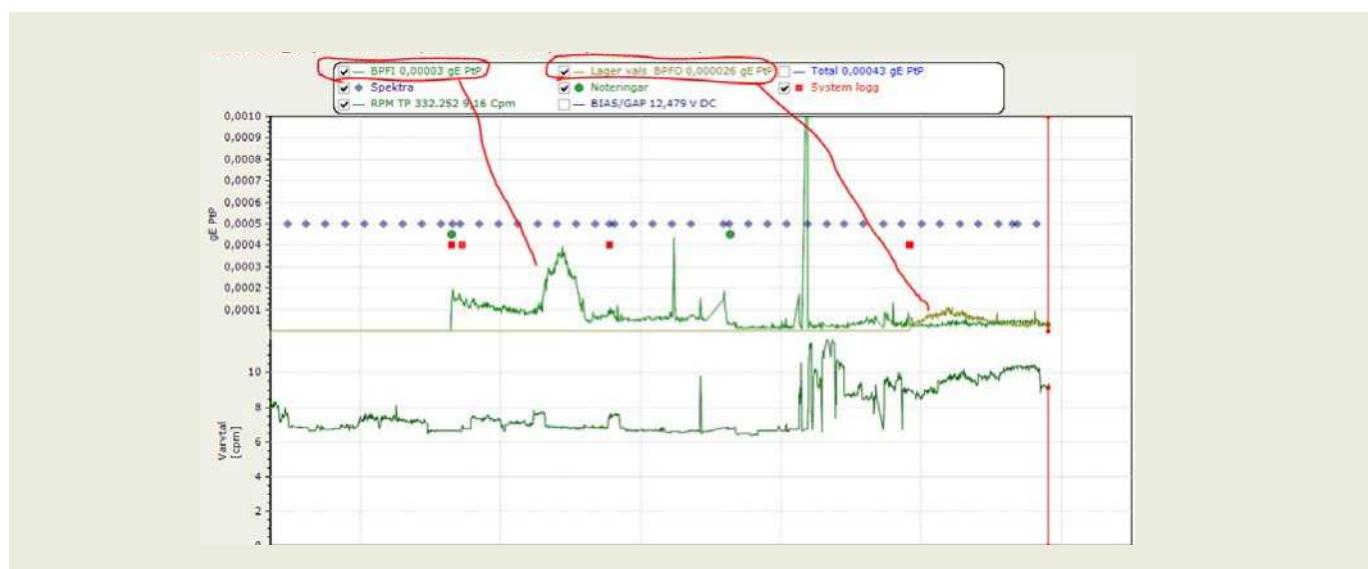
Fig. 12: Trend of bearing frequencies

Since an online system collects data automatically, it has the advantage of recording data at much shorter intervals than is practical with a portable system. This was an important feature in finding and tracking the bearing fault in this specific case. **Fig. 12** shows the trend of the bearing frequencies as measured with acceleration enveloping with order tracking. It can be seen that the inner ring damage trend increased significantly at the end of March, then went down at the beginning of April. Without an online system it is possible that this event would have been missed. Indications of outer race damage about a month later also pointed to increasing damage severity.

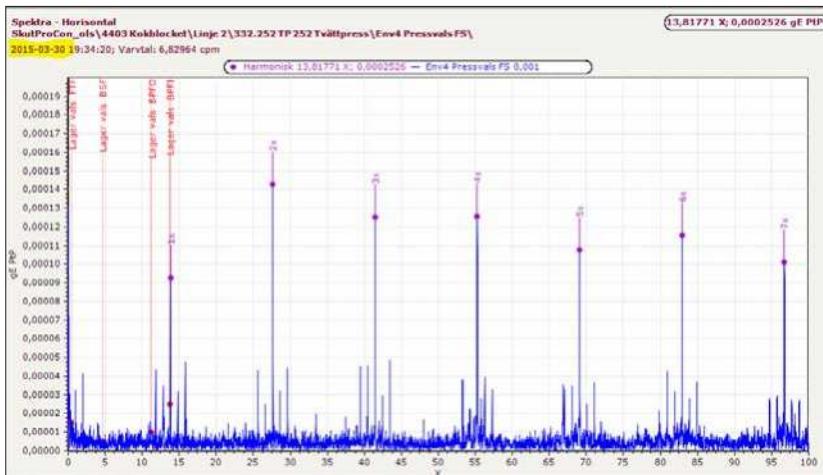
Fig. 13: Frequency spectrum showing clear inner ring bearing damage

Fig. 13 shows the frequency spectrum at the end of March with very clear inner ring defect peaks, harmonics, and sidebands. This frequency pattern type seen at this high enveloping filter range indicates a small but sharp-edged bearing defect.

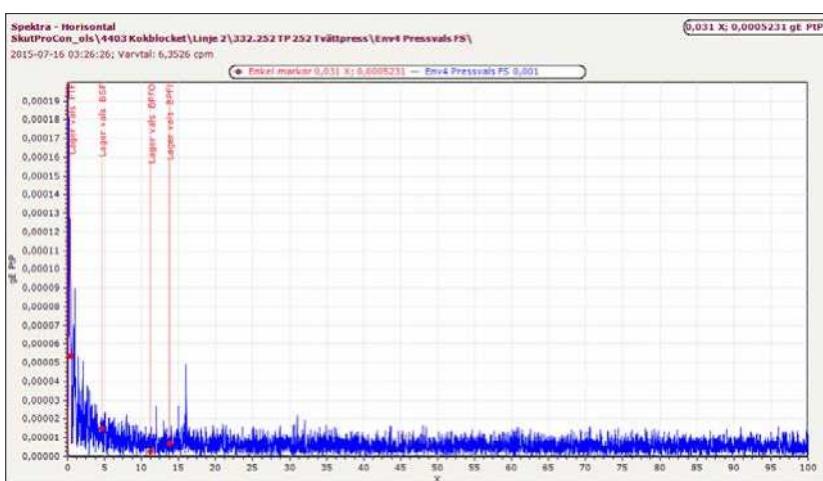
Fig. 14: Spectrum taken in July; bearing defect peaks have disappeared

It was observed that the frequency peaks, which had been quite clear, disappeared after some time. **Fig. 14** shows the frequency spectrum in July which, in contrast to **fig. 13**, shows no peaks that match the bearing frequencies. It was suspected that the inner ring may have started to slip on the shaft (which could happen with a cracked inner ring), prompting the decision to replace the bearing at the earliest opportunity.

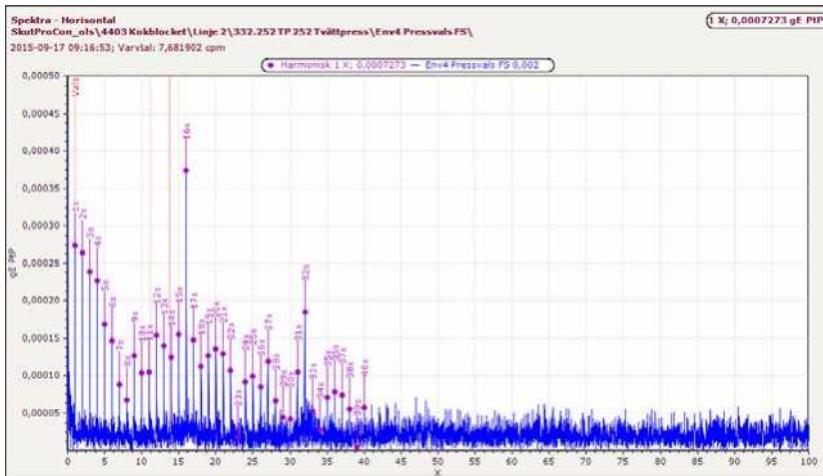
Fig. 15: Spectrum showing running speed harmonics, an indication of looseness

In September, a spectrum taken just before the bearing was replaced showed peaks at the rotation speed and its harmonics indicating looseness (→ **fig. 15**).

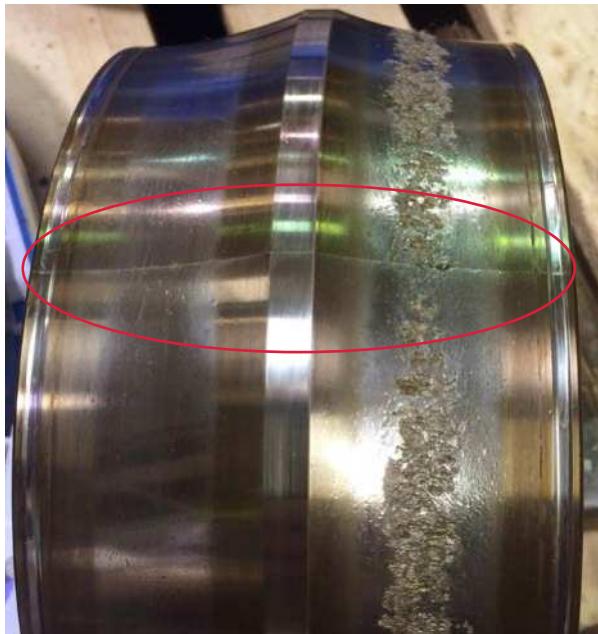
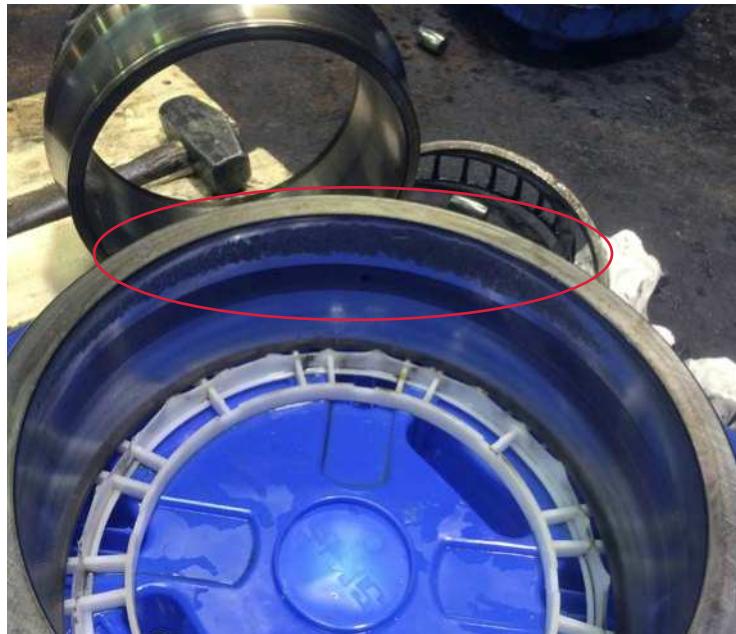
Fig. 16: Damaged bearing inner and outer rings

Fig. 16 shows the bearing after it was dismounted and cleaned for root cause failure analysis. Both the inner ring crack as well as damage from one side/roller set are clearly visible. The latter indicates the possibility of overloading in the axial direction or wear from contamination or insufficient lubrication.
