**SKF**

# **BEARING DAMAGE AND FAILURE ANALYSIS**

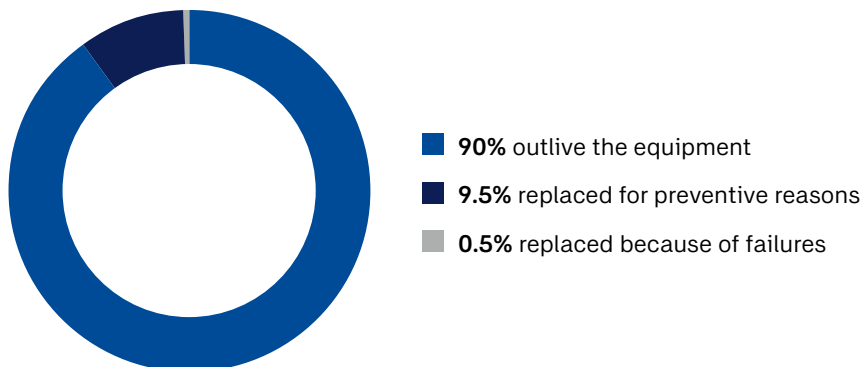
Diagram 1

Every year billions of bearings are manufactured around the world. Only a small fraction of all bearings in use actually fail (**diagram 1**). Most of them (some 90%) outlive the equipment in which they are installed. A number of bearings (9,5%) are replaced prior to failure for security (preventive) reasons. Approximately 0,5% of bearings are replaced because they are damaged or fail.

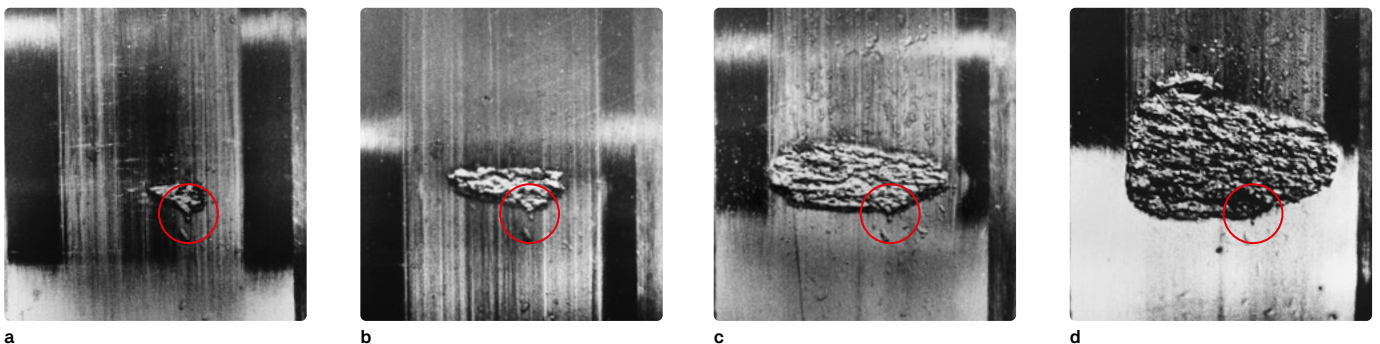
Fig. 1

A hard contaminant was over-rolled and made an indentation in the inner ring raceway of a cylindrical roller bearing (a). The surface initiated fatigue resulting in a spall started just behind the indentation. Over a period of time, spalling became more and more pronounced (b, c). If the machine was not stopped in time, secondary damage to machine components could have occurred. The initial indentation is no longer recognizable (d).

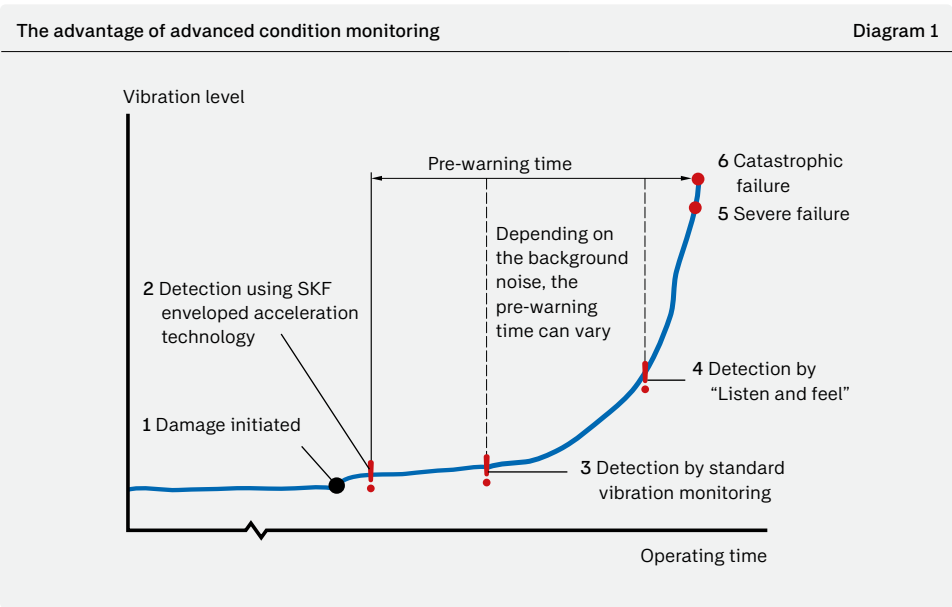
Fig. 1

**Fig. 1** shows the progress of damage as illustrated in **diagram 1**:

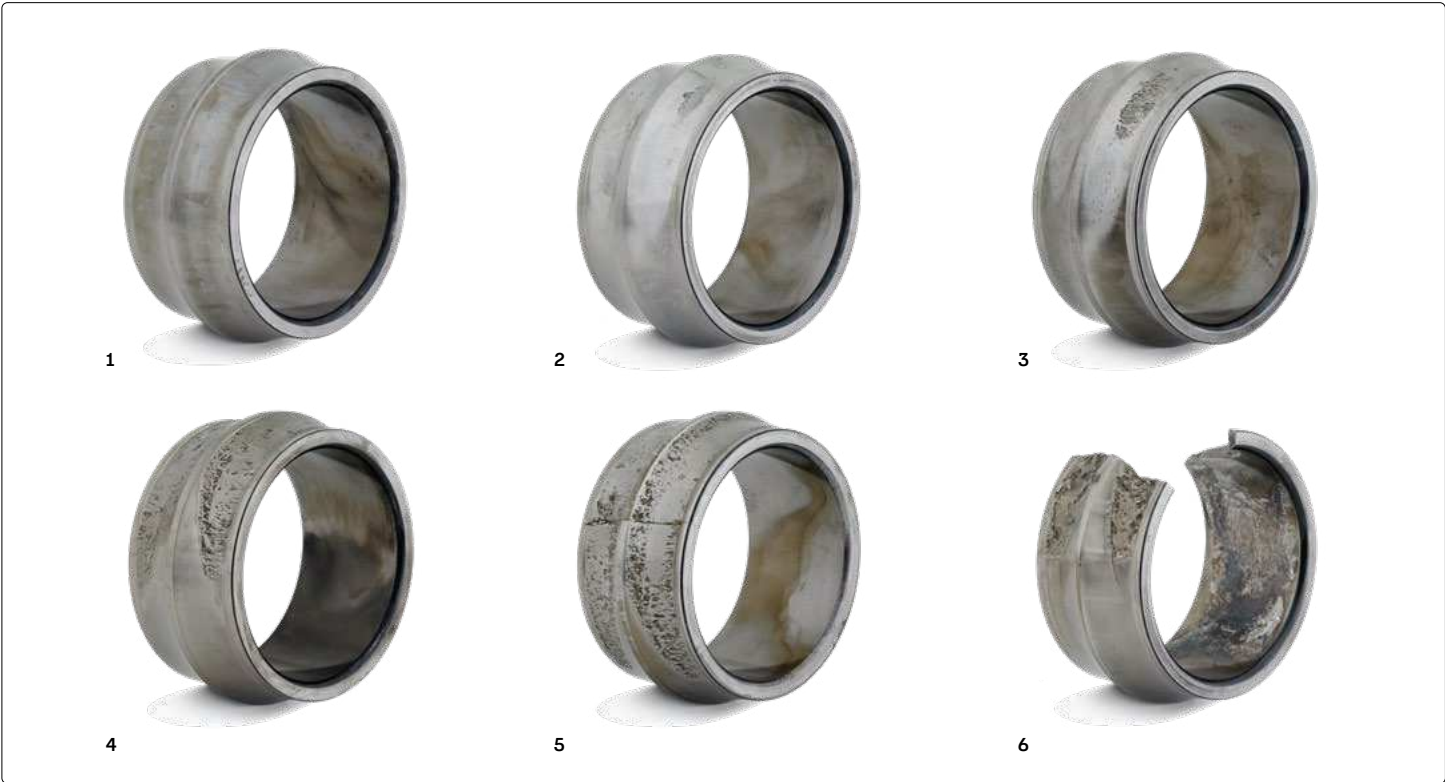
1. Bearing exhibits incipient abrasive wear.
2. First spall, detected by SKF enveloped acceleration technology.
3. Spalling has developed to an extent that the damage can be detected by standard vibration monitoring.
4. Advanced spalling causes high vibration and noise levels and an increase in operating temperature.
5. Severe damage occurs: fatigue fracture of the bearing inner ring.
6. Catastrophic failure occurs with secondary damage to other components.

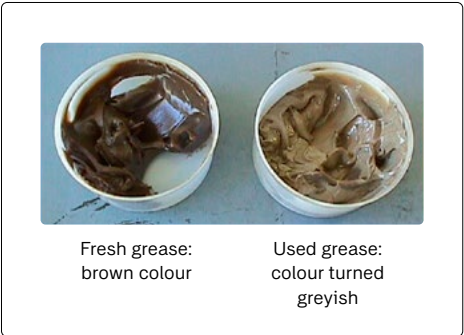
Fig. 2

- Take photographs throughout the inspection process to help document the condition of the bearing, lubricant and machine in general.
- Check the condition of the grease at different places and compare with fresh grease (fig. 2). Keep a representative sample of the grease for further analysis.
- Certain large and medium-size bearings are suitable for remanufacturing. For additional information, refer to the *SKF bearing maintenance handbook* and publication *SKF Remanufacturing Services*.

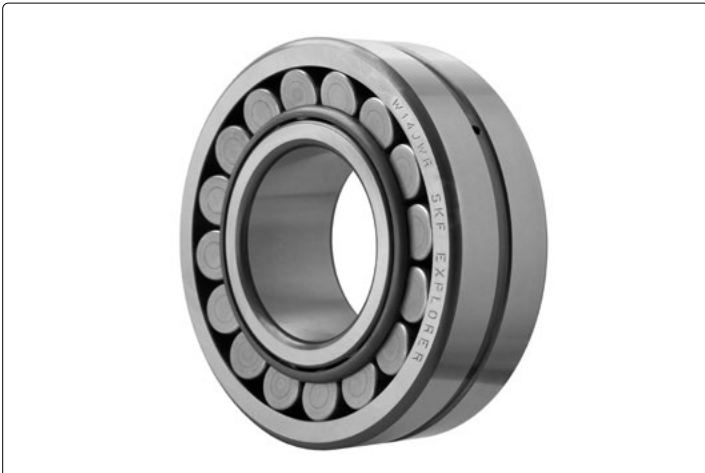
Fig. 1

A new bearing looks beautiful, like a piece of art (fig. 1). Its components have been made to exacting dimensions, often to fractions of a micron. The dimensions of components and the assembled bearing have been checked during the manufacturing process. The areas that have been ground, such as the surfaces of inner and outer rings and rolling elements, look very shiny. Unground surfaces (chamfers, shoulders, etc.) can have uneven coloration due to the heat treatment.

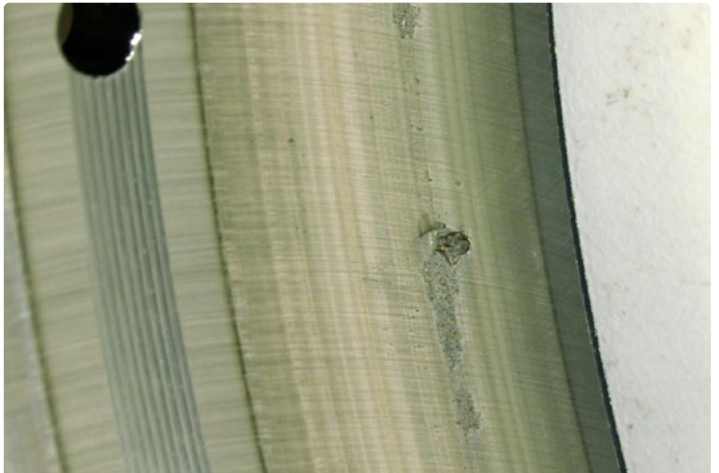
Fig. 2

- wear and spalling on raceway (fig. 2)
- cage wear
- creep marks on the inner ring bore or outer ring outside surface
- fretting corrosion on the inner ring bore or outer ring outside surface
- spalls on the rolling elements and raceways

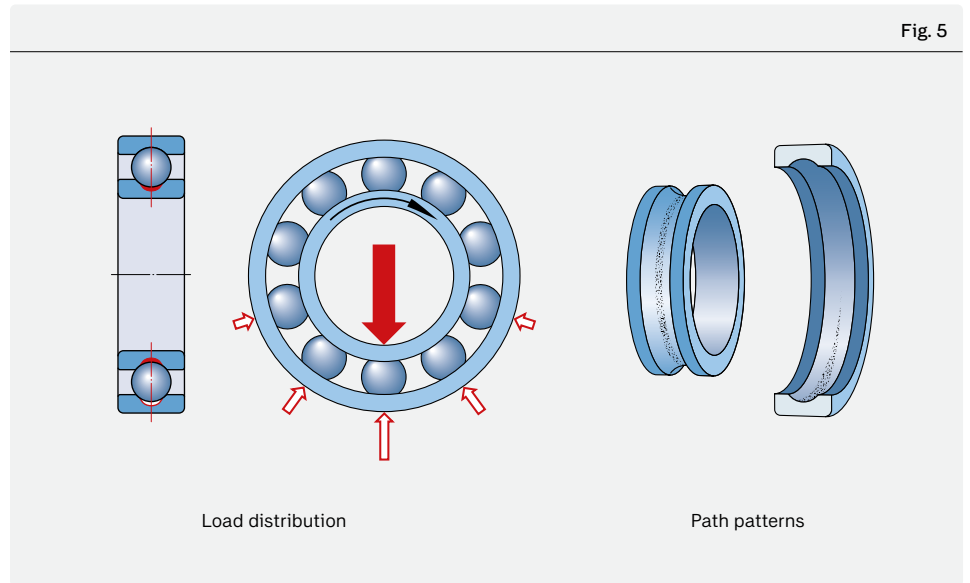
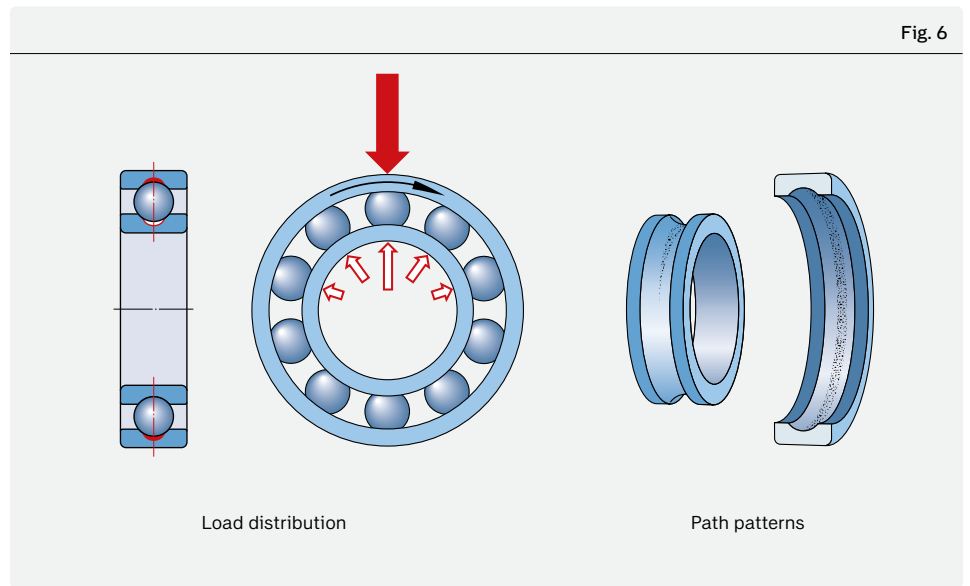
Fig. 4 shows the load distribution in a radial bearing (inner ring rotation).

The large arrow at the 12 o'clock position represents the applied load on the shaft. The small arrows from 4 o'clock to 8 o'clock represent the load zone in the outer ring and show how the applied load is shared or supported by the rolling elements in the bearing.

Fig. 5 illustrates how an applied unidirectional and constant radial load acting on the rotating inner ring of a bearing is distributed to the stationary outer ring by the rolling elements.

The stationary outer ring has a centred path pattern that is limited to the load zone. This is referred to as a stationary outer ring load zone. The load distribution in the outer ring load zone varies. The path pattern is widest in the direction of the load and decreases in either direction from that point. In most applications, bearings operate with radial clearance and the load zone is approximately  $150^\circ$  (fig. 4).

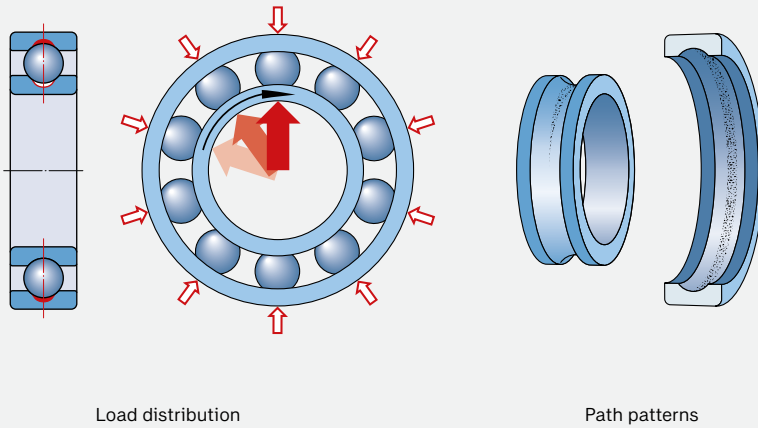
Fig. 7 illustrates how an applied constant radial load rotating in phase with the inner ring of a bearing (i.e. imbalanced or eccentric load) is distributed to the stationary outer ring by the rolling elements.

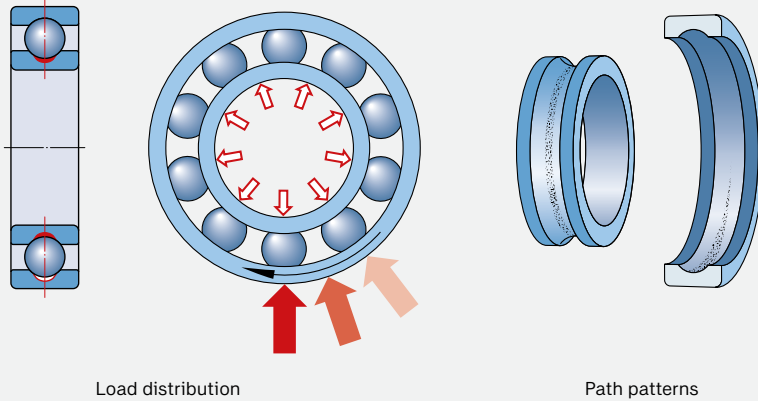
Fig. 8 illustrates how an applied constant radial load rotating in phase with the outer ring of a bearing (i.e. imbalanced or eccentric load) is distributed to the stationary inner ring by the rolling elements.

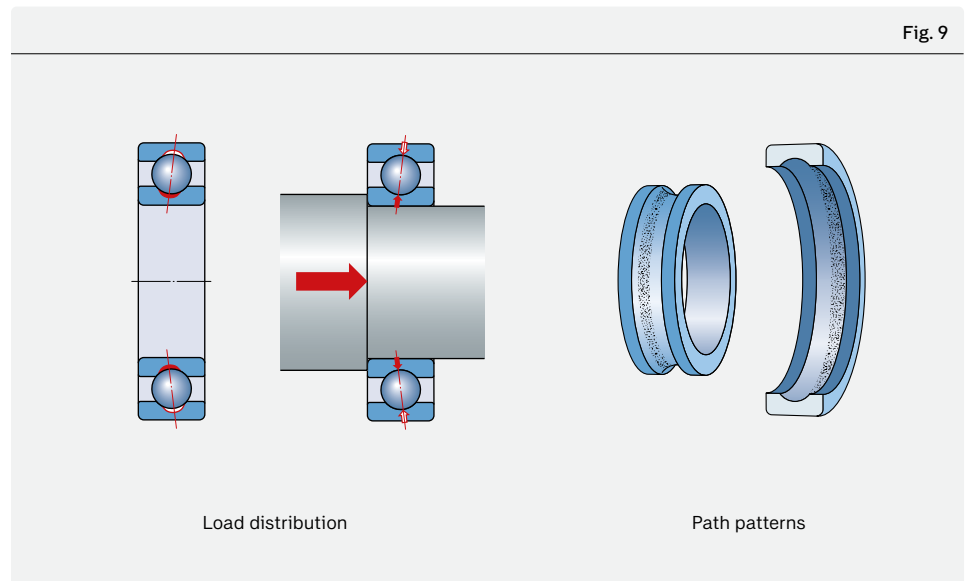
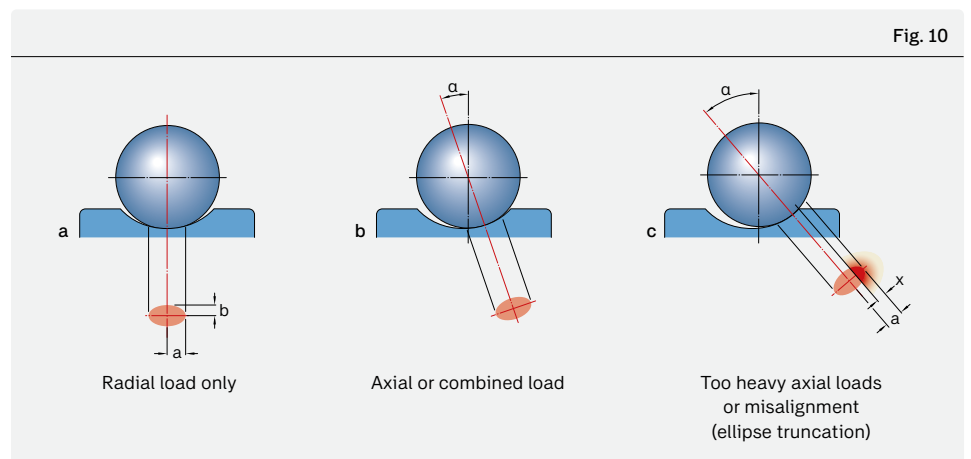
raceway in a deep groove ball bearing is an ellipse (fig. 10). Under pure radial load, the contact ellipse is centred in the middle of the raceway (fig. 10a). When the bearing is subjected to an axial load, the bearing operates with a contact angle ( $\alpha$ ) and the contact area moves along the groove profile towards the ring edge (fig. 10b).

Under too heavy axial loads or misalignment, the loading conditions of the bearing can be such that part of the contact ellipse is no longer supported by the raceway (fig. 10c). This phenomenon is called ellipse truncation, which leads to stress concentrations in the contact area. This may be detrimental for both bearing fatigue life and noise levels.

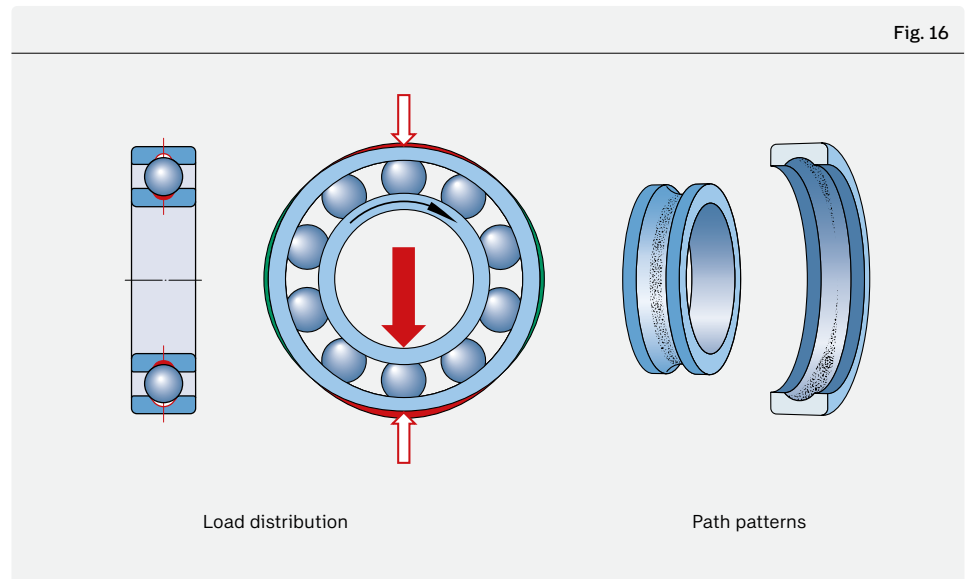
Fig. 16 illustrates how an applied uni-directional and constant radial load acting on the rotating inner ring of a bearing is distributed to the stationary and oval clamped outer ring by the rolling elements.

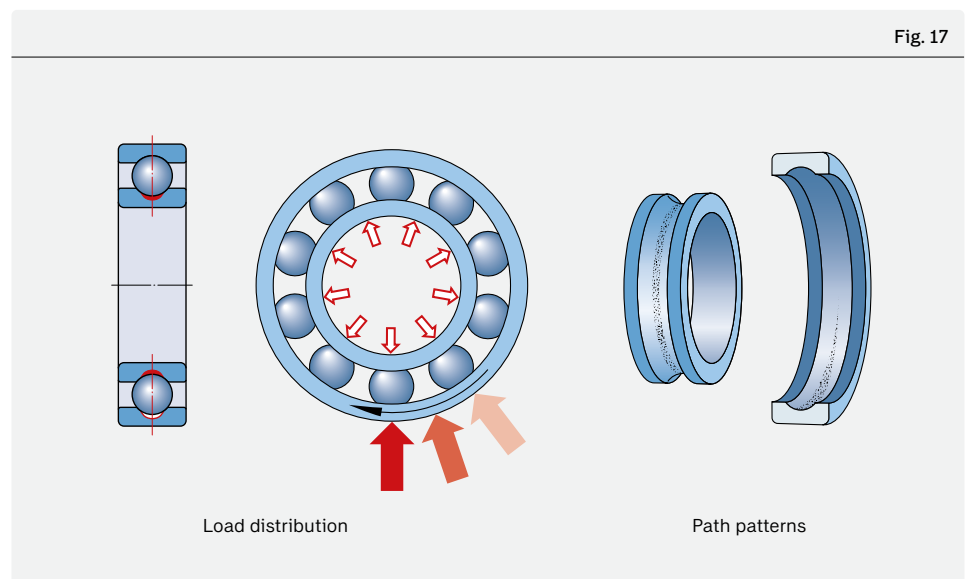
Fig. 17 illustrates how an applied uni-directional and constant radial load acting on the rotating inner ring of a radially preloaded bearing is distributed to the stationary outer ring by the rolling elements.

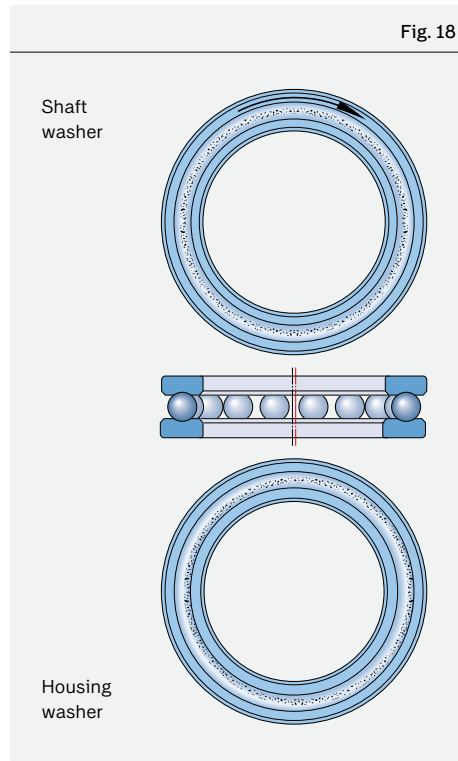
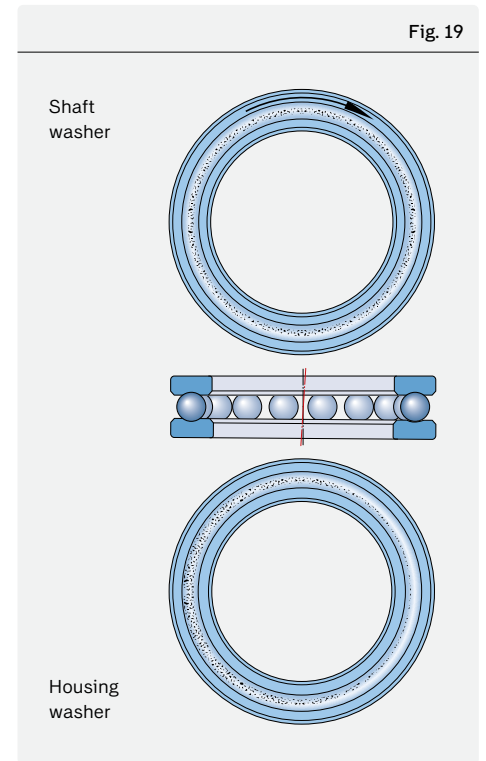
The shaft washer has a path pattern around its raceway that is centred and uniform in width.

The housing washer has a path pattern around its raceway that is centred, but varies in width.

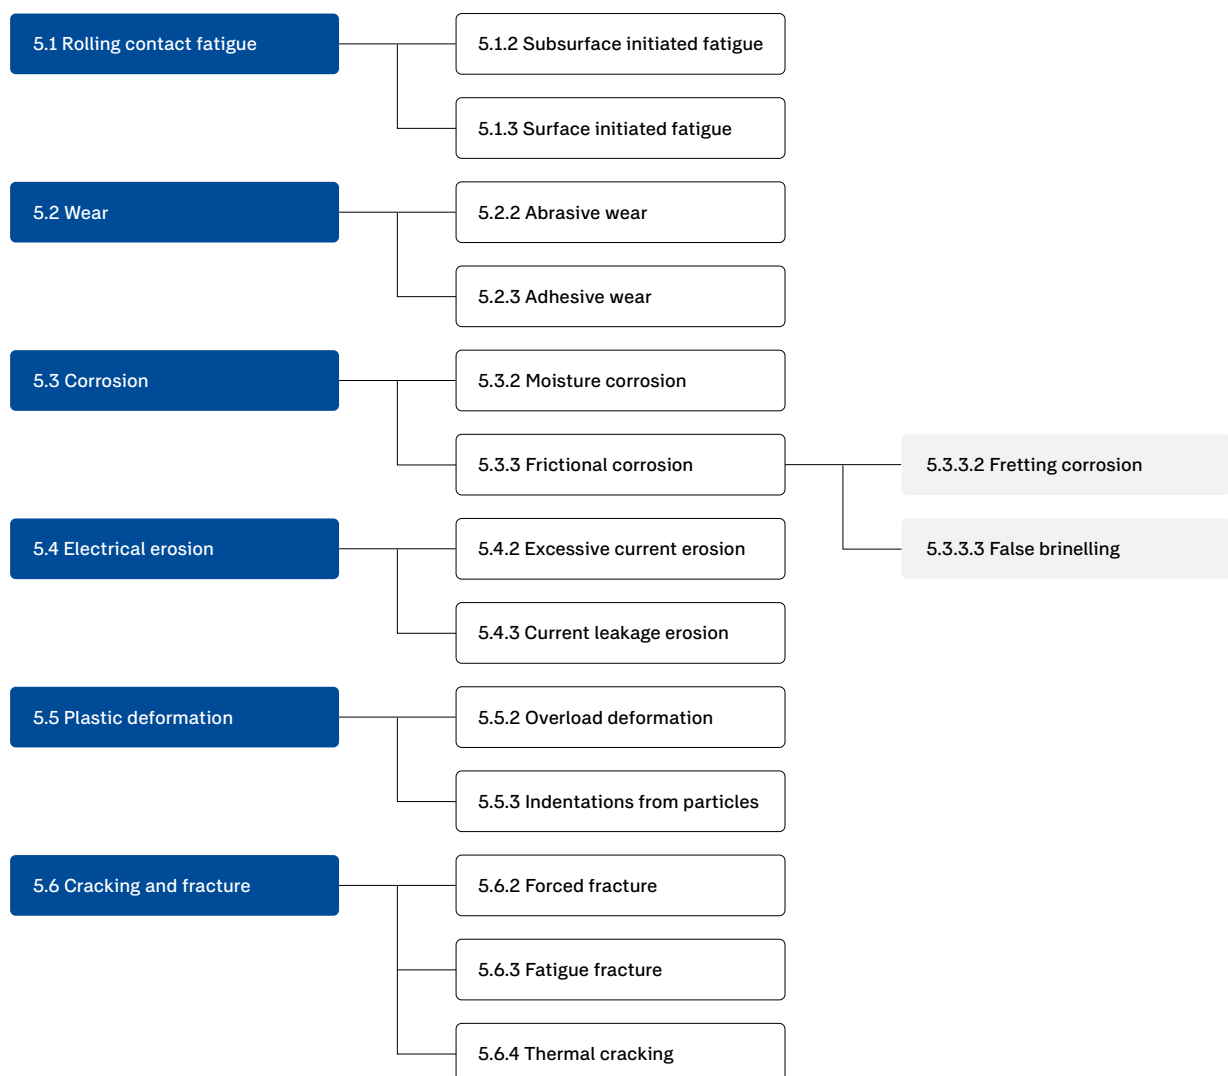
Diagram 1

The failure modes are divided into 6 main modes and thereafter into sub-modes (**diagram 1**). There are 14 failure modes in total. The features of each mode, together with some typical examples, are covered in this chapter.

ISO 15243 failure modes classification

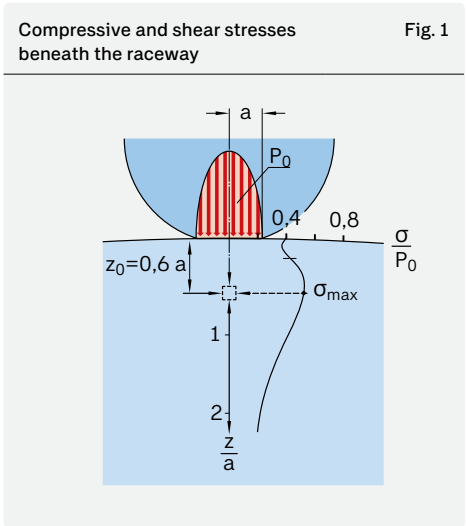
Fig. 2

In these planes, so-called subsurface microcracks develop beneath the surface at the weakest location, around the zone of maximum shear stress, typically at a depth of 0.1 to 0.5 mm (figs. 2 and 3). The depth depends on the load, material, cleanliness, temperature and the micro-structure of the steel. The crack finally propagates to the surface and spalling occurs (fig. 4).

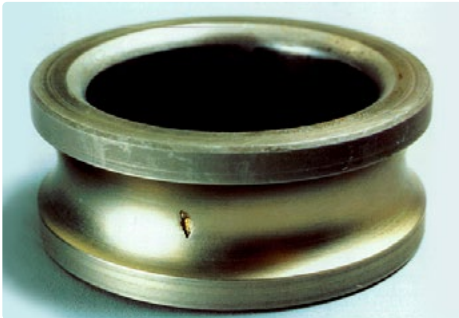
Fig. 4

Initial subsurface spalling on the inner ring of a deep groove ball bearing

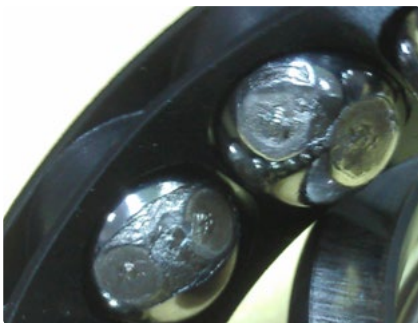
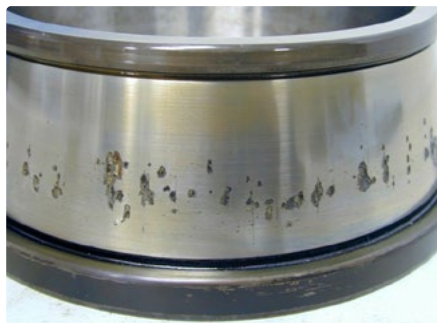
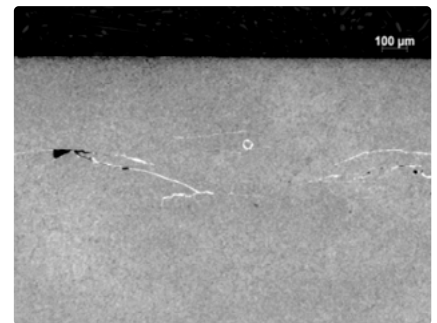
Fig. 5

The premature fatigue occurs much earlier in the bearing operating life (for example < 5 to 10% of rating life) compared to its expected calculated rating life. Premature fatigue can evidence itself via large subsurface white etching crack (WEC) networks when the material is sectioned, etched, and examined under high magnification. WEC can also be observed in the subsurface of the material at early stages before migration to the surface (fig. 5).

Premature subsurface initiated fatigue - Calotte spalling of steel balls caused by hydrogen induced cracking from  $\text{CO}_2$  and condensing water (left), general spalling due to stress overload (center), white etched crack (right)

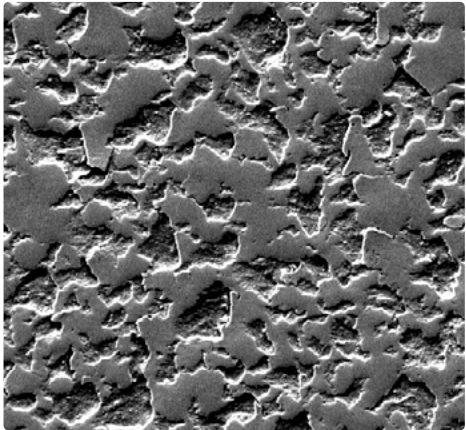
Fig. 8

Generally, these microspalls are only a few microns in size and the surface just looks dull and grey (fig. 7). Only under a microscope can cracks and spalls be detected (fig. 8).

Microspalls on the raceway surface (250× magnification)

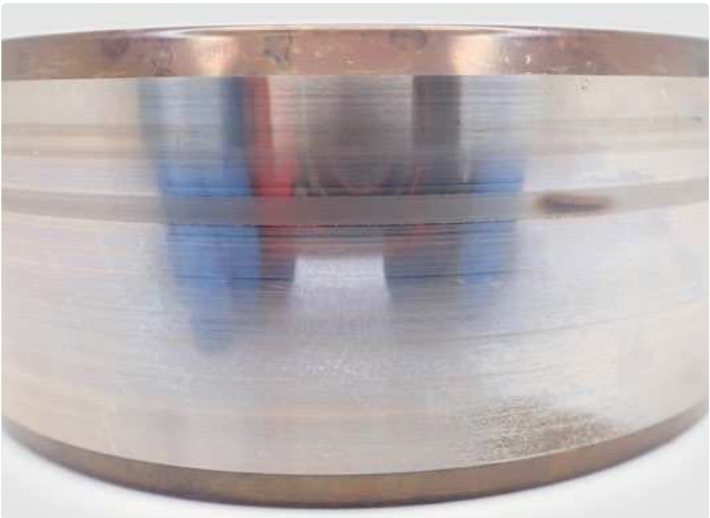
Fig. 7

Microspalls on the inner ring raceway of a cylindrical roller bearing. See fig. 8 for magnification.

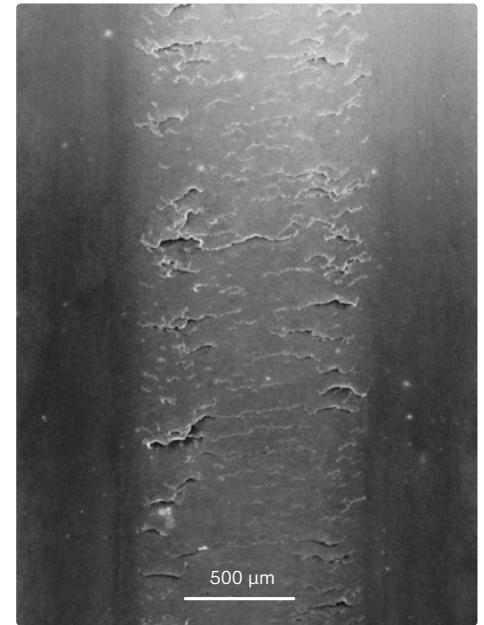
Fig. 9 shows the start of spalling following surface initiated fatigue due to inadequate lubrication.

Initial spalling resulting from surface initiated fatigue on the inner ring raceway of a deep groove ball bearing

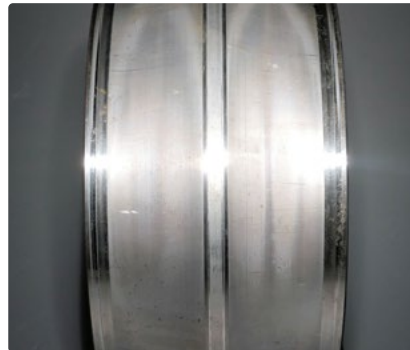
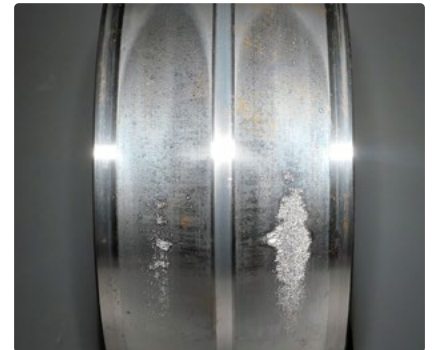
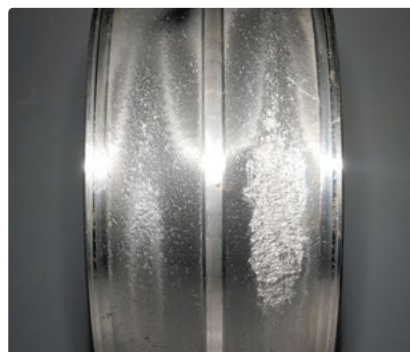
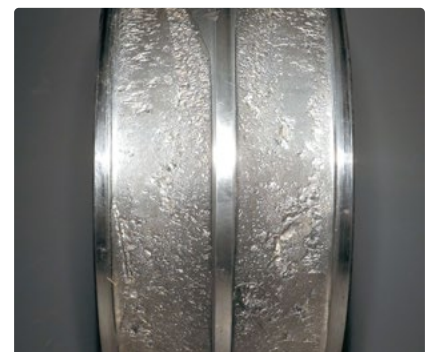
Fig. 10 shows the progression of surface initiated fatigue into overall spalling.

Progress of surface initiated fatigue on the inner ring raceways of a spherical roller bearings

1. Initial wear

2. Local spalling

3. Advanced spalling

4. Spalling over the entire raceways

1. Initial wear
2. Local spalling
3. Advanced spalling
4. Spalling over the entire raceways

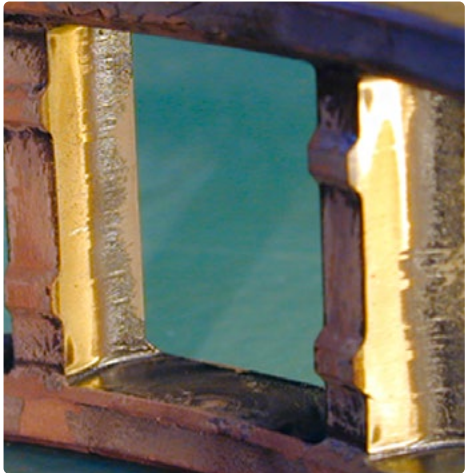
The cage is a critical part of the bearing. Rings and rolling elements are hardened to approximately 60 HRC. Most metal cages are unhardened (sheet metal or brass). Under poor lubrication conditions, the cage may be the first component to wear. Fig. 13 shows pocket wear in a solid brass cage.

Abrasive wear on the cage bars of a cylindrical roller bearing

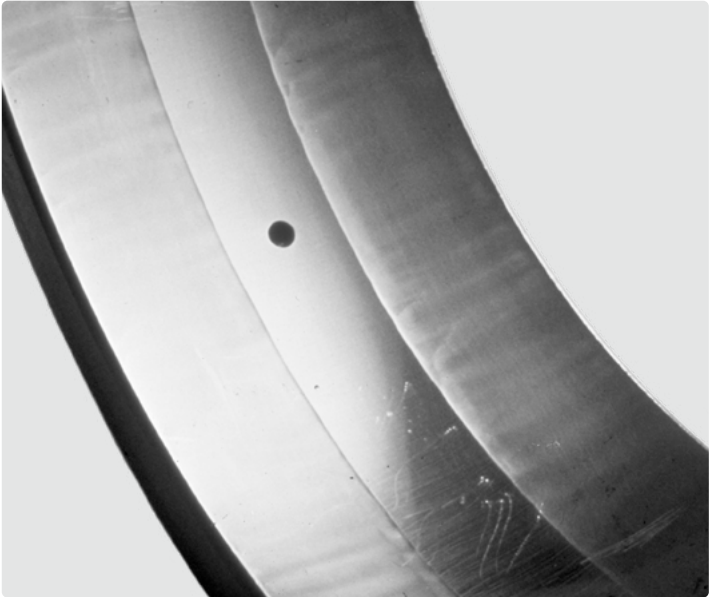
Light abrasive wear on the outer ring raceway of a spherical roller thrust bearing

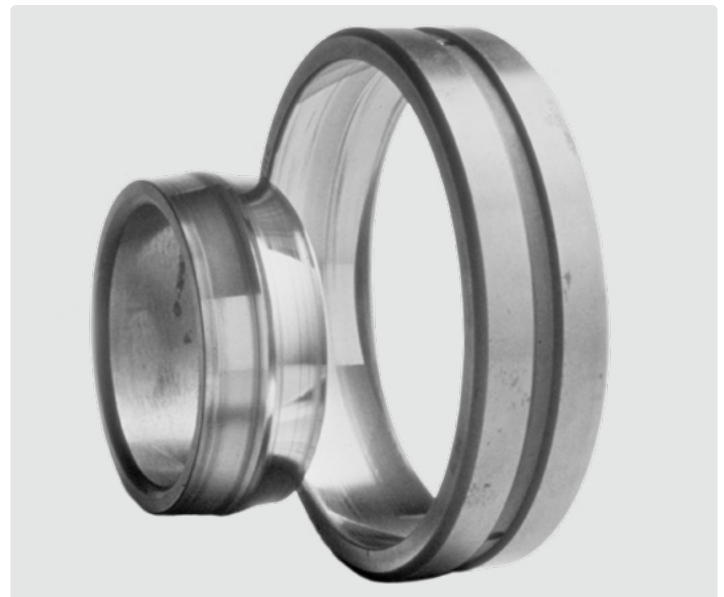
Fig. 14

Polishing wear is a special form of abrasive wear. The raceway surfaces of new bearings are shiny but not highly reflective (mirror-like). Real mirror-like surfaces in a bearing that has been in service (fig. 14) result from inadequate lubrication caused by a thin oil film, and particles that are acting as a polishing agent. This allows metal-to-metal contact, which leads to abrasive wear and plastic deformation of the asperities (fig. 15). The surfaces may become extremely shiny – all depending on the size of the particles, their hardness and running time.

This level of abrasive wear results from a combination of factors: the viscosity of the oil is too low and there is an excessive amount of very small abrasive particles in the oil. Other factors can include a combination of low speeds, heavy loads and an insufficient oil film.

Polishing wear (mirror-like raceway surfaces) on the inner and outer rings of a spherical roller bearing

To avoid this type of damage, increase the viscosity of the lubricant and monitor the cleanliness of the lubricant regularly.

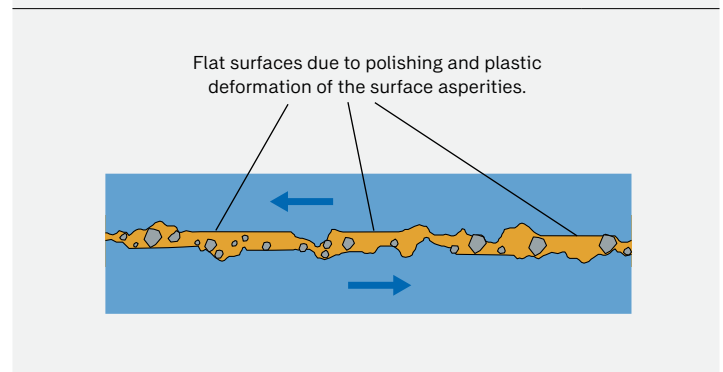
Fig. 15

Process of polishing wear in a bearing

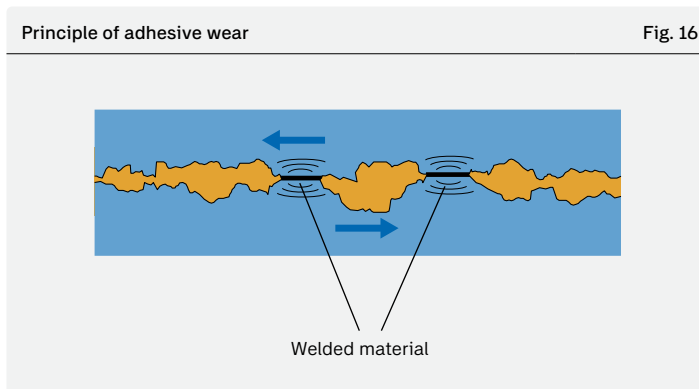
Fig. 17

The rolling elements are therefore subjected to rapid (sudden) acceleration when they enter the load zone (fig. 17). This sudden acceleration can cause sliding, which can generate enough heat, so that the two surfaces melt together at the points of metal-to-metal contact (fig. 16). This welding process causes material to be transferred from one surface to the other, which also leads to higher friction (fig. 18).

Highest risk for adhesive wear when rolling elements accelerate as they enter the load zone

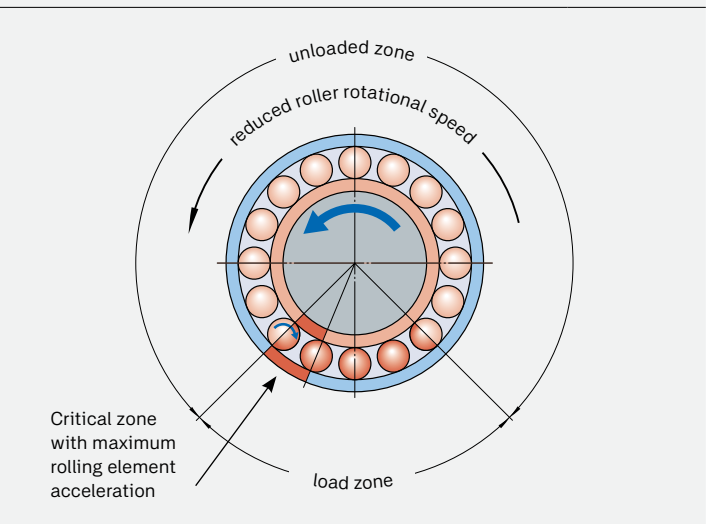
*Smearing (adhesive wear) due to too light loading*

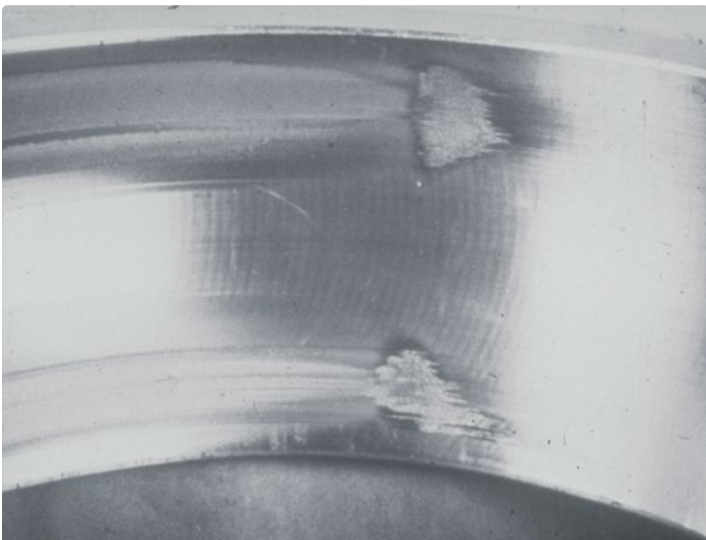
Fig. 18

Smearing on the raceways of a spherical roller bearing outer ring (smearing marks at the entrance of the load zone)

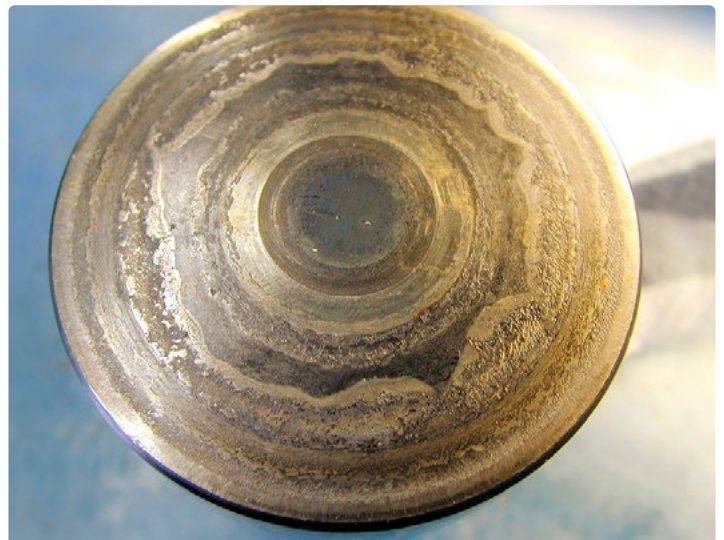
Fig. 19

Smearing on a roller thrust face of a spherical roller thrust bearing

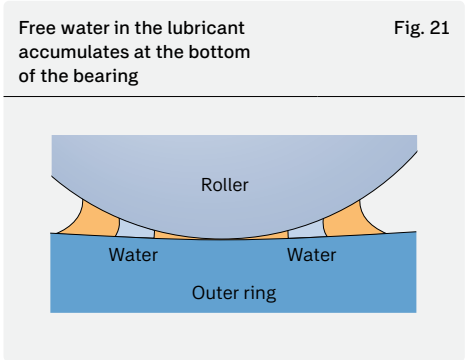
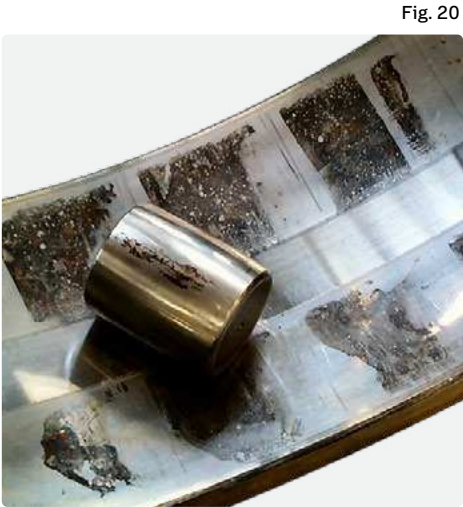
Corrosion on the outer ring raceways and roller of a spherical roller bearing

Etching usually leads to premature, extended spalling as the material is subjected to a structural change and the surfaces in the load zone are reduced to such an extent that overloading occurs. The best way to avoid corrosion is to keep the lubricant free from water and aggressive liquids by adequately sealing the application. Using a lubricant with good rust-inhibiting properties also helps.

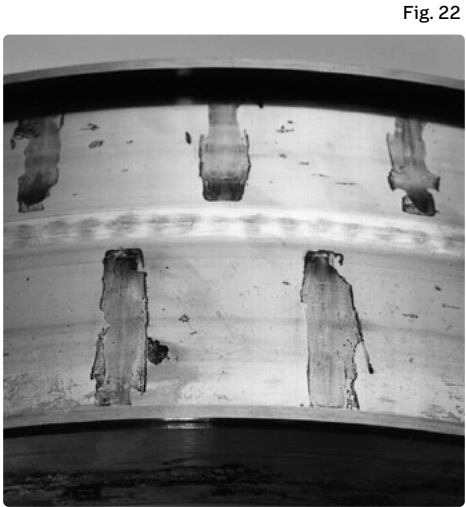
Initial patches of etching at rolling element spacings on the inner ring raceways of a spherical roller bearing

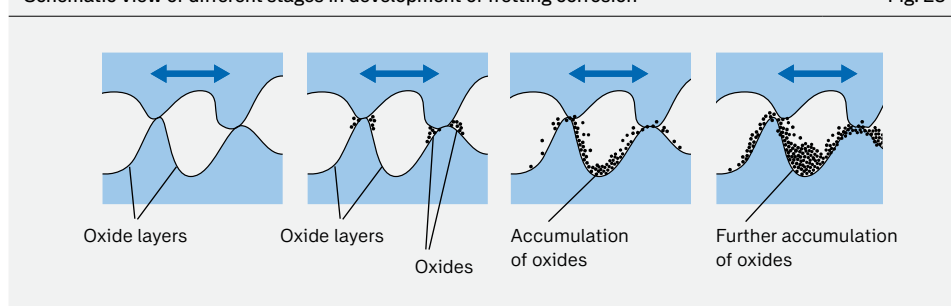
Fig. 23

The relative movement may cause small particles of material to become detached from the bearing surface and its seat. These particles oxidize quickly when exposed to air and the result is iron oxide (fig. 23). Iron oxide is larger in volume than iron (steel). As a result of the fretting corrosion, the bearing rings may not be evenly supported, which can have a detrimental effect on the load distribution in the bearing.

Schematic view of different stages in development of fretting corrosion

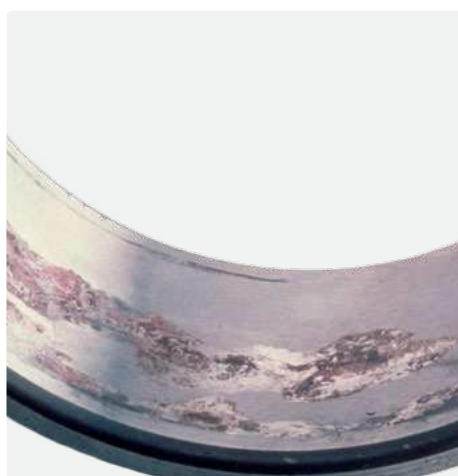
Fig. 24 shows fretting corrosion resulting from a shaft surface that was not properly machined or from shaft bending (due to a cantilever load or an overhung load).

Fretting corrosion on an inner ring bore resulting from an inadequate shaft seat or shaft bending

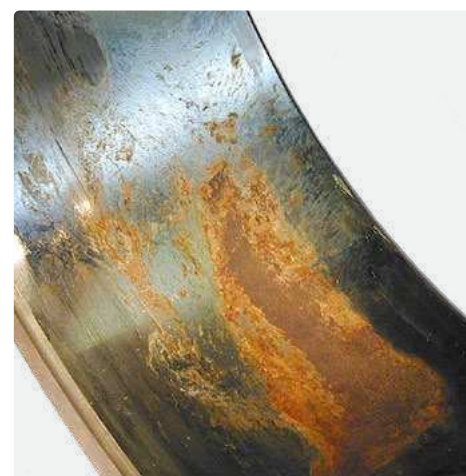
Fig. 25 shows fretting corrosion from very heavy loading or an inadequate seat.

Fretting corrosion on an inner ring bore resulting from heavy load or inadequate shaft seat

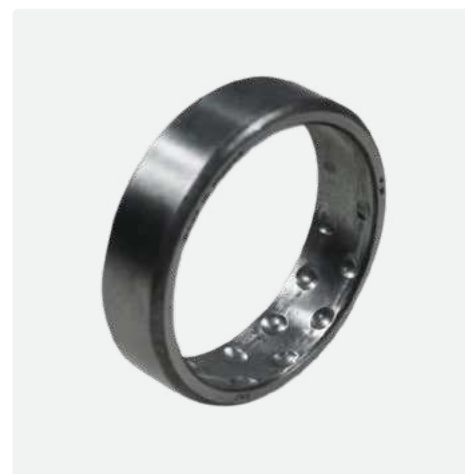
Fig. 26 shows severe false brinelling damage caused to the outer ring raceway of a self-aligning ball bearing at standstill.

Severe false brinelling on the outer ring raceway of a self-aligning ball bearing

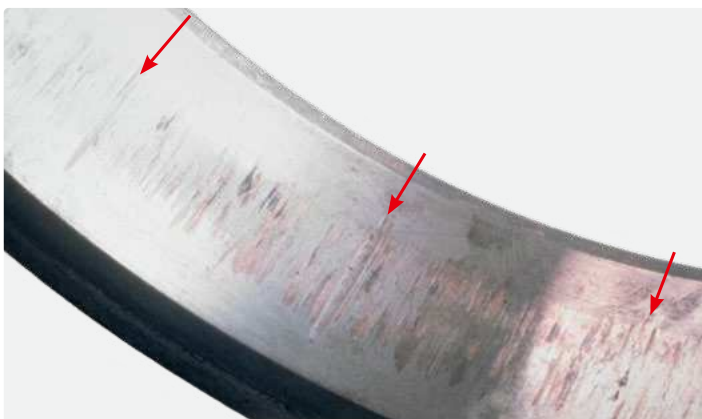
Fig. 27 shows false brinelling damage on the outer ring raceway of a cylindrical roller bearing. The root cause is vibration during standstill. The bearing was mounted in auxiliary equipment, with long standstill periods. Several sets of brinell marks can be observed at roller spacing, each set resulting from a period of standstill. The magnitude of damage depends on the level of vibration, frequency of vibration, and length of standstill.

False brinelling on the outer ring raceway of a cylindrical roller bearing

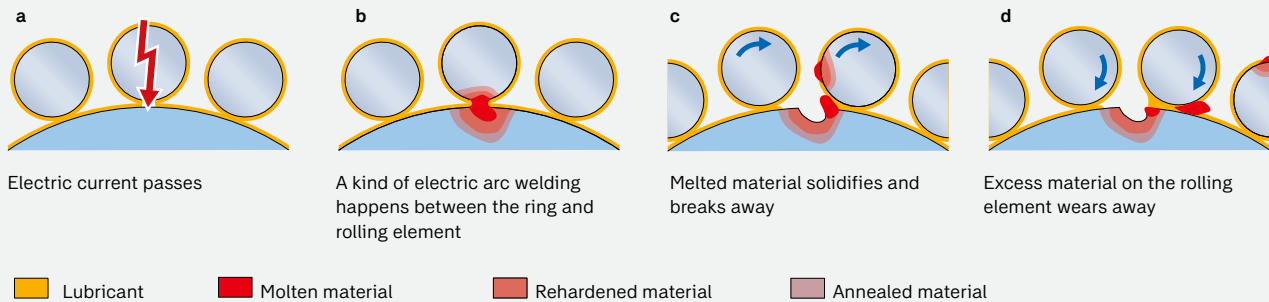
Fig. 28

When an electric current (fig. 28) passes from one ring to the other via the rolling elements, damage will occur (a). At the contact surfaces, the process is similar to electric arc welding (high current density over a small contact surface, b). The material is heated to temperatures ranging from tempering to melting levels. This leads to the appearance of discoloured areas, varying in size, where the material has been tempered, rehardened or melted. Craters also form where the material has

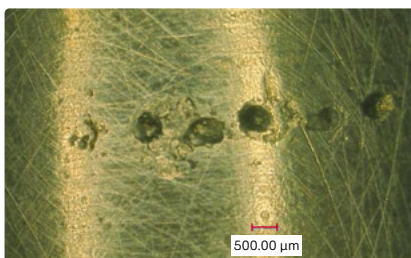
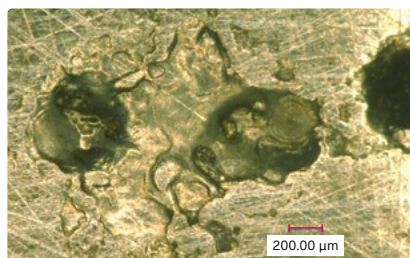
Fig. 29 shows an example of a spherical roller bearing subjected to an excessive electrical current. A number of rather large craters can be seen on the roller. A magnification clearly shows the craters with the molten material around their edges.

Excessive current erosion on a roller of a spherical roller bearing

Craters of 0.5 mm in size

Magnification

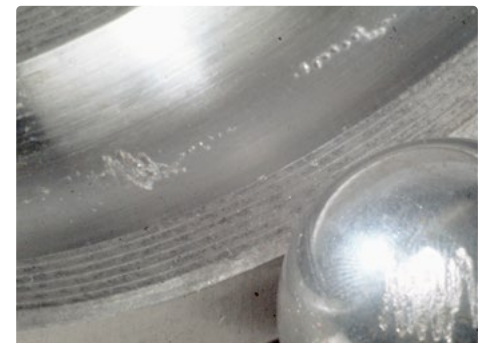
Fig. 30 shows damage caused by excessive electrical current in a deep groove ball bearing, both on the outer ring raceway and ball. Notice the zigzag burns.

Excessive current erosion on the outer ring raceway and ball of a deep groove ball bearing

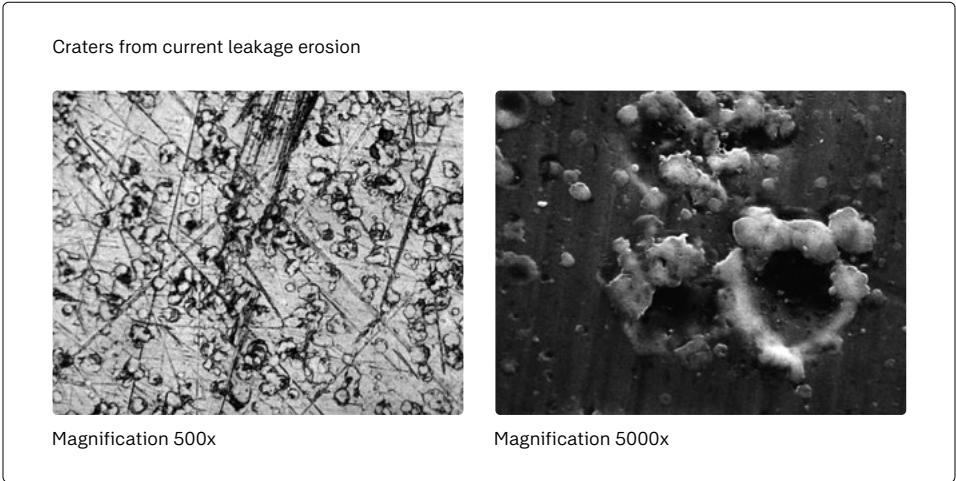
Fig. 32

A fluting pattern may develop from craters over time. The pattern appears on the raceways (**figs. 32** and **34**). For roller bearings, the fluting pattern also appears on the rollers (**fig. 34**). In ball bearings, the balls typically become discoloured (dull, light to dark grey) over their entire surface.

Fluting caused by current leakage erosion

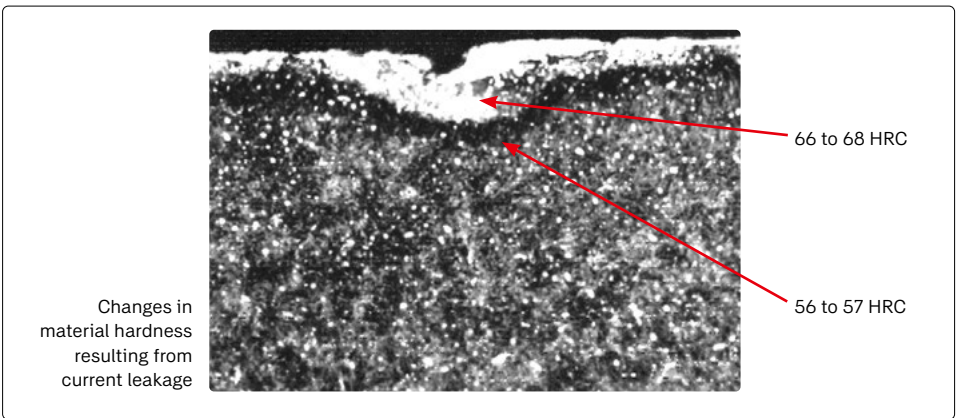
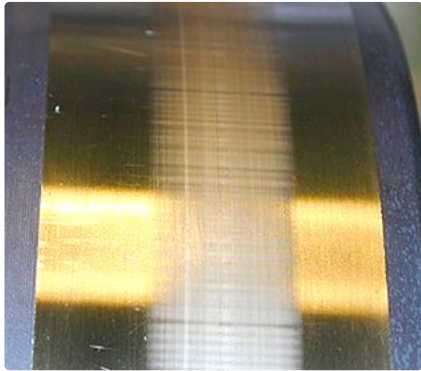
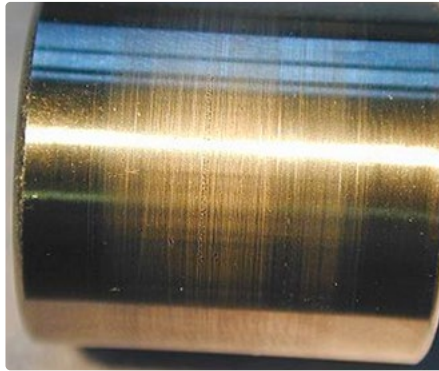
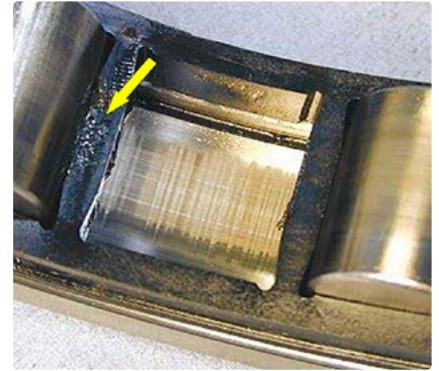
Fig. 34

Fluting on inner and outer rings and roller raceways

**Fig. 34** shows damage to a cylindrical roller bearing due to current leakage. Fluting is developing on the raceways and rollers. Notice the grease on the cage pockets. At the start of this failure mode, the grease is gradually carbonized and loses its ability to form a lubricant film. This eventually leads to surface initiated fatigue, spalling and even sudden seizure.

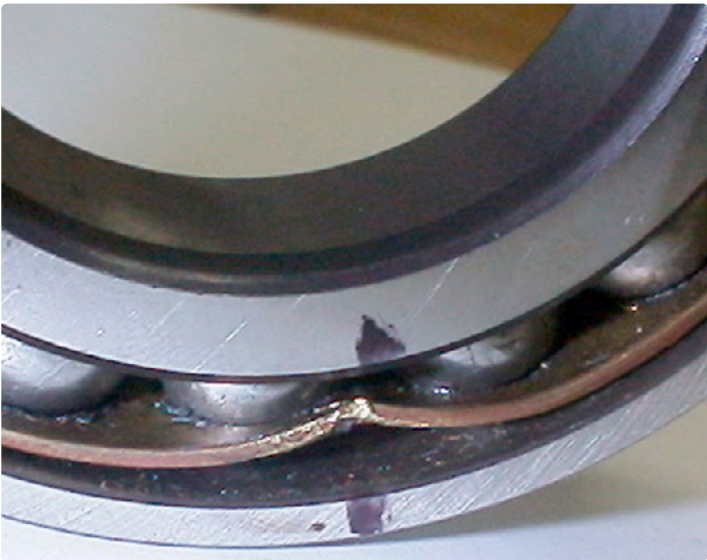
Fig. 35 shows a case where a cage was hit directly, causing it to deform. If this bearing were put into operation, high noise and vibration levels would result.

Plastic deformation on the cage of an angular contact ball bearing resulting from poor handling
