**SKF**

# **BEARING DAMAGE AND FAILURE ANALYSIS**

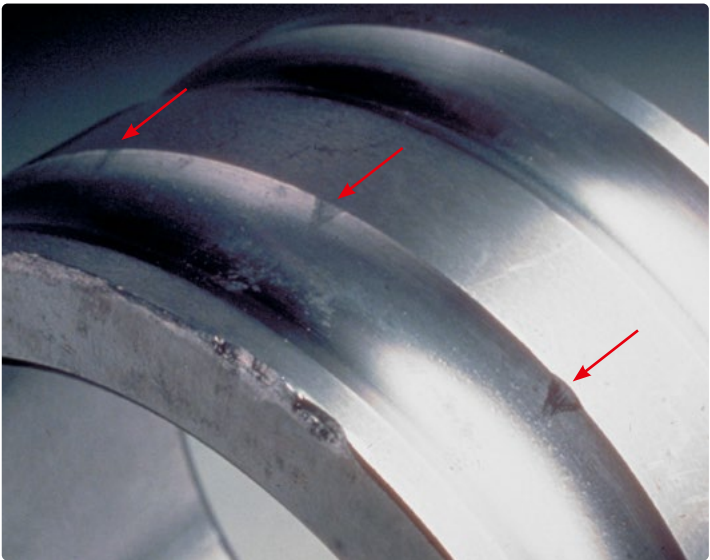
Fig. 37

Raceways and rolling elements may become dented if the mounting force is applied through the rolling elements (fig. 36), or if the bearing is subjected to abnormal loading while stationary. The distance between the indentations is at rolling element spacing (fig. 37).

Indentations at ball spacing on the raceway of a double row angular contact ball bearing resulting from incorrect mounting

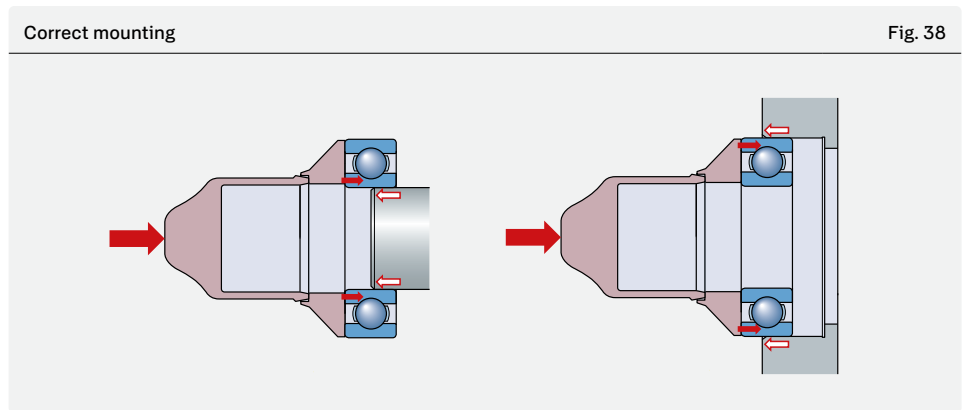
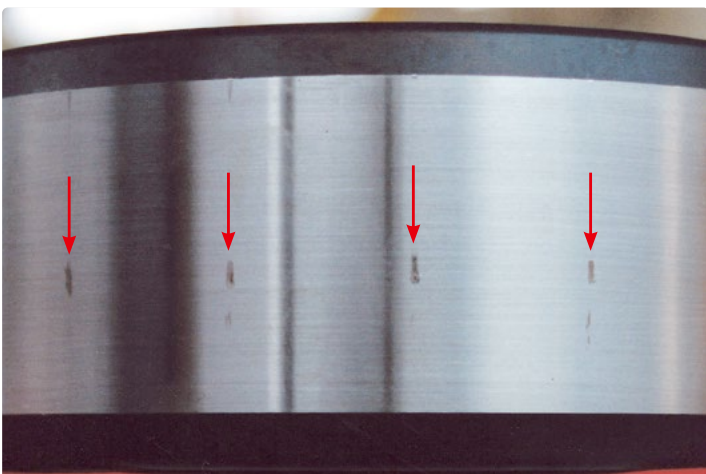
Handling is critical during manufacturing, transport, storage and mounting. Poor handling is characterized by local overloading and visible “nicks” caused by hard and/or sharp objects. Fig. 39 shows an example of poor assembly of a cylindrical roller bearing in the mounting stage. The rollers have made nicks on the inner ring raceway at roller spacing. If put into service, high noise and vibration levels will result.

Nicks on the inner ring raceway of a cylindrical roller bearing that occurred during assembly

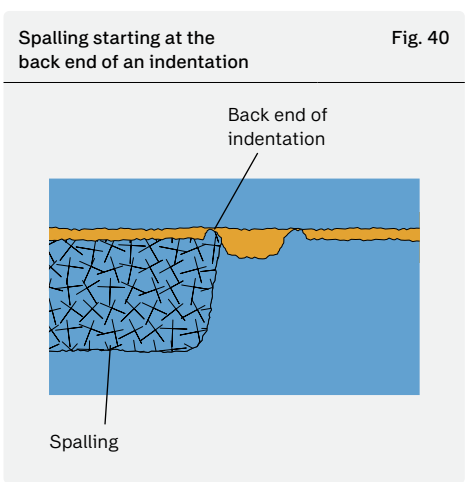
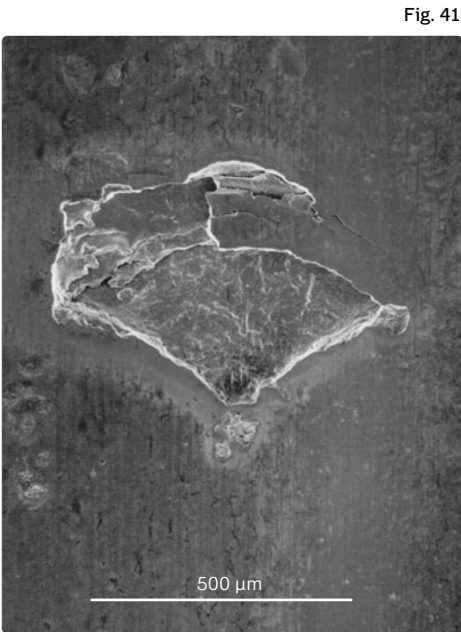
Fig. 41 shows spalling in a deep groove ball bearing, resulting from an indentation. The over-rolling direction is from bottom to top. The V-shape is a typical sign of indentation damage in a bearing where the initial spalling opens up from the back end of the indentation.

Spalling resulting from an indentation in the inner ring raceway of a deep groove ball bearing

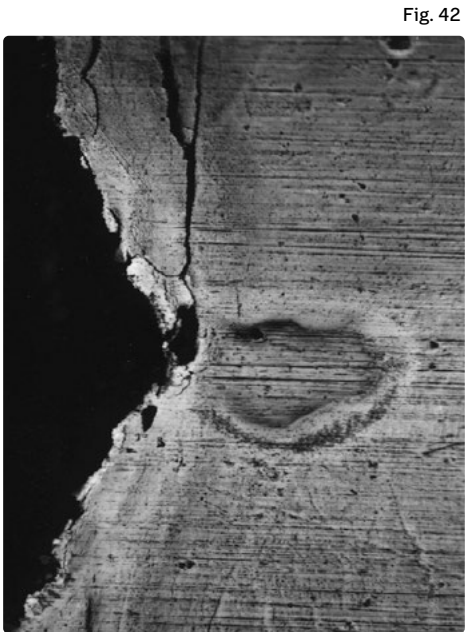
Fig. 42 clearly shows the consequences of indentations (spherical roller bearing inner ring). The over-rolling direction is from right to left. A rather large and soft contaminant was trapped in the raceway and over-rolled. At the bottom of the dent, grinding lines are still visible. Also notice the raised rim around the dent. To the left, behind the dent, there is a large spall (black colour) where material has been detached. There are also some cracks, where the material is about to be detached.

Spalling resulting from an indentation in the outer ring raceway of a spherical roller bearing

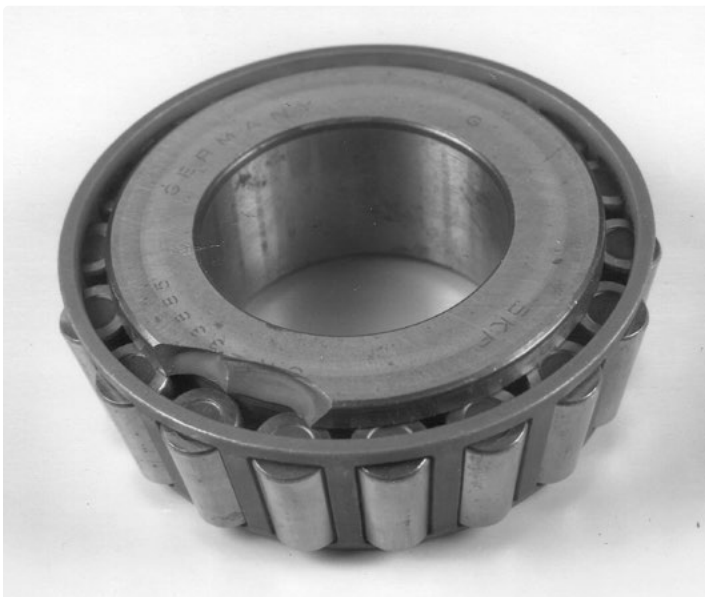
Fig. 43

Fracture on the large shoulder of a tapered roller bearing inner ring resulting from rough treatment

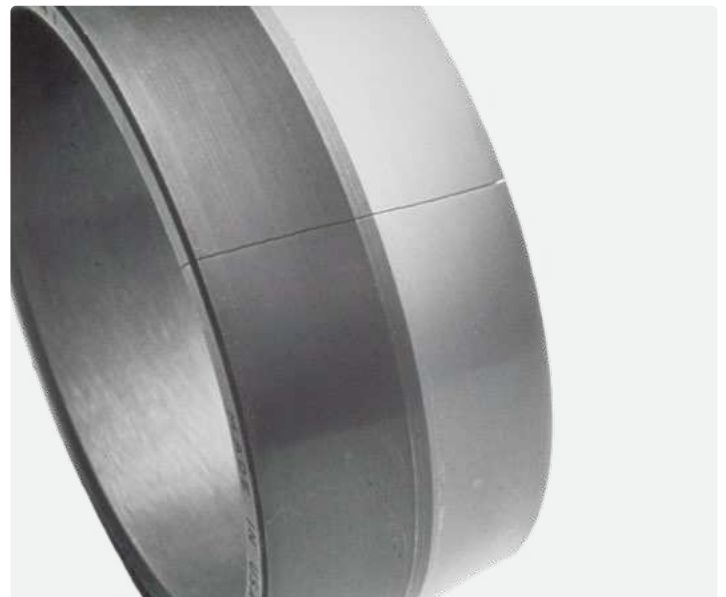
Fig. 44

Fractured inner ring of a spherical roller bearing with a tapered bore resulting from excessive drive-up

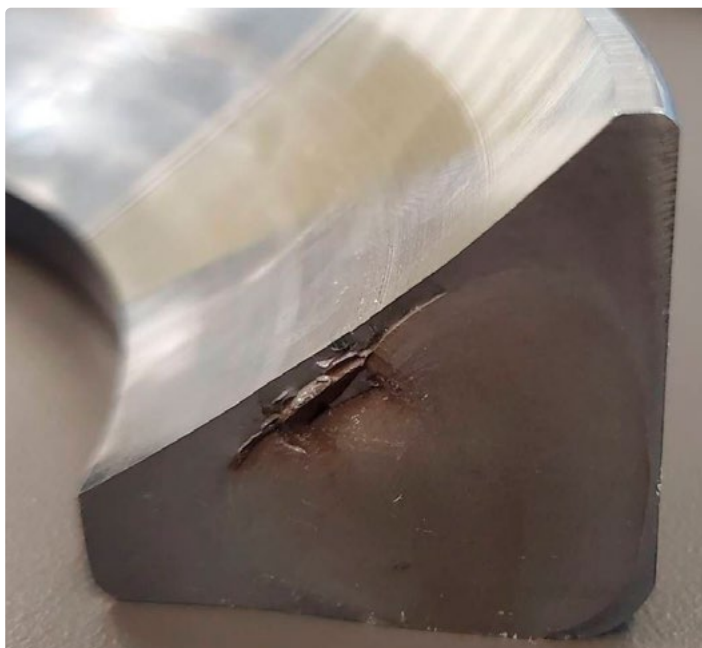
Fatigue fracture of spherical roller thrust bearing housing washer

Fig. 45 and fig. 46 show examples of fatigue fractures.

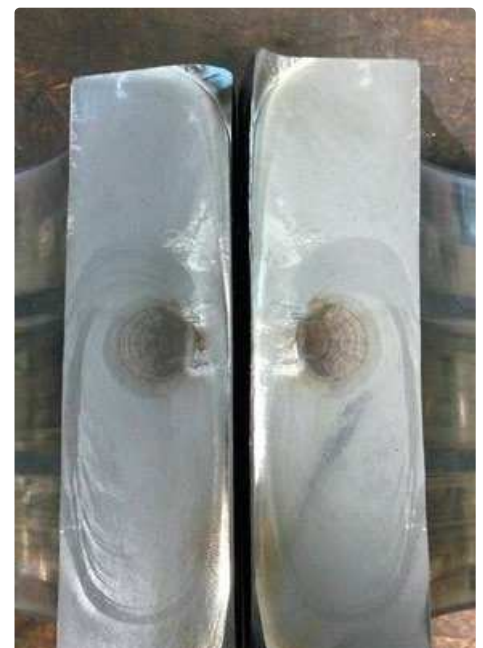
A fatigue fracture starts when the fatigue strength of a material is exceeded under cyclic bending. Repeated bending causes a hairline crack which propagates until the ring or cage develops a through crack. Fatigue fracture is often a secondary damage initiated from a stress concentration such as fatigue spalling on the rolling contact surface or fretting corrosion on the bearing inner ring bore or outer ring outside surface.

Fatigue fracture of cylindrical roller bearing outer ring

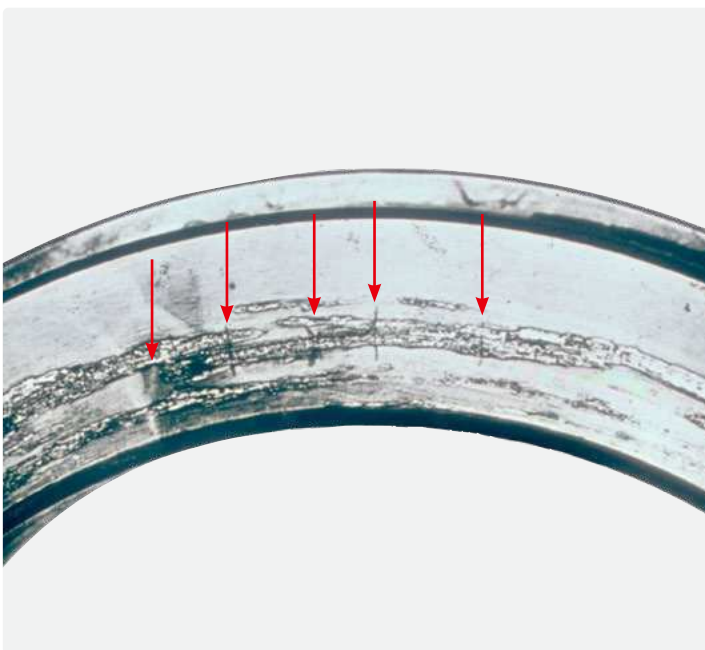
Fig. 47

Transverse thermal cracks on the small side face of the inner ring of a tapered roller bearing

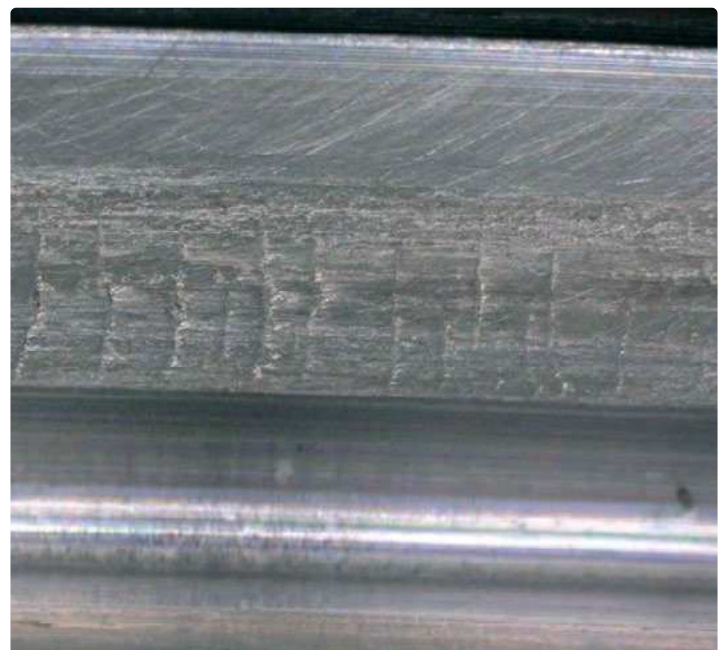
Fig. 48

Thermal cracks on the inner ring flange of a cylindrical roller bearing

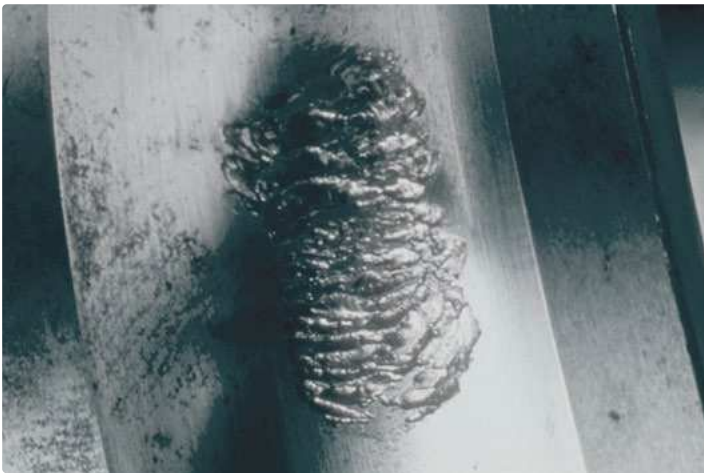
Deep groove ball bearing inner ring  
Material fatigue

- Make sure you have the right bearing for the actual application conditions and their variations (load, temperature, speed, misalignment, mounting, etc.)
- Use modern, state-of-the-art quality bearings
- If available, use SKF Explorer performance class bearings, which provide extended life
- Make sure adjacent components are properly designed and manufactured
- Mount correctly

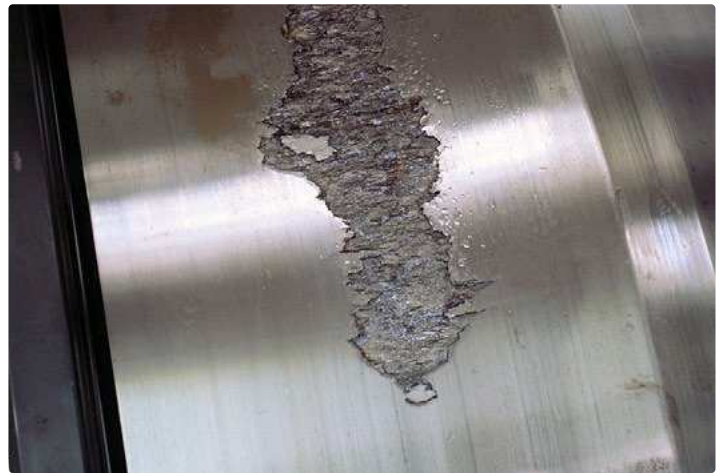
Spherical roller bearing inner ring  
Material fatigue

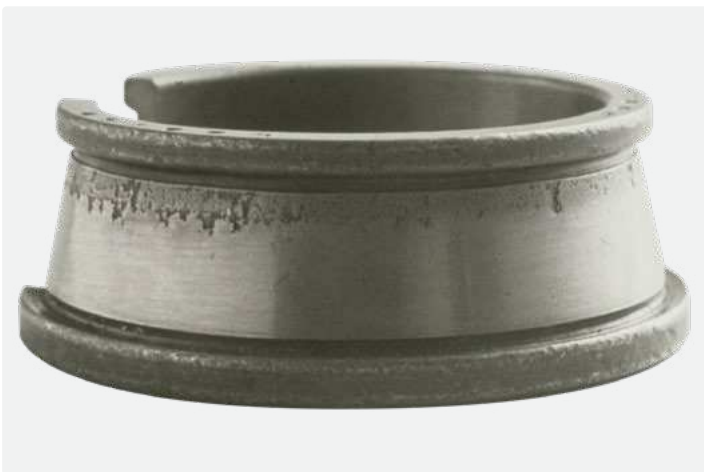
Tapered roller bearing inner ring  
Spalling on one side of the raceway only, resulting from misalignment and consequent edge loading, leading to higher stress and failure

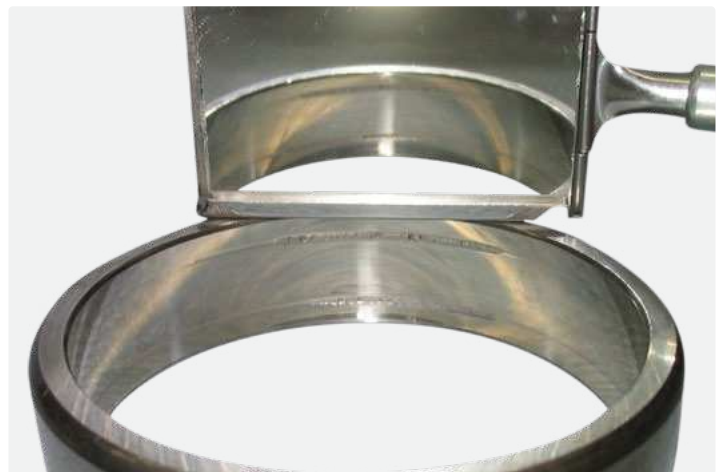
Self-aligning ball bearing outer ring  
Spalling at 180° apart, resulting from excessive load due to oval clamping

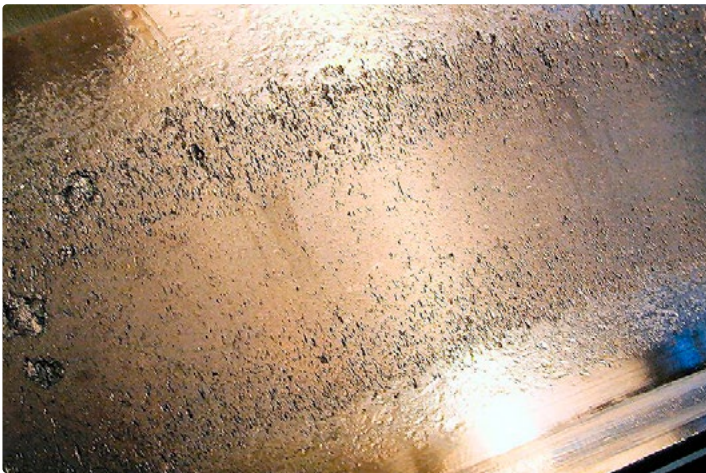
**Spherical roller bearing inner ring**  
Inadequate lubrication, surface distress with incipient spalling

- Make sure you have the right bearing for the actual application conditions and their variations (load, temperature, speed, misalignment, mounting, etc.)
- Make sure the lubrication is adequate: right lubricant, right quantity, right time
- Improve the surface separation capability of the lubricant (lubricant viscosity, additives, grease formulation)
- Check the lubricant quality at regular intervals
- Reduce the contamination (improved sealing, oil filtration)

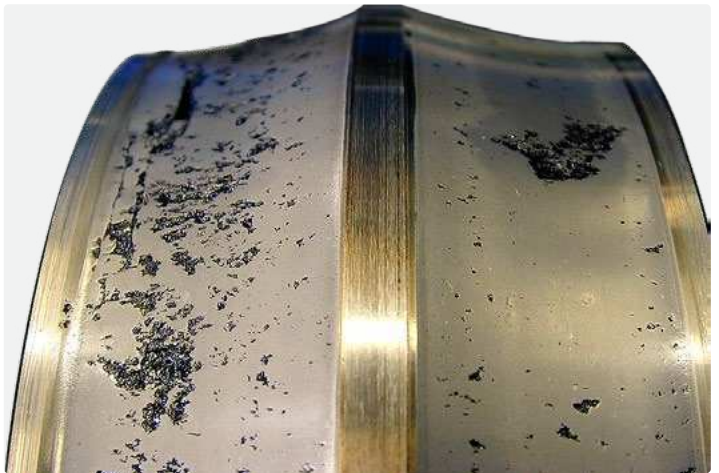
**Spherical roller bearing inner ring**  
Inadequate lubricant film. Initially, abrasive wear due to contamination, developed into surface distress and spalling

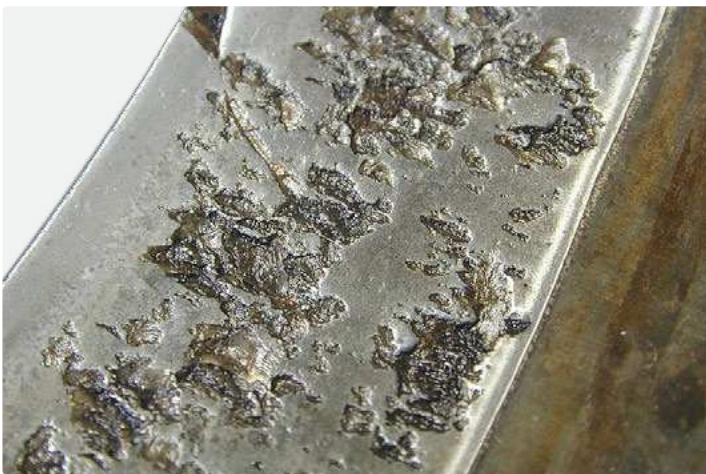
**Spherical roller bearing outer ring**  
Initially, abrasive wear due to contamination, developed into surface distress and advanced spalling

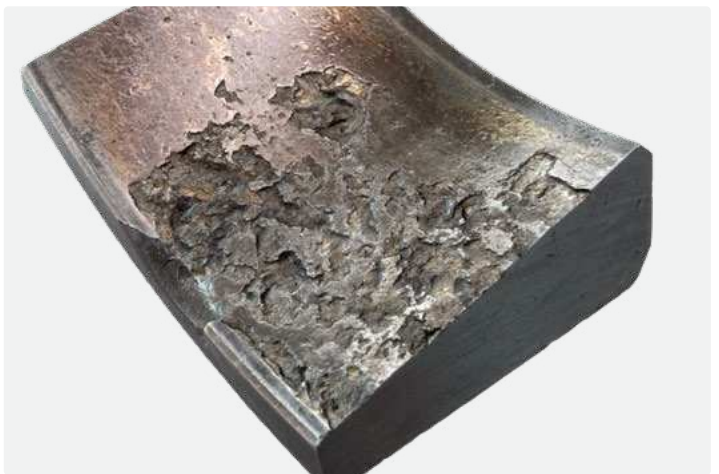
**Tapered roller bearing outer ring**  
Inadequate lubricant film leading to surface distress and advanced spalling

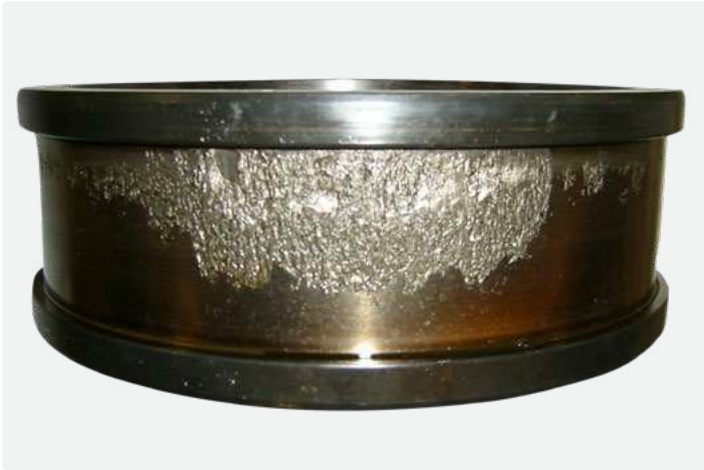
**Cylindrical roller bearing inner ring**  
Inadequate lubricant film, excessive misalignment, advanced surface distress

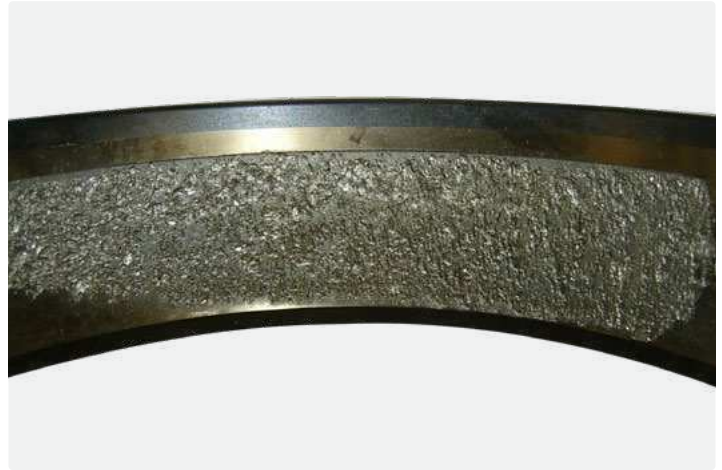
**Cylindrical roller bearing outer ring**  
Inadequate lubricant film, some misalignment, advanced surface distress

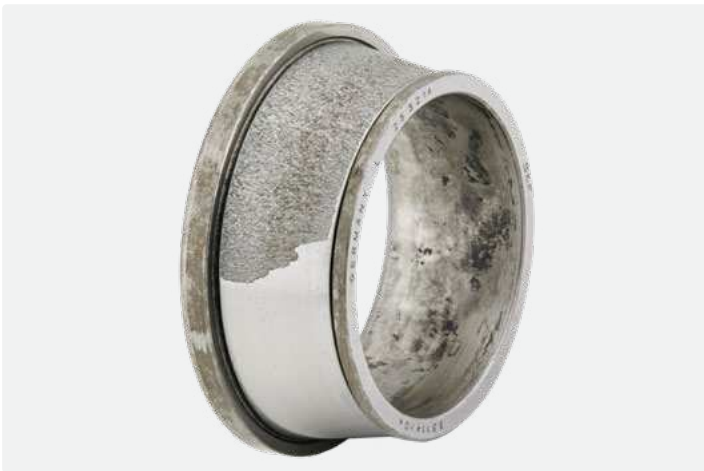
**Tapered roller bearing inner ring**  
Inadequate lubricant film, surface distress over a large area

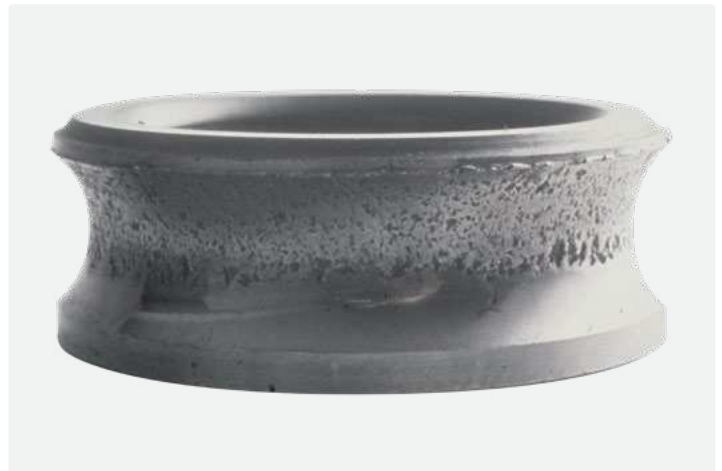
**Deep groove ball bearing inner ring**  
Excessive axial load, resulting in too thin lubricant film and surface distress

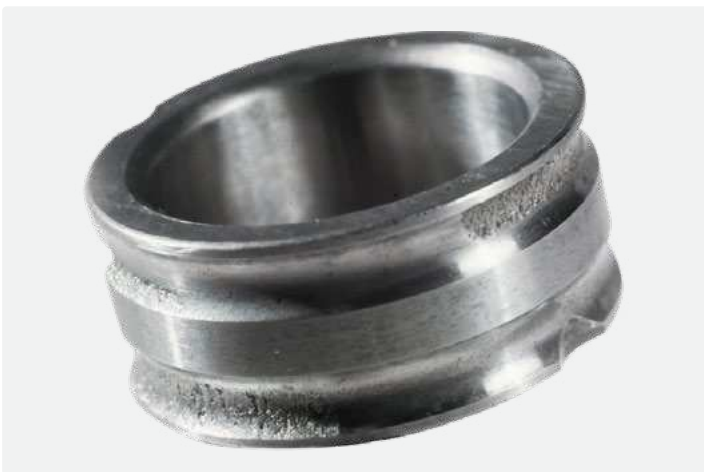
**Double row angular contact ball bearing inner ring**  
Excessive misalignment, resulting in excessive loads, with two load zones 180° apart.

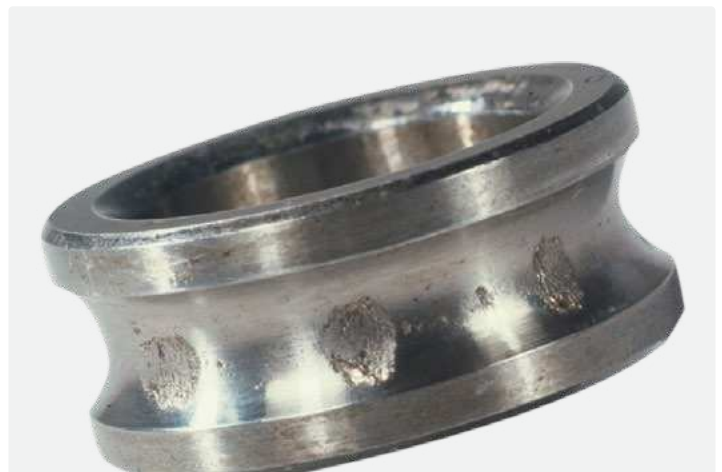
**Deep groove ball bearing inner ring**  
Impact during mounting, resulting in spalling at ball spacing

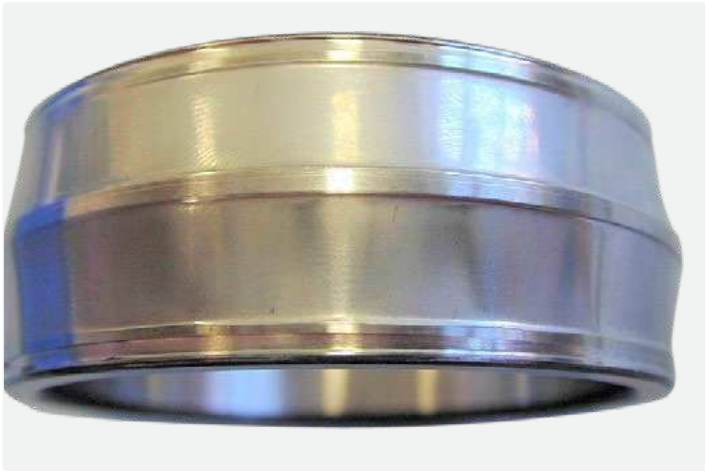
**Spherical roller bearing inner ring**  
Contamination and resulting inadequate lubrication leading to abrasive wear of the raceway tracks – slightly shiny

- Make sure an adequate sealing arrangement is in place considering the operational conditions
- Make sure the lubrication is adequate: right lubricant, right quantity, right time
- Check the quality of the lubricant at regular intervals
- Check the quality of the sealing arrangement at regular intervals
- Make sure housing and shaft fits are adequate to avoid creep

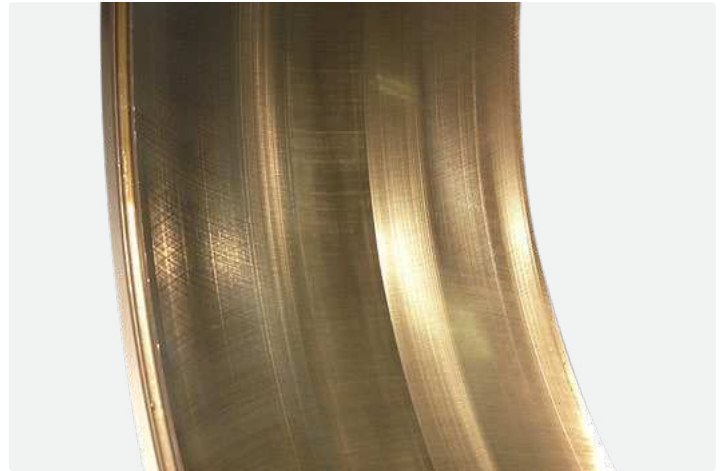
**Spherical roller bearing outer ring**  
Abrasive wear of the raceway tracks in an early stage

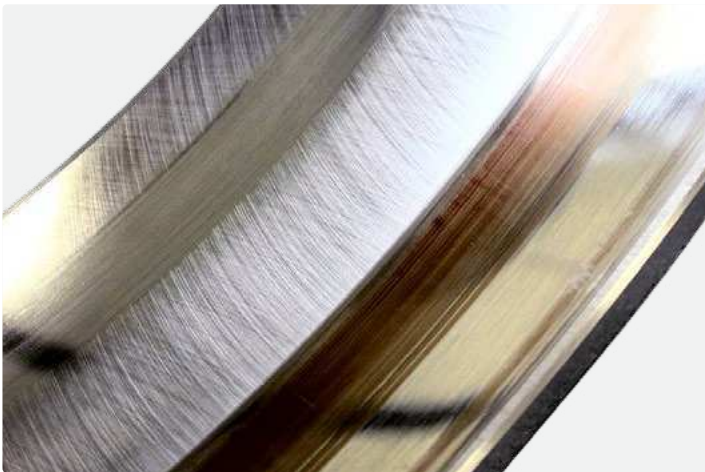
**Spherical roller bearing outer ring**  
Abrasive wear of the raceway tracks. The axially loaded one also partly discolored indicating inadequate lubrication and heat generation. The other raceway track shows a narrower load pattern with a matt appearance.

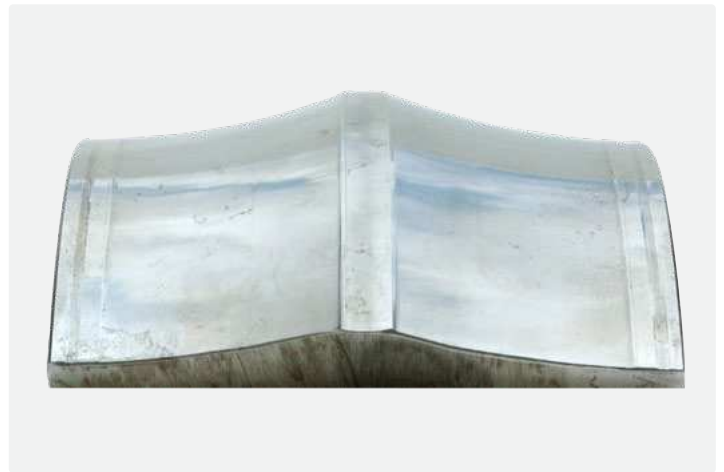
**Spherical roller bearing inner ring**  
Contamination by fine particles – abrasive wear of the raceway tracks – rather shiny. Due to cage pocket wear, a groove has been cut by the cages on either side.

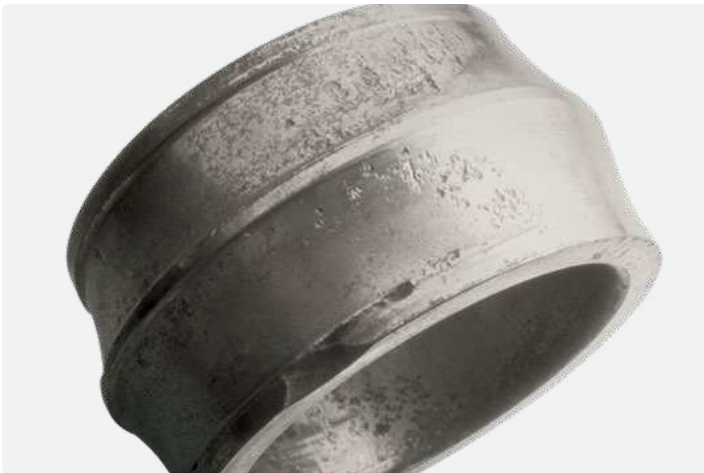
**Spherical roller bearing inner ring**  
Contamination and resulting inadequate lubrication leading to abrasive wear of the raceway tracks – one raceway track more damaged due to axial load

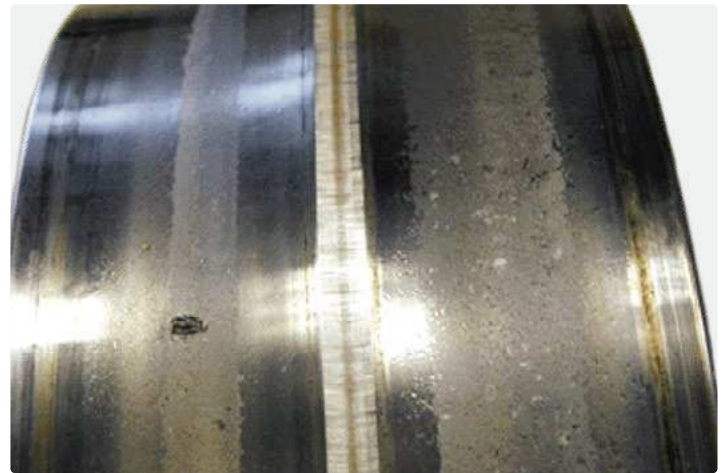
**Spherical roller bearing inner ring**  
Ingress of contaminants leading to inadequate lubrication, abrasive wear on the tracks and one incipient spall

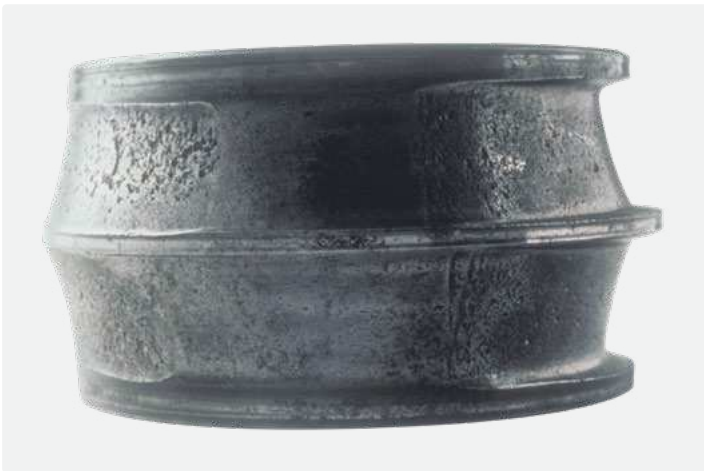
**Spherical roller bearing inner ring**  
Inner ring stationary – heavy abrasive wear – two wear zones: one with heavy wear; then creep of the inner ring with subsequent second wear zone

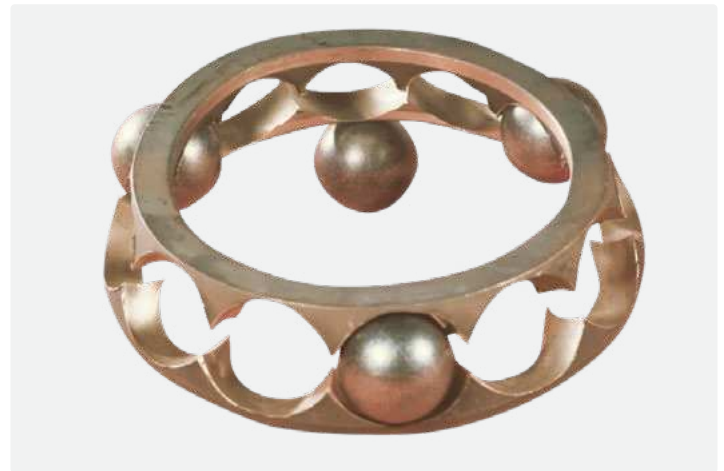
**Angular contact ball bearing cage**  
Abrasive wear of the cage pockets due to inadequate lubrication and vibration. Cage bars worn away.

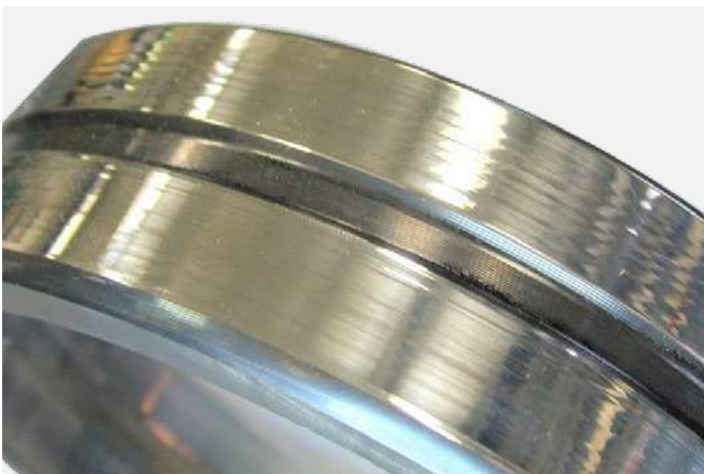
**Spherical roller bearing outer ring**  
Ring creep in the housing from inadequate housing fit for the load condition – polishing wear on the outside surface

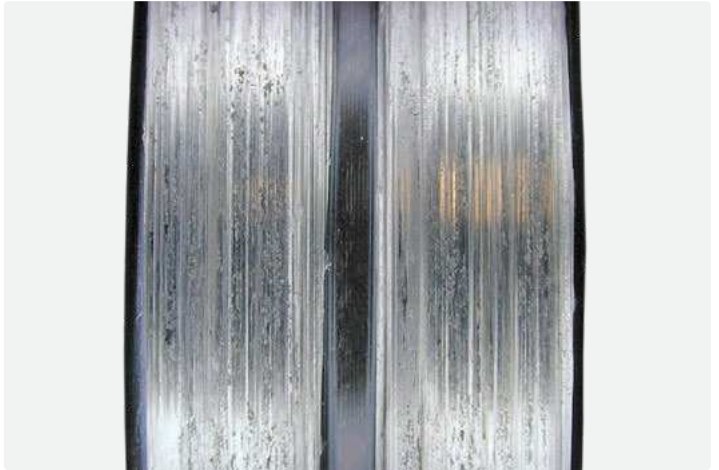
**Spherical roller bearing outer ring**

Ring creep in the housing from inadequate housing fit for the load condition  
– adhesive wear marks on the outside surface

- Make sure the bearing is adequately loaded
- Make sure the sealing arrangement is operating efficiently
- Consider bearing downsizing
- Verify lubricant selection (viscosity, AW and EP additives)
- Consider using coatings
- Consider using hybrid bearings

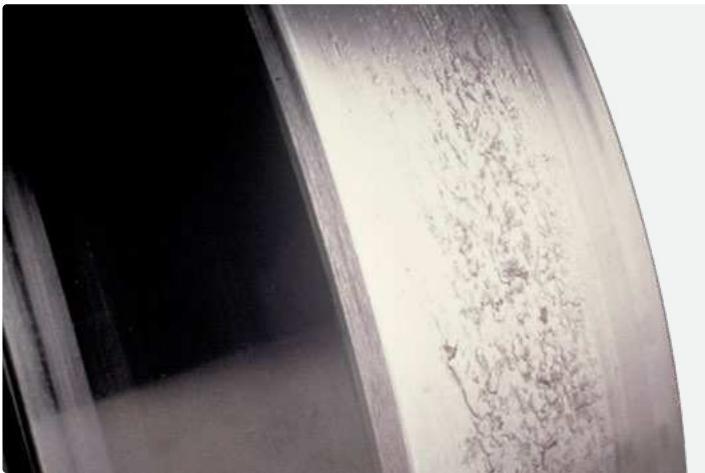
**Spherical roller bearing inner ring**

Too low load combined with inadequate lubrication

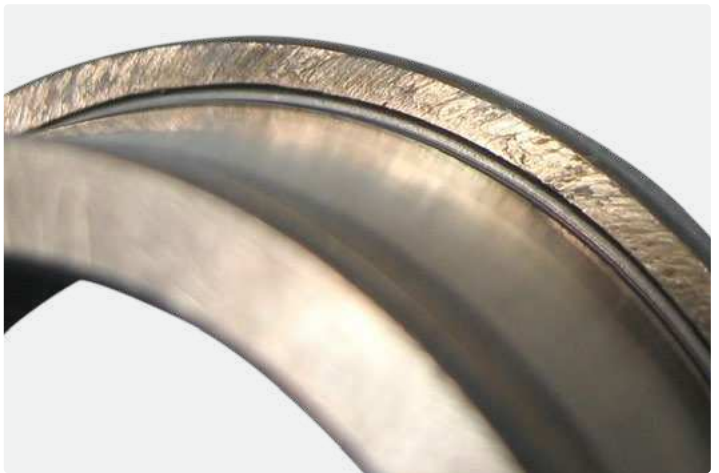
**Tapered roller bearing inner ring**

Contamination and inadequate lubrication resulting in adhesive wear of the flange as well as a shiny raceway

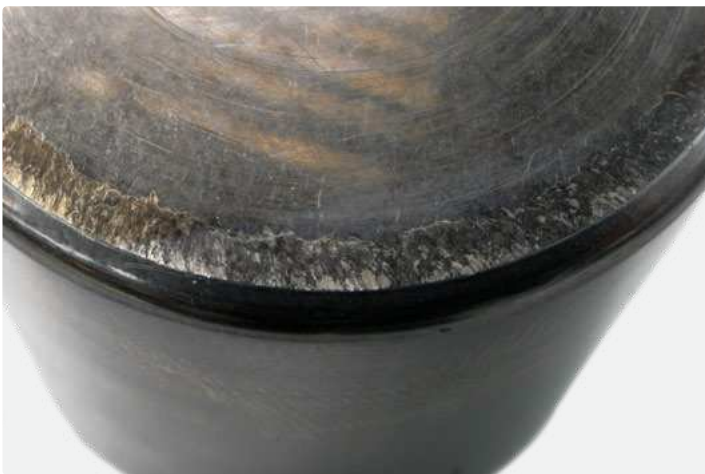
**Tapered roller bearing – roller**

Contamination and inadequate lubrication leading to adhesive wear marks on the large roller end face

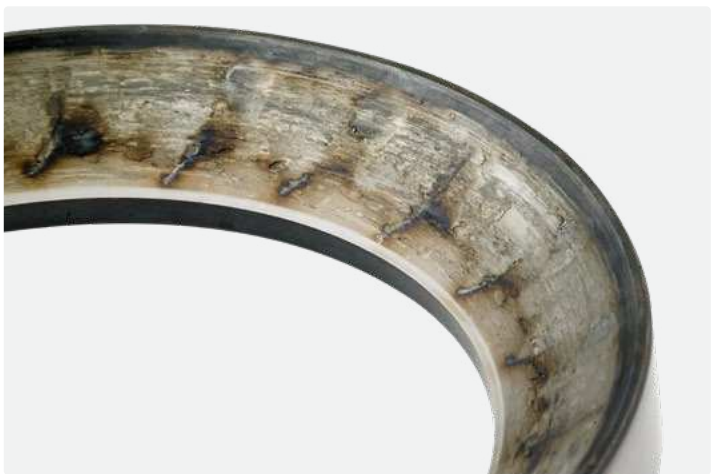
**Spherical roller thrust bearing outer ring**

Initially adhesive wear, then excessive heat generation, finally seizure

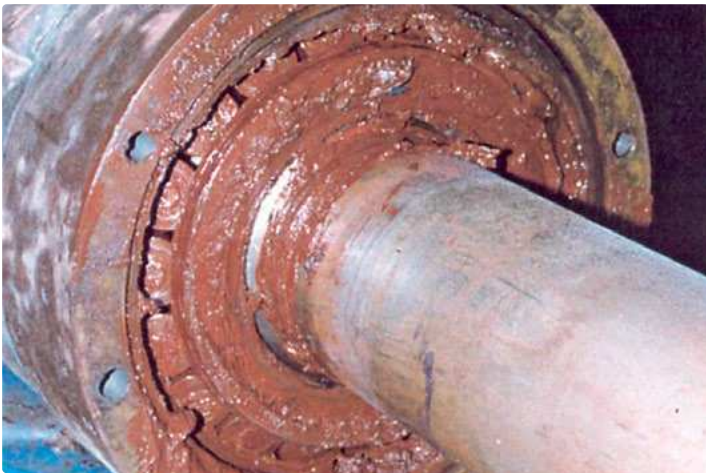
**Tapered roller bearing in a pump unit**  
Seal failure, bearing corrosion and reddish discoloured grease

- Make sure the bearing arrangement is adequately protected
- Consider using sealed bearings in respect of the operating environment
- Make sure the lubrication is adequate: right lubricant, right quantity, right time
- Do not unpack bearings until mounting them
- Protect mounted bearings adequately

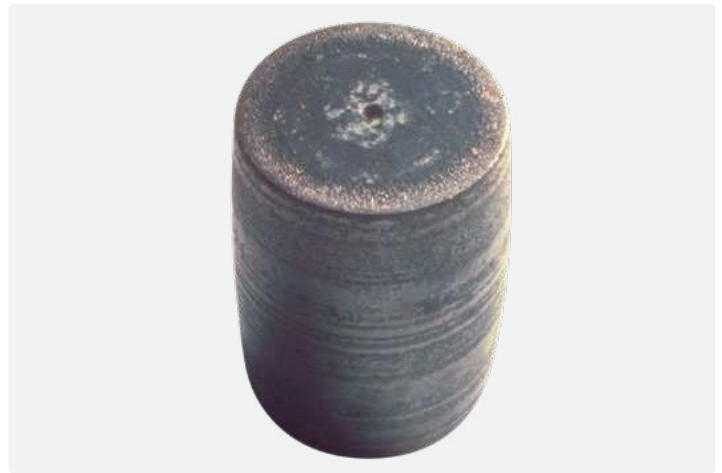
**Spherical roller bearing – roller**  
Corroded roller due to severe water penetration into the bearing

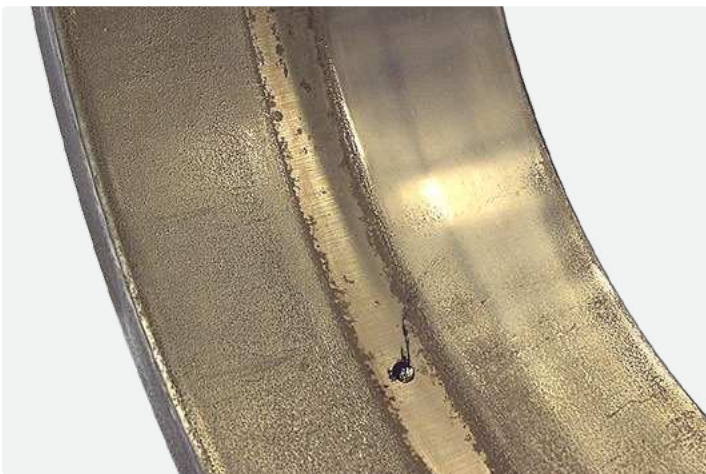
**Spherical roller bearing outer ring**  
Sealing arrangement failure, corrosive substance entered the bearing

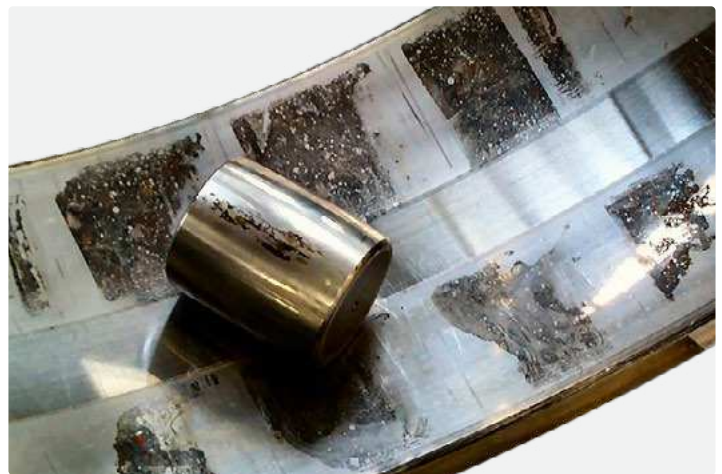
**Spherical roller bearing outer ring and roller**  
Too high water content in the lubricant, standstill corrosion of the raceways at roller spacing

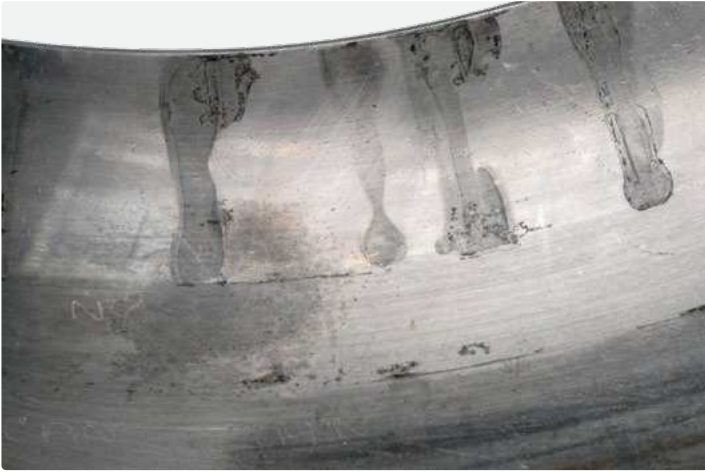
**Spherical roller bearing outer ring**  
Too high water content in lubricant, sets of etching marks at roller spacing at standstill

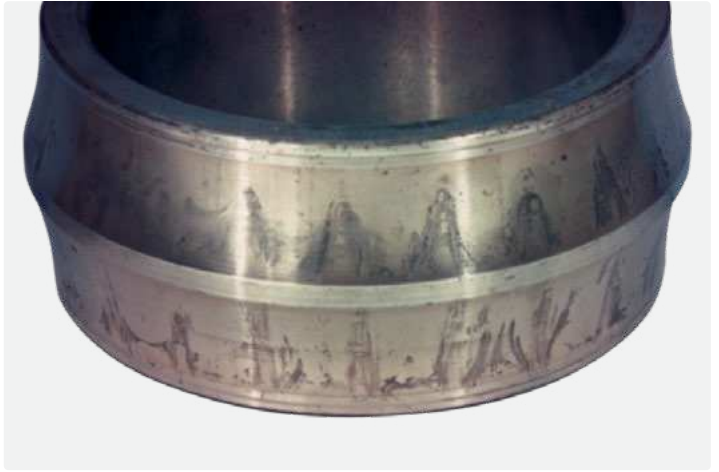
**Spherical roller bearing inner ring**  
Lubricant contaminated by water, etching marks at roller spacing at standstill

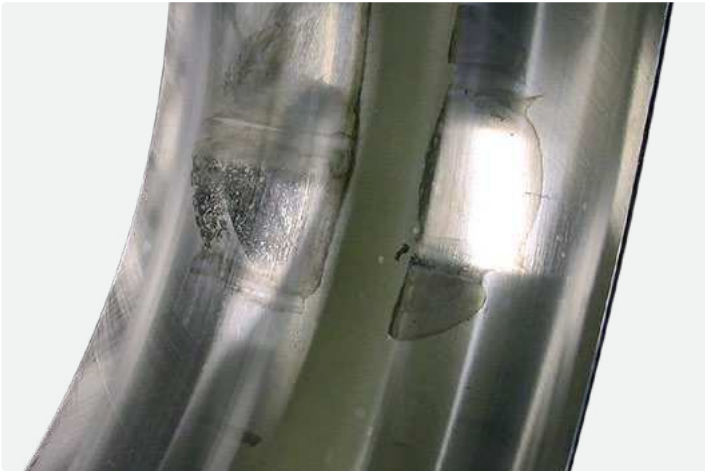
**Spherical roller bearing outer ring**  
Sealing arrangement failure, corrosion at standstill

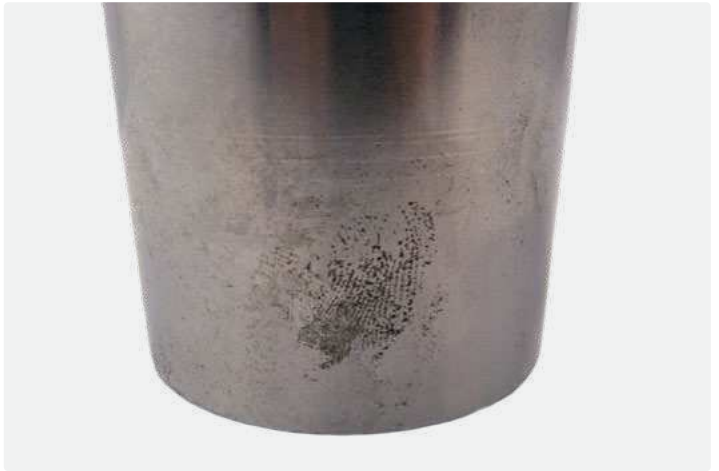
**Tapered roller bearing – roller**  
Rusty surface on raceway resulting from finger perspiration

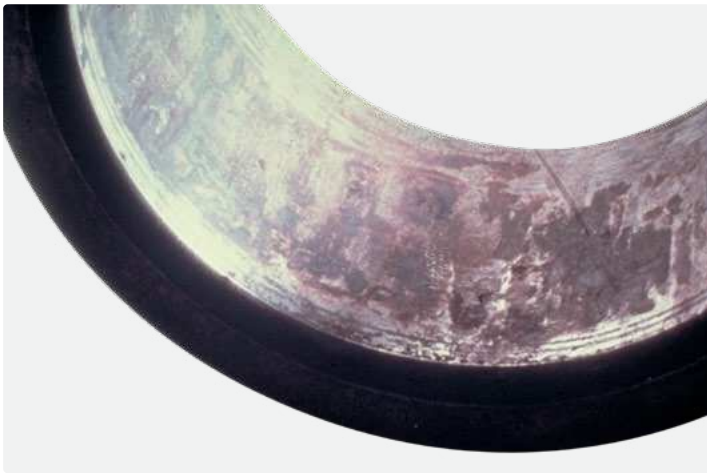
Cylindrical roller bearing inner ring  
Inappropriate shaft fit (too loose)

- Select appropriate fits
- Make sure the bearing seats are adequately machined
- Make sure the bearing seats conform to dimensional and geometrical specifications (even after overhaul of the machine)
- In the case of loose fits, consider applying an anti-fretting paste or coatings on one of the bearing surfaces

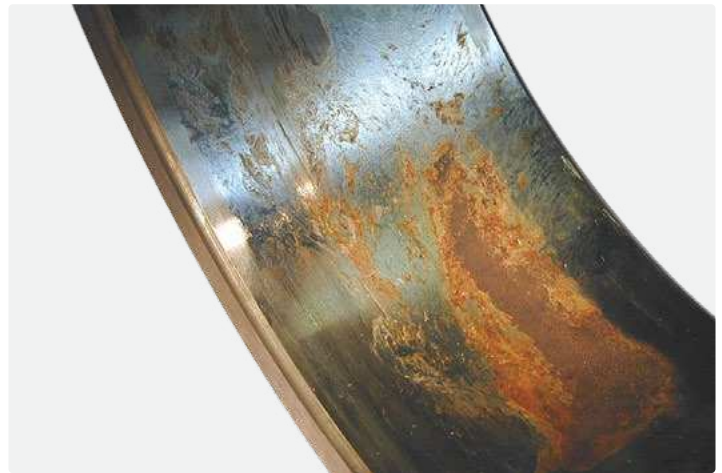
Cylindrical roller bearing inner ring  
Inappropriate shaft fit, uneven support

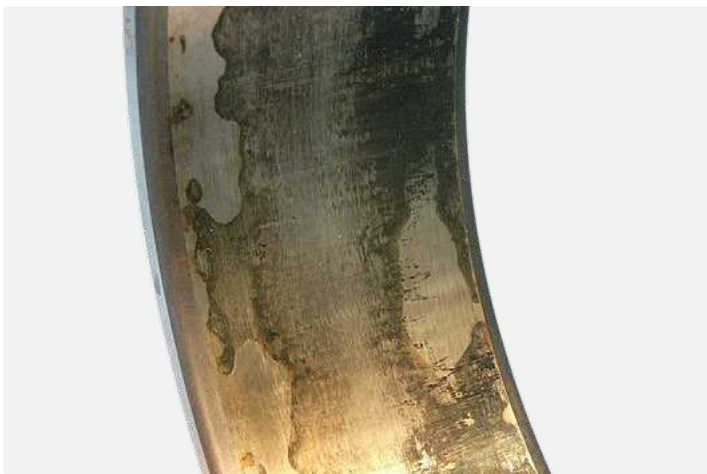
Cylindrical roller bearing inner ring  
Inappropriate shaft fit, uneven support

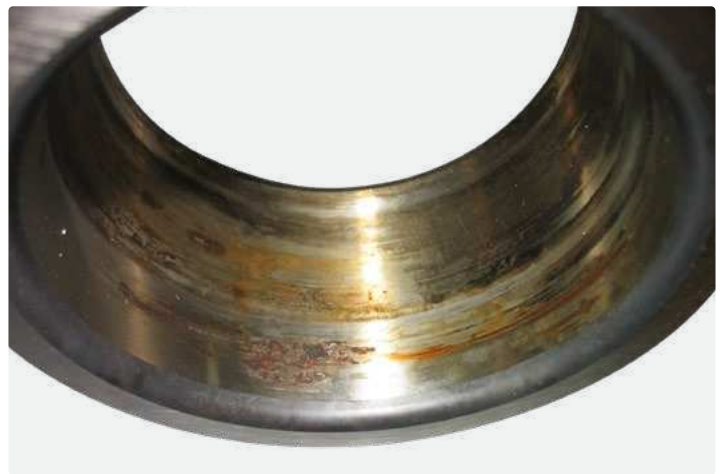
Tapered roller bearing inner ring  
Inappropriate shaft fit

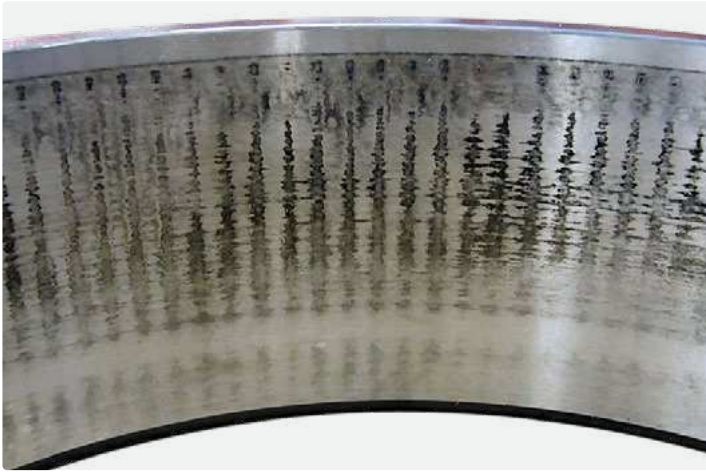
Tapered roller bearing inner ring  
Micromovement marks corresponding to shaft machining waviness

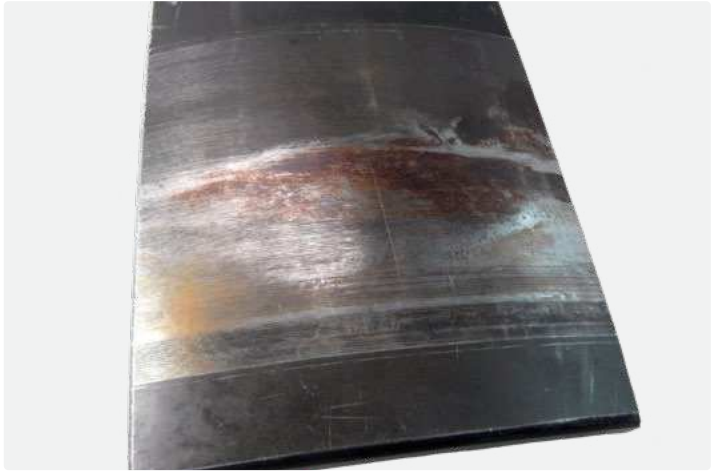
Tapered roller bearing outer ring (phosphated)  
Uneven ring support

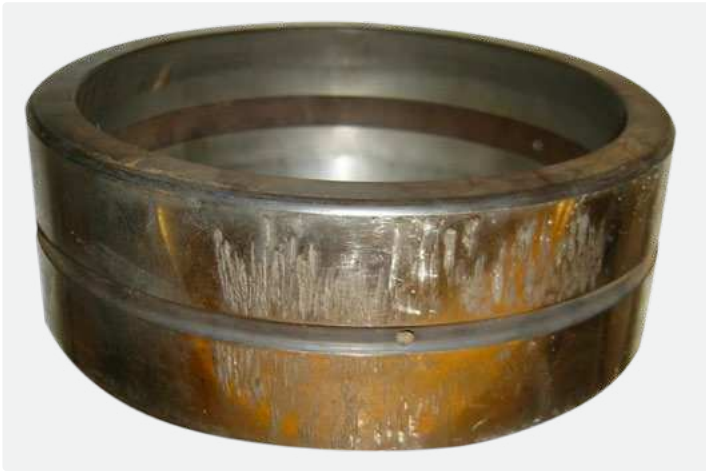
Spherical roller bearing outer ring  
Brown coloured fretting corrosion area from micromovements due to advanced raceway spalling, with scratches due to dismounting

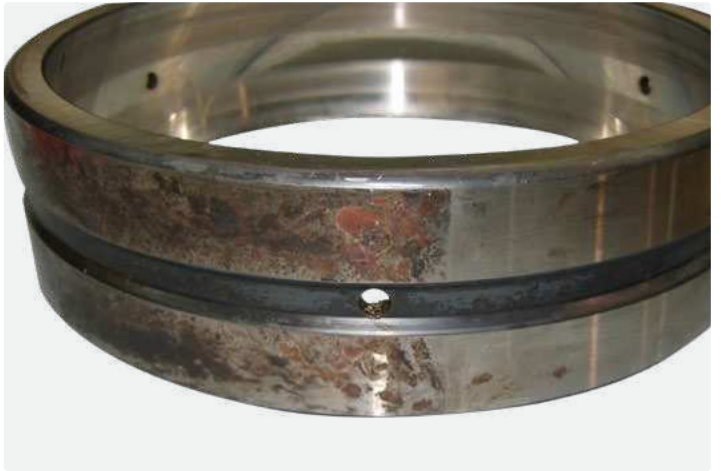
Spherical roller bearing outer ring  
Inadequately supported ring

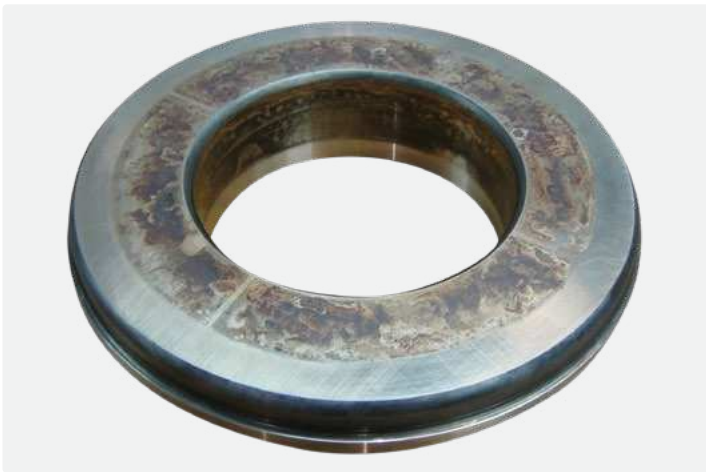
Spherical roller thrust bearing shaft washer  
Inadequate seat

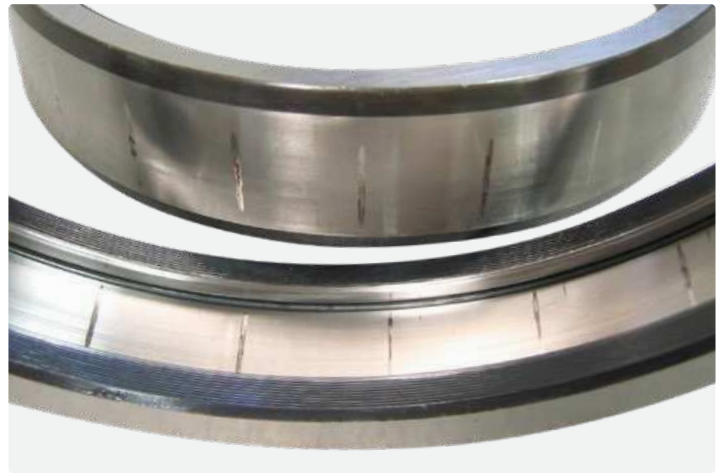
Cylindrical roller bearing inner and outer rings  
Exposure to vibrations at standstill, false brinelling marks at roller spacing

- Do not expose bearings to vibrations at standstill
- Consider installing vibration damping pads
- Apply lubricant with anti-brinelling properties
- Rotate standby machines at regular intervals
- Use adequate bearing designs for vibratory applications
