**SKF**

# **BEARING DAMAGE AND FAILURE ANALYSIS**

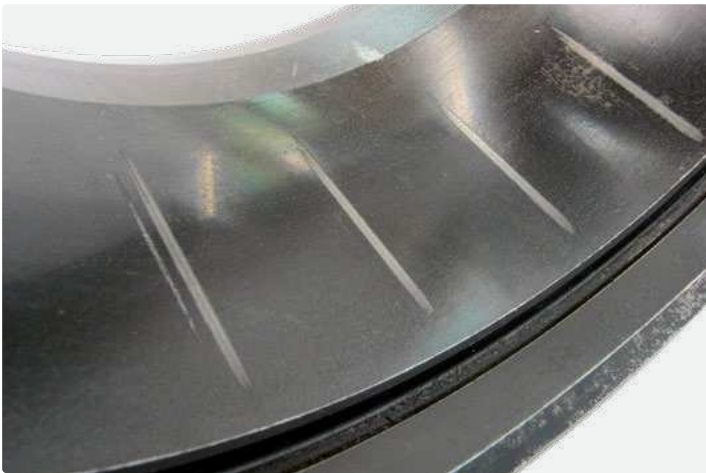
Double row tapered roller bearing outer ring  
Exposure to vibrations at standstill, false brinelling marks at roller spacing

- Do not expose bearings to vibrations at standstill
- Consider installing vibration damping pads
- Apply lubricant with anti-brinelling properties
- Rotate standby machines at regular intervals
- Use adequate bearing designs for vibratory applications

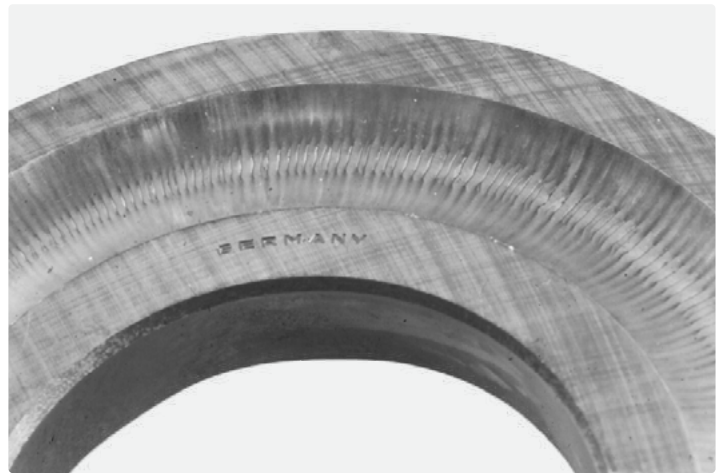
Thrust ball bearing shaft washer  
Exposure to vibrations at standstill, several sets of false brinelling marks at ball spacing

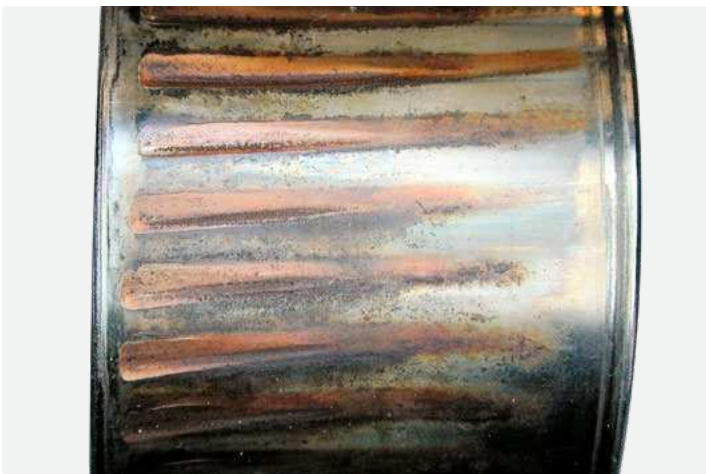
CARB toroidal roller bearing inner ring  
Exposure to vibrations at standstill with small oscillatory movements, false brinelling marks at roller spacing

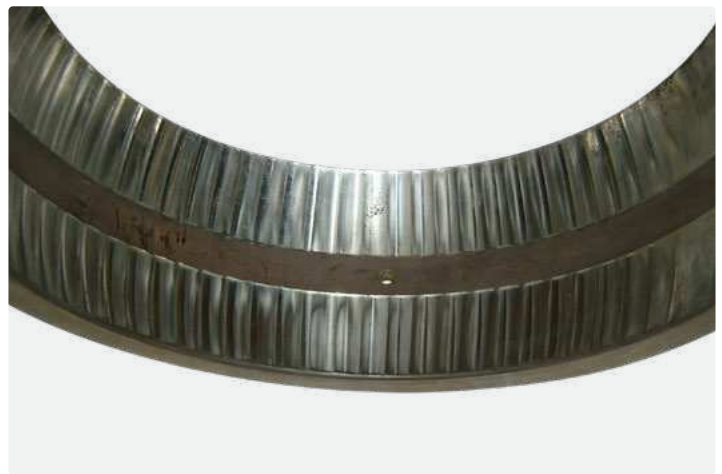
Spherical roller bearing outer ring  
Exposure to excessive vibrations at standstill, sets of false brinelling marks at roller spacing

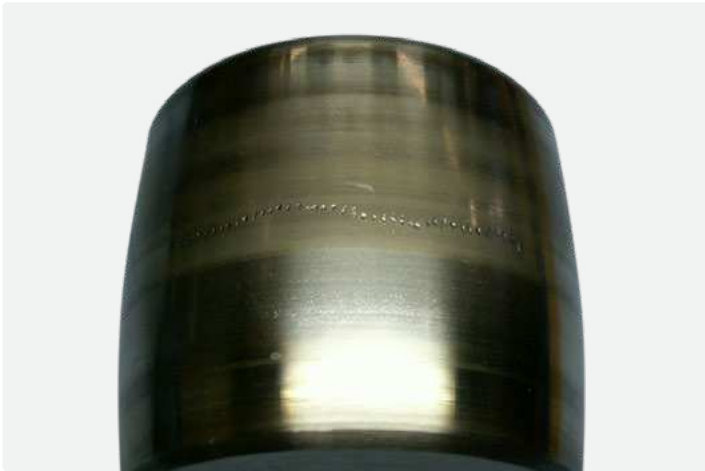
**Spherical roller bearing – roller**  
Excessive current resulting in a large number of craters in a bead-like formation

- Make sure earthing connections are installed properly
- Use insulated bearings (INSOCOAT or hybrid bearings)

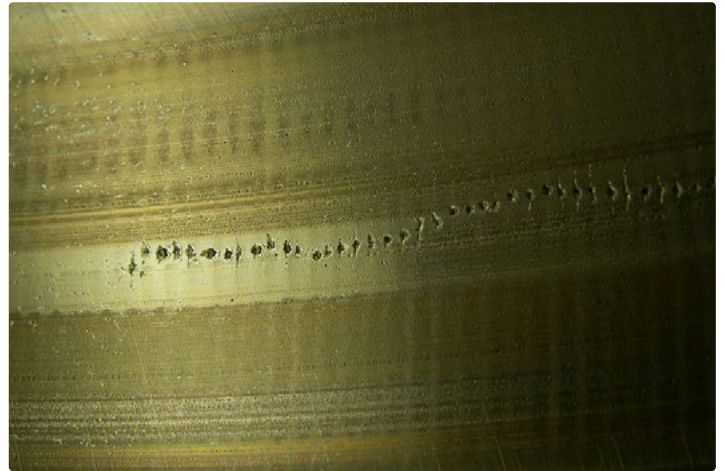
**Spherical roller bearing – roller**  
Enlarged view of craters in a bead-like formation

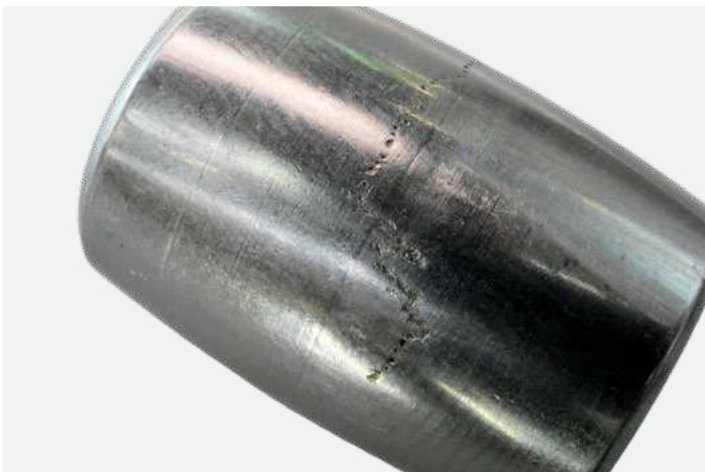
**Spherical roller bearing – roller**  
Excessive current resulting in a large number of craters in a zig-zag formation

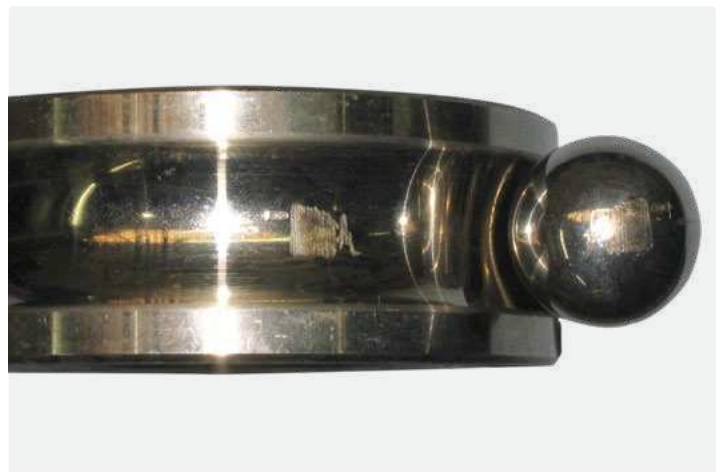
**Deep groove ball bearing inner ring and ball**  
Excessive current resulting in a number of craters in zig-zag formation on the ball and raceway

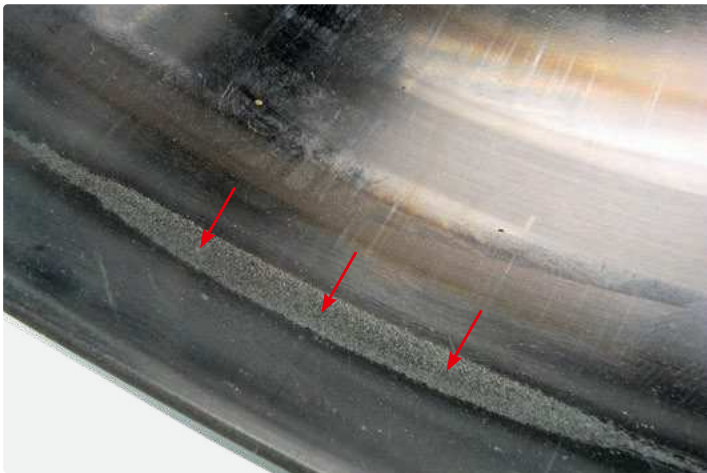
Spherical roller bearing outer ring  
Damage in early stage: dull grey zone with small shallow craters

- Use symmetric cabling
- Make sure the stator and rotor are properly aligned
- Use insulated bearings (INSOCOAT or hybrid bearings)
- Make sure earthing connections are installed properly

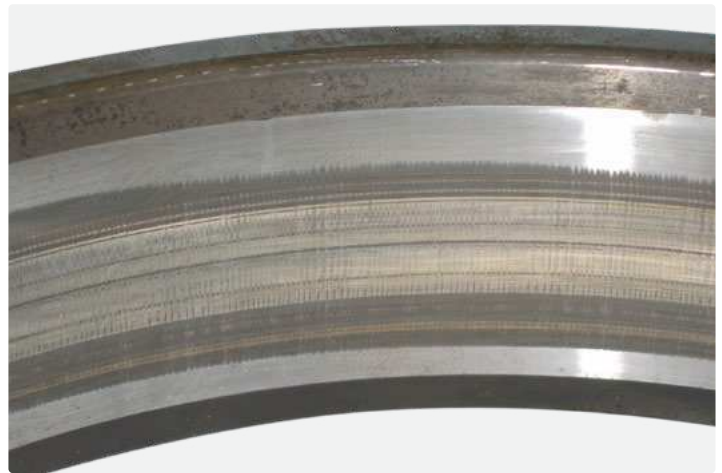
Cylindrical roller bearing outer ring  
Early stage of fluting

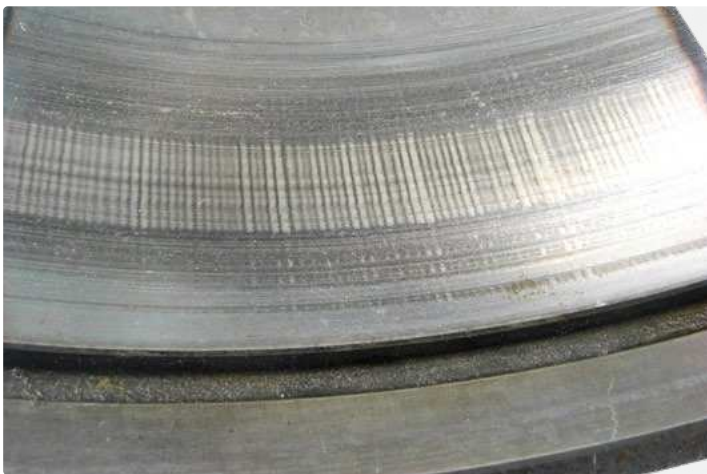
Tapered roller bearing outer ring  
Early stage of fluting

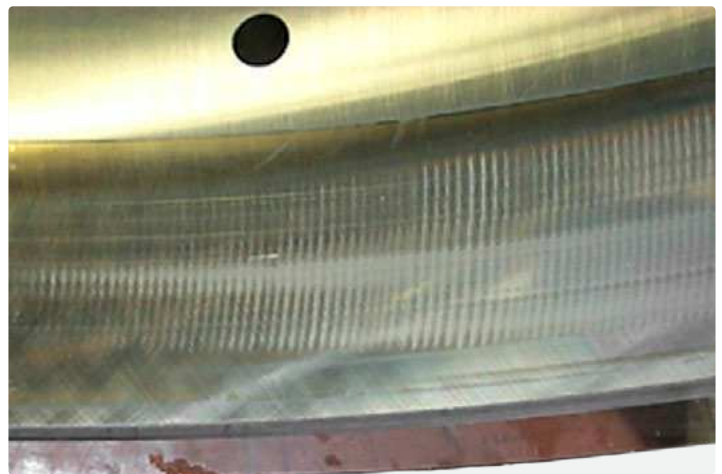
Spherical roller bearing outer ring  
Current leakage erosion

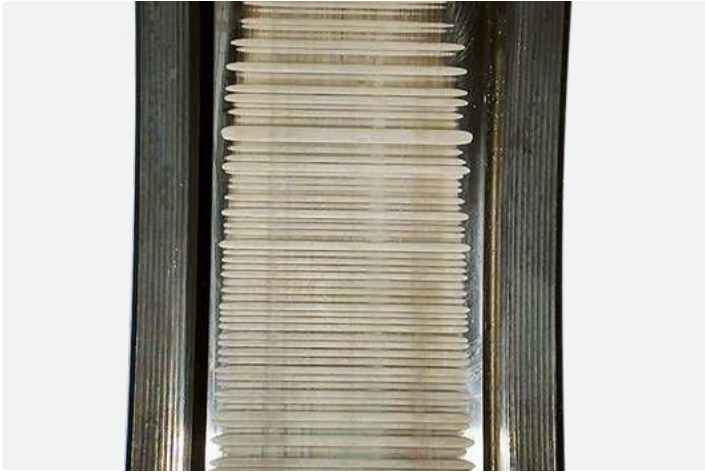
Cylindrical roller bearing outer ring  
Advanced stage of fluting

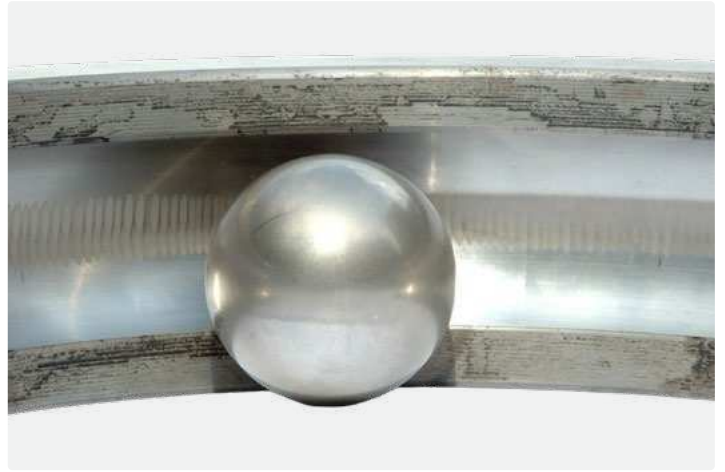
Deep groove ball bearing outer ring and ball  
Fluting in the outer ring and dull ball surface

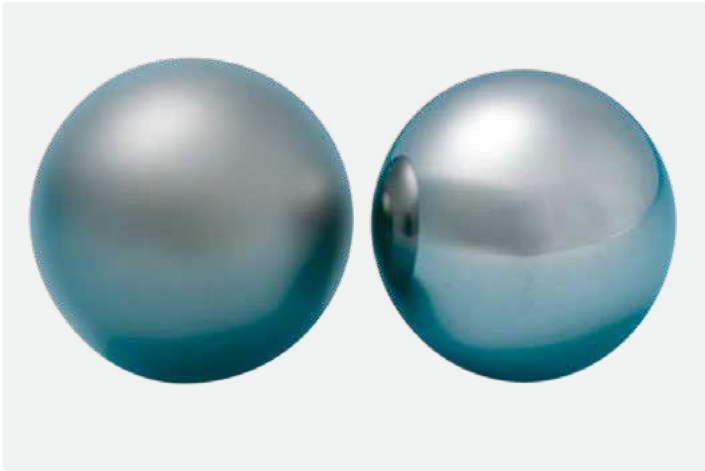
Deep groove ball bearing – balls  
Left: damaged ball – dull surface  
Right: new ball – shiny surface

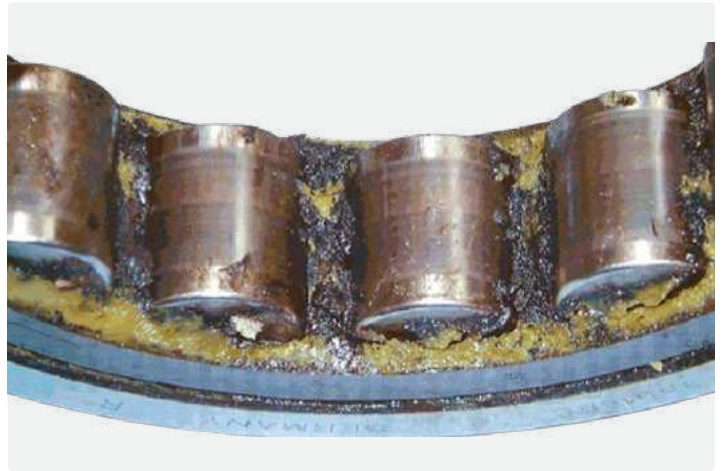
Cylindrical roller bearing outer ring with cage, rollers and grease  
Current leakage resulted in degradation of the grease (black) on the cage bars

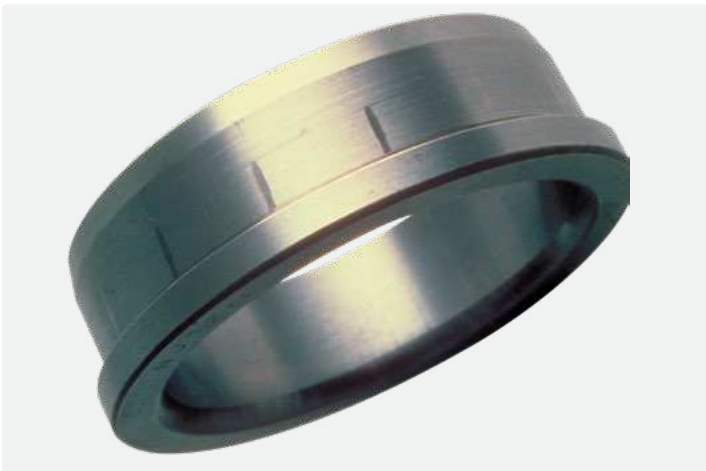
**Cylindrical roller bearing inner ring**  
During the assembly procedure, inner and outer rings were not aligned properly.  
Axial marks at roller spacing.

- Use appropriate methods for mounting bearings
- Use appropriate tools or mounting sleeves as needed
- Follow mounting procedures and instructions carefully

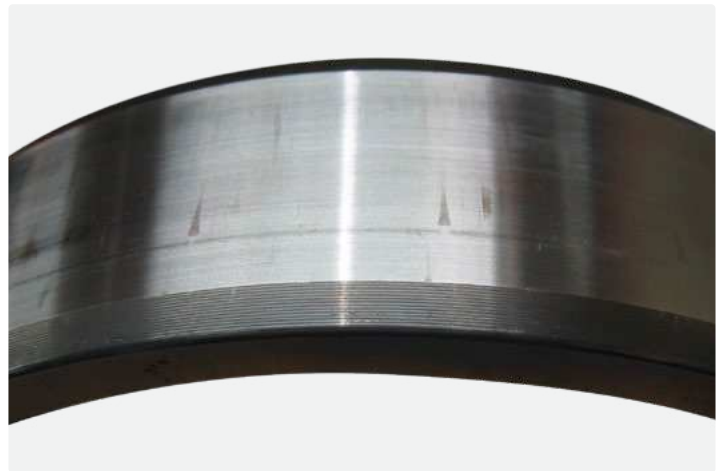
**Cylindrical roller bearing inner ring**  
During the assembly procedure, inner and outer rings were not aligned properly.  
Axial marks at roller spacing.

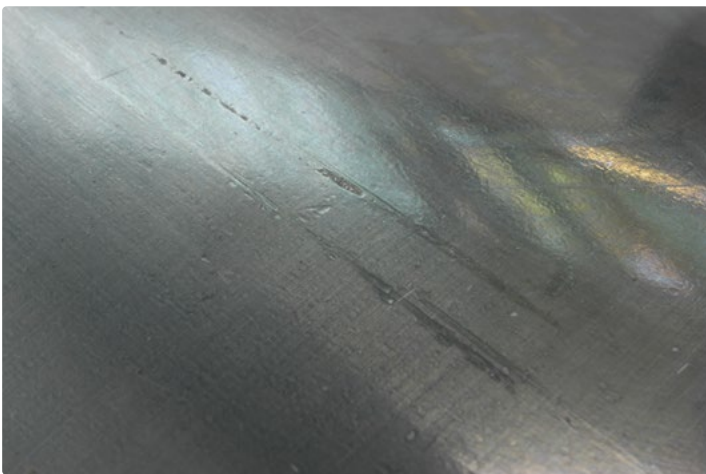
**Tapered roller bearing outer ring**  
Scoring during handling

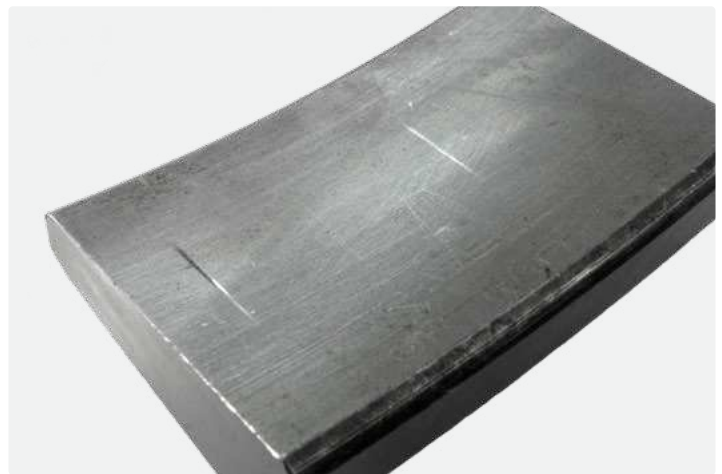
**Tapered roller bearing outer ring**  
Scoring during assembly procedure

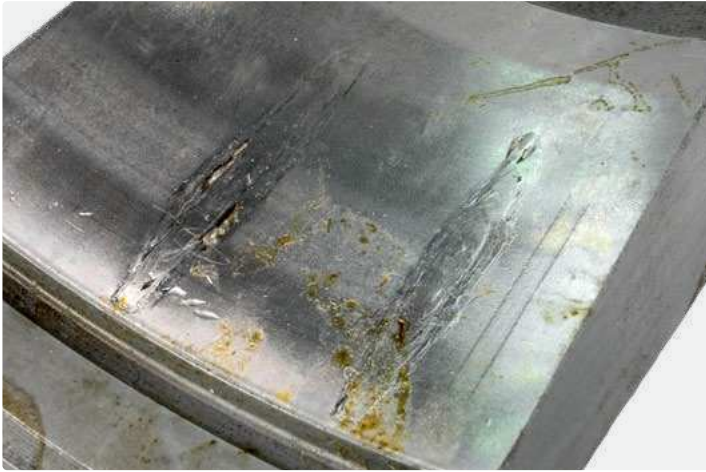
**Double row tapered roller bearing outer ring**  
Overload impact and misalignment at standstill, resulting in deformation and subsequent spalling at roller spacing

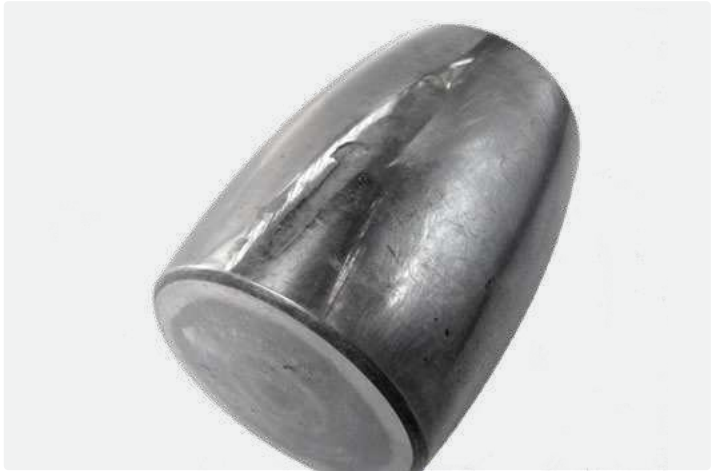
**Spherical roller thrust bearing – roller**  
Heavy impact, plastic deformation

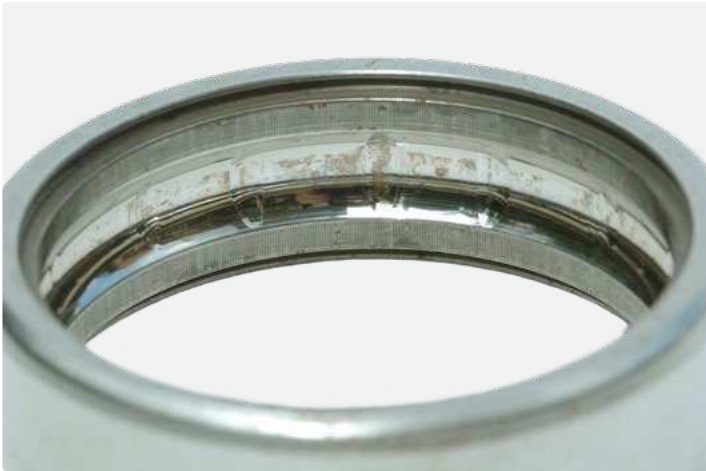
**Deep groove ball bearing outer ring**  
Plastic deformation at ball spacing from applying mounting force to the wrong ring

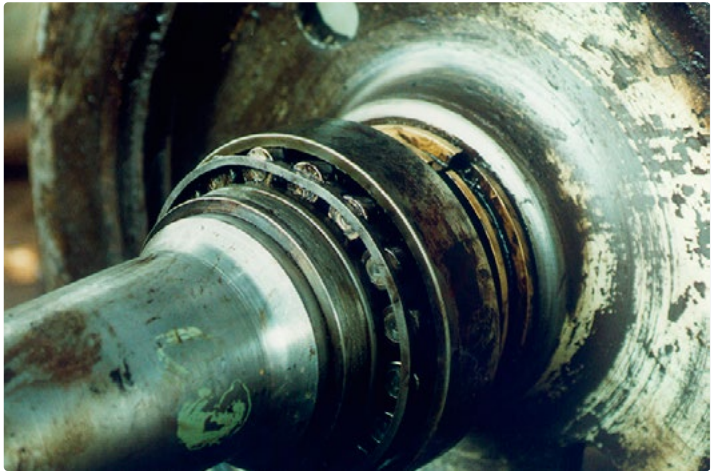
**Tapered roller bearing mounted on a railway wheel set**  
Cage was hit directly during mounting, resulting in permanent deformation (flattening)

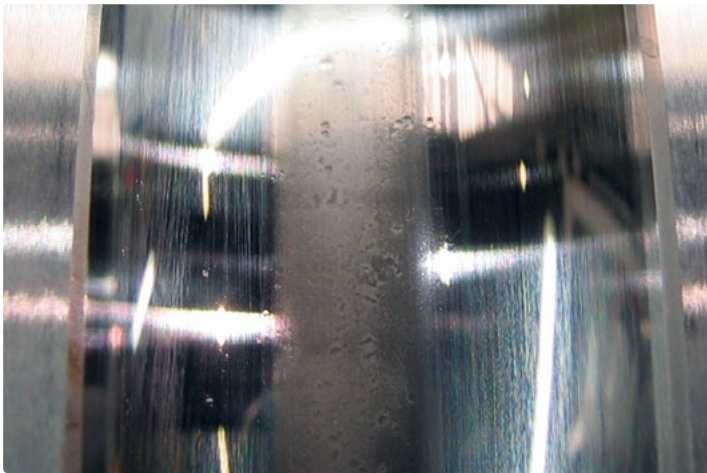
**Deep groove ball bearing inner ring**  
Dents resulting from overrolling of hard particles – inadequate sealing arrangement

- Make sure to work in clean conditions
- Use adequate sealing to protect the bearing
- Make sure the lubrication is adequate: right lubricant, right quantity, right time
- Never drop a bearing
- Treat bearings carefully

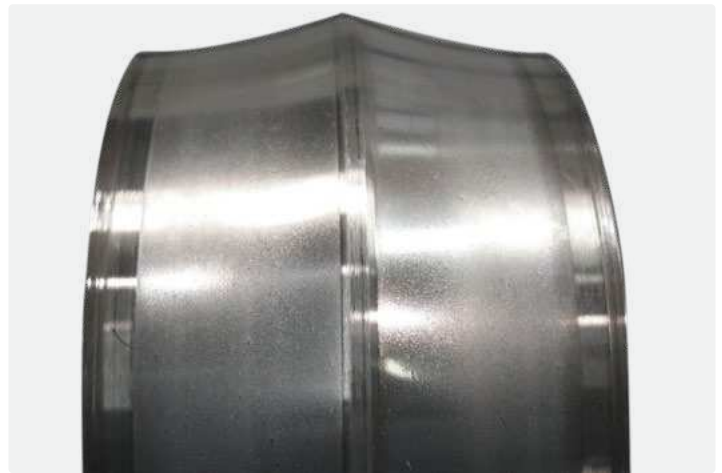
**Spherical roller bearing inner ring**  
Many small dents resulting from overrolling of small hard particles  
– inadequate sealing arrangement

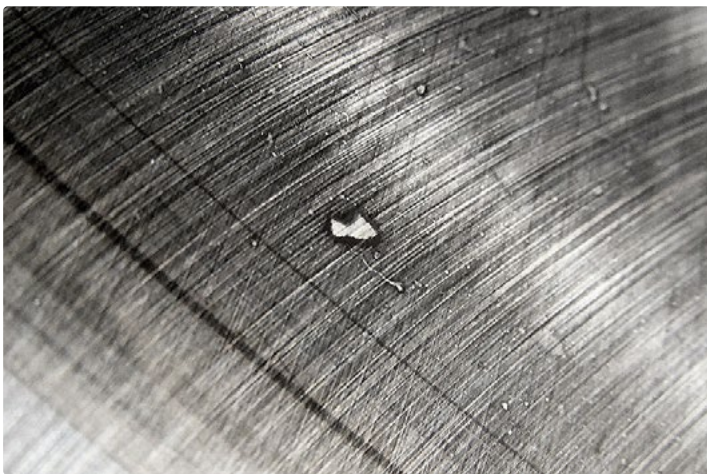
**Spherical roller bearing outer ring**  
Overrolling of hard particles that entered the bearing during mounting  
– lack of cleanliness

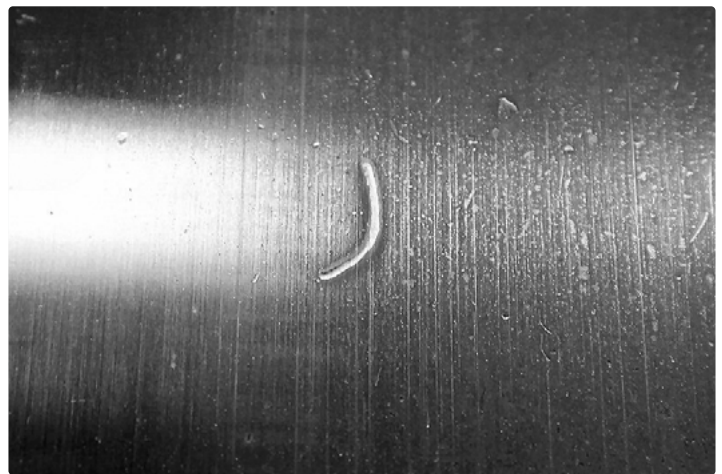
**Spherical roller bearing outer ring**  
Overrolled swarf/chip will lead to spalling

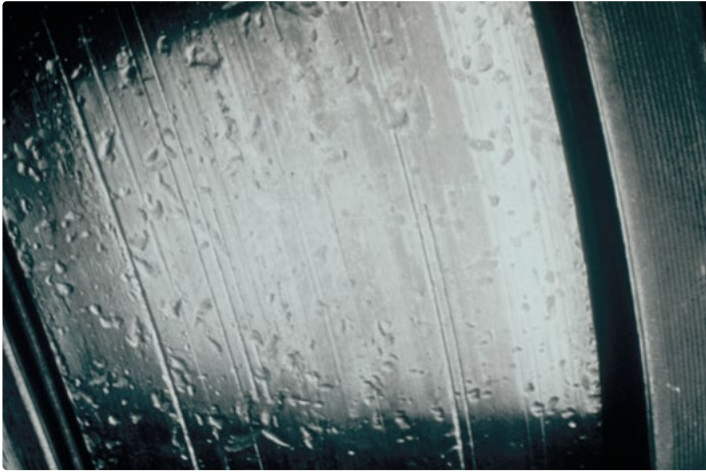
**Tapered roller bearing inner ring**  
Overrolling of big and hard particles that entered the bearing due to inadequate sealing arrangement

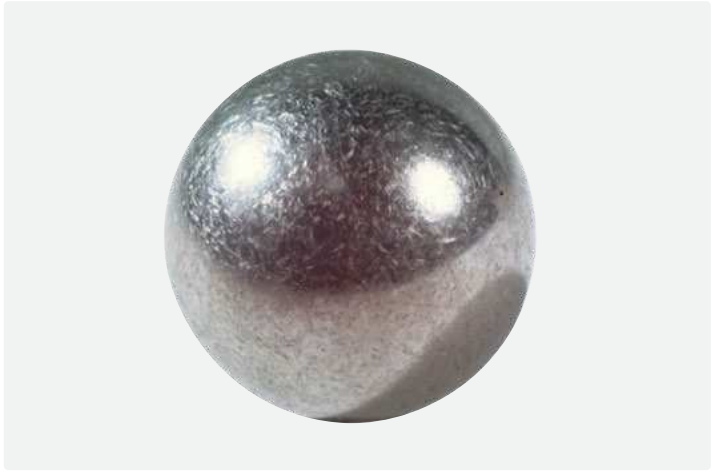
**Deep groove ball bearing – ball**  
Damage resulting from hard particles in very contaminated lubricant

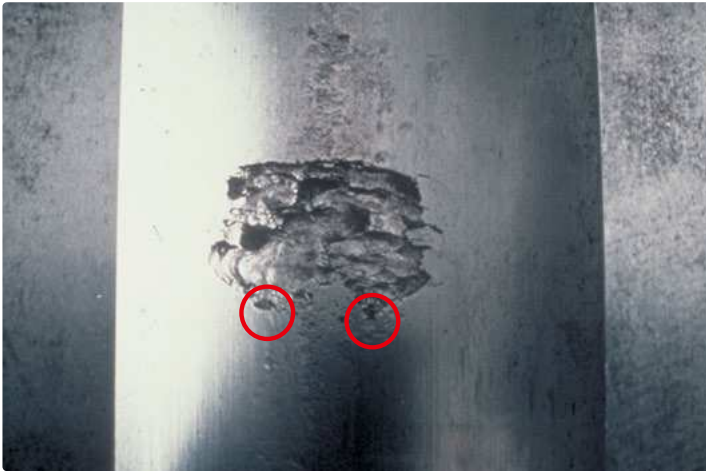
**Deep groove ball bearing inner ring**  
Overrolling of particles with sequential spalling starting at the back of the dents

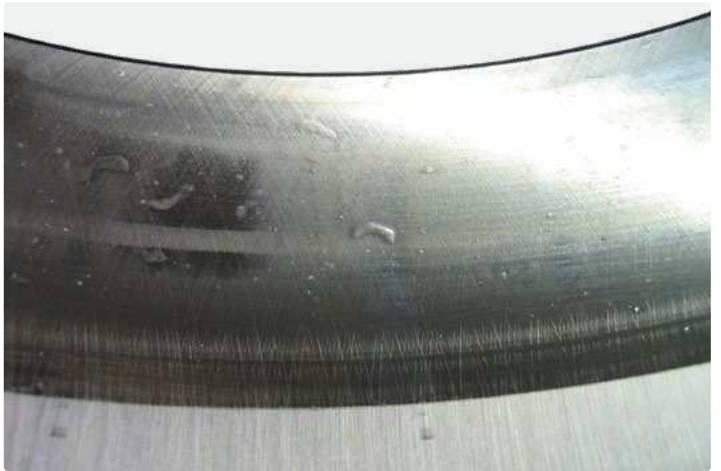
**Spherical roller bearing outer ring**  
Overrolling of swarf entered during mounting – lack of cleanliness

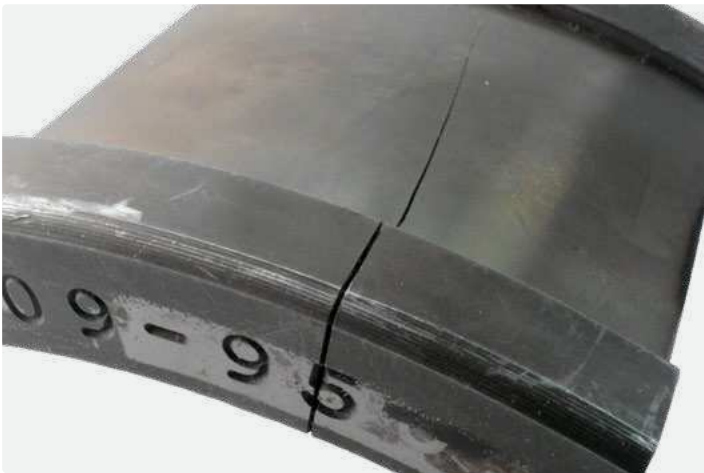
**Tapered roller bearing inner ring**  
The bearing was fitted to an oversized shaft

- Select appropriate fits
- Use appropriate methods for mounting bearings
- Use appropriate tools or mounting sleeves as needed
- Follow mounting procedures and instructions carefully
- Never use brute force on bearings or apply mounting forces through the rolling elements

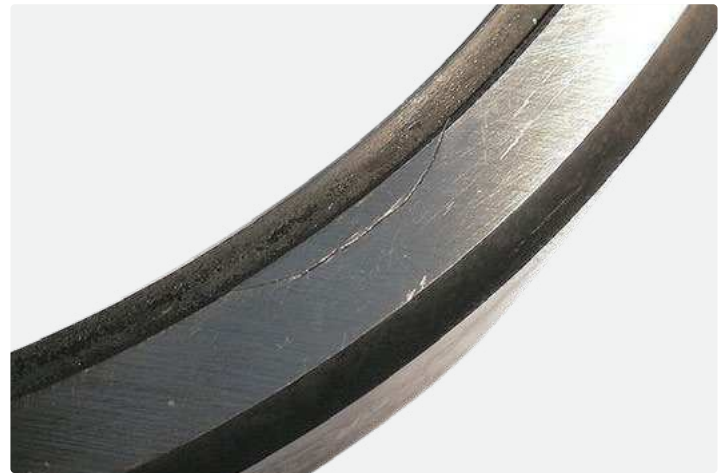
**Deep groove ball bearing outer ring side face**  
Fracture at seal anchorage groove due to impact when mounting the bearing

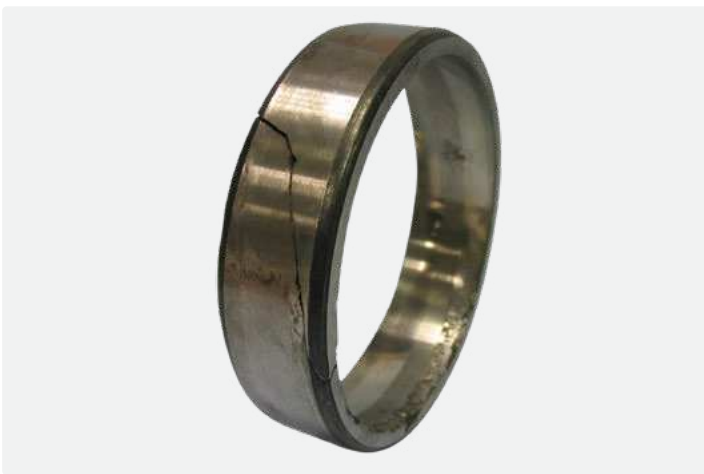
**Self-aligning ball bearing outer ring**  
Fracture resulting from excessive misalignment and balls running over the raceway edge

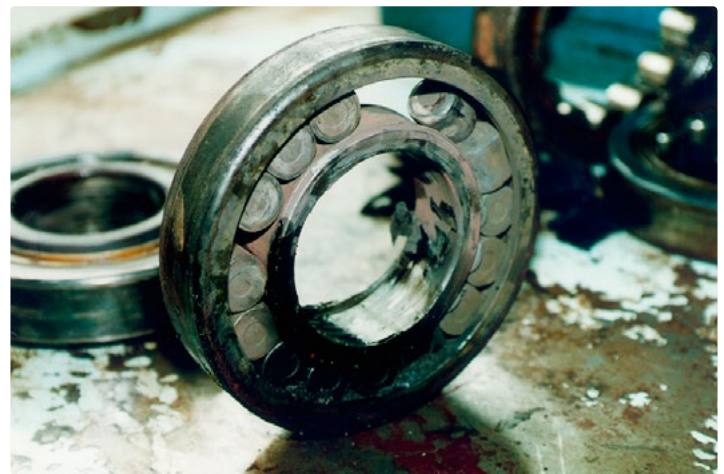
**Cylindrical roller bearing – inner ring, outer ring and rollers**  
Seized bearing – forced fracture of cage due to lubrication problem

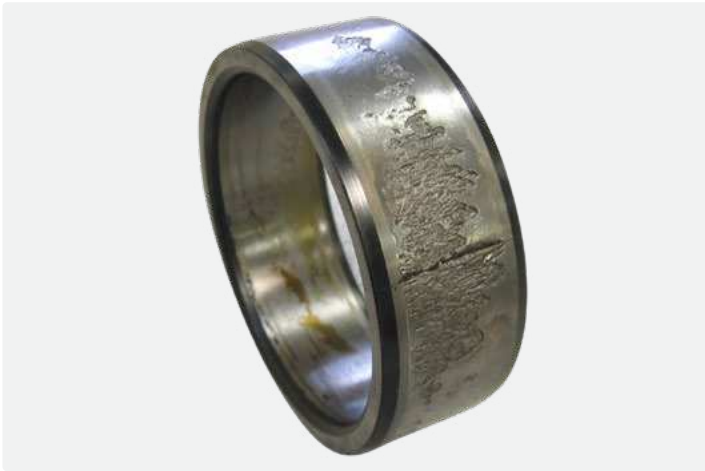
Cylindrical roller bearing inner ring  
Very heavy spalling – fatigue fracture as sequential damage

- Make sure bearing seats conform to geometrical specifications
- For split housings, make sure the two halves join correctly
- Bearing seats should be clean (no swarf or chips, which could create local stress rise)
- Use appropriate tools and methods for mounting

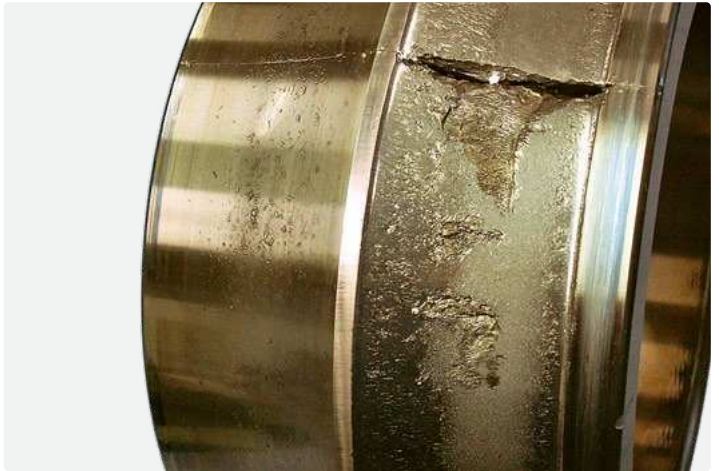
Spherical roller bearing inner ring  
Very heavy spalling – fatigue fracture as sequential damage

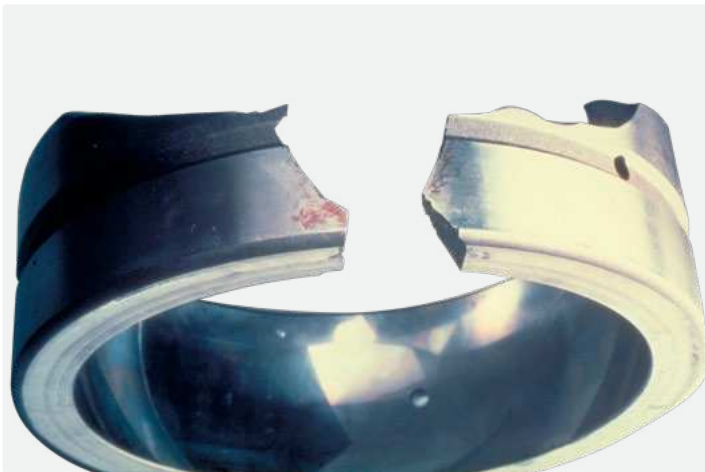
Spherical roller bearing outer ring  
Fatigue fracture resulting from inadequate housing seat  
(swarf trapped at the bottom of the housing)

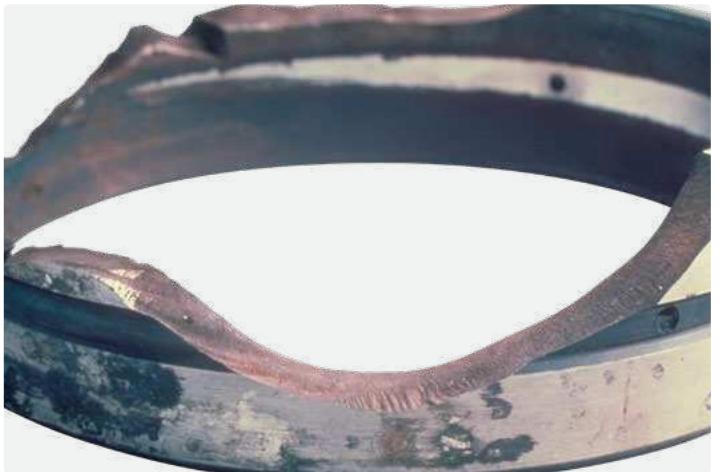
Spherical roller bearing outer ring  
Inadequate housing seat leading to fretting corrosion and finally fatigue fracture

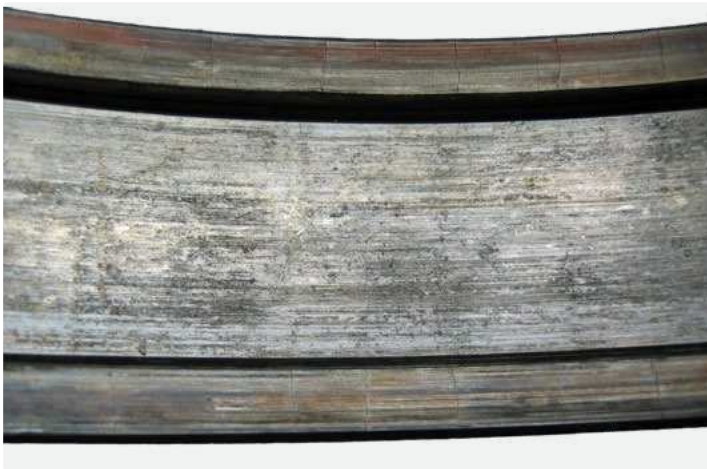
**Cylindrical roller bearing outer ring**  
Thermal cracks at both shoulder-cage contact due to inadequate lubrication

- Lubricate sliding surfaces or apply coatings to reduce local peak temperatures
- Make sure the lubrication is adequate: right lubricant, right quantity, right time
- Check for application specific solutions with the SKF application engineering service

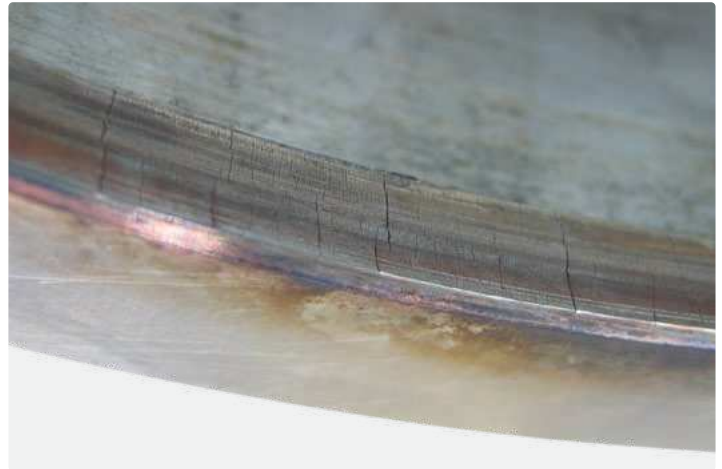
**Cylindrical roller bearing outer ring**  
Thermal cracks at shoulder-cage contact due to inadequate lubrication

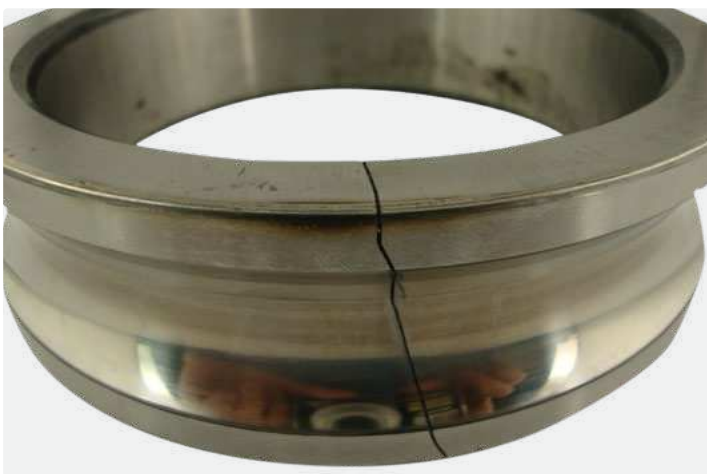
**Deep groove ball bearing inner ring**  
Ring fractured due to excessive friction against a stationary part of the bearing assembly. The through fracture of the ring is a result of the thermal cracking. See the enlarged figure to the right.

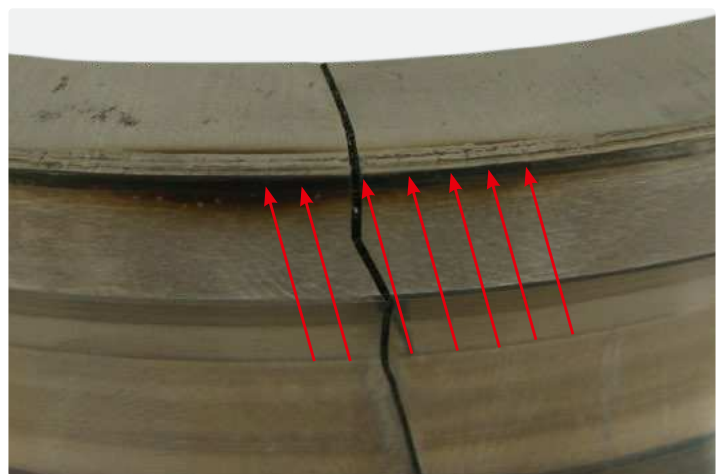
**Deep groove ball bearing inner ring**  
Enlarged view of fractured ring, with many heat cracks along the inner ring shoulder

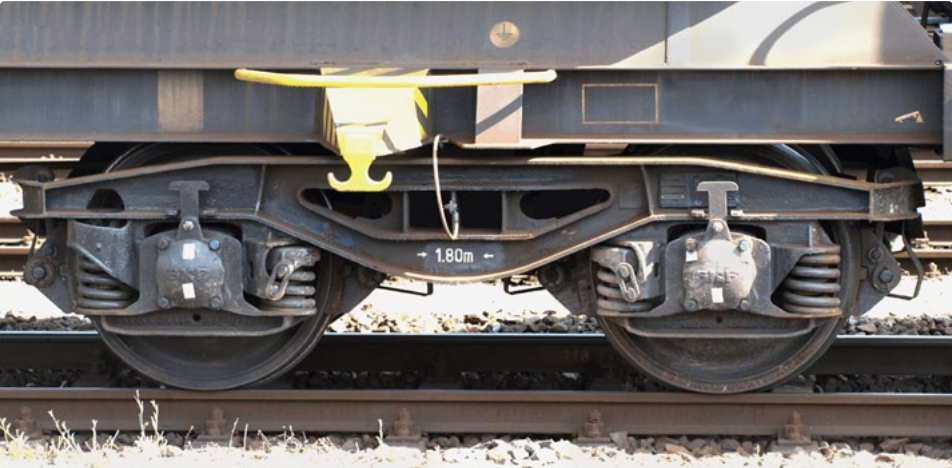
Fig. 1

Industry:	Railway
Application:	SKF axleboxes for goods wagons (figs. 1 and 2), 20-tonne axle payload
Bearings:	2 x SKF 229750 J/C3R505 per axlebox
Problem:	Derailment

Goods wagons equipped with “Y-25” bogies, incorporating axleboxes with a double spring suspension

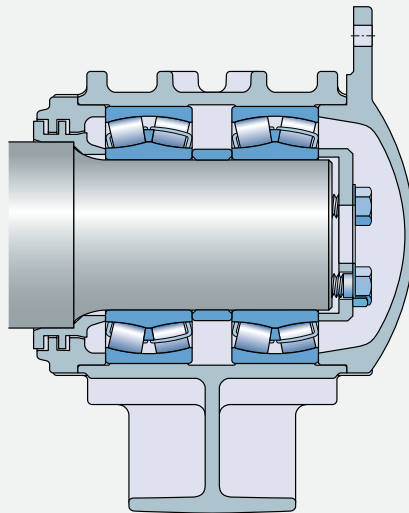
Fig. 2

Typical axlebox bearing arrangement for 20-tonne axle payload

Both the inner rings of the inboard and outboard bearing are held in place by a labyrinth collar on the shaft, a 35 mm spacer between the inner rings, and an end plate. The axlebox is located axially by a split labyrinth cover on the inboard side and an end cover on the outboard side.

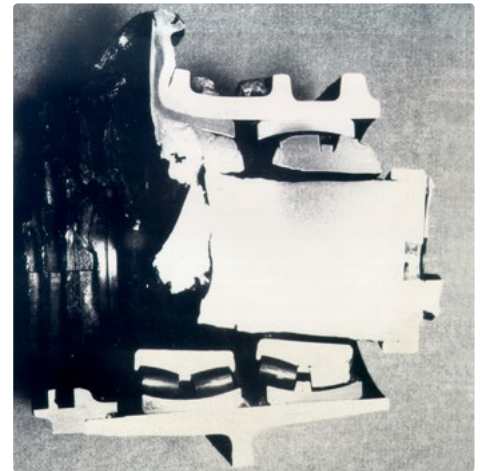
Fig. 3

This was clearly more than a “hot runner” (fig. 3). The outer ring of the inboard bearing was severely deformed. Based on the level of deformation, the metal reached a temperature well over 800 °C (1 470 °F).

There was a gap between the outer ring of the inboard bearing and the labyrinth seal, measuring 21 mm (fig. 3, bottom left).

Remains of the failed axlebox (cut),  
as presented for the failure analysis

Apparently, the shorter spacer was installed during the overhaul. As a result, the bearing inner rings were not properly axially clamped and able to move on their shaft seat towards the outboard side, which increased shaft bending. Also the outer rings were not properly positioned in the axle box housing, leading to axial contact in the labyrinth seals. This resulted in high frictional heat, bearing seizure, shaft fracture and derailment.

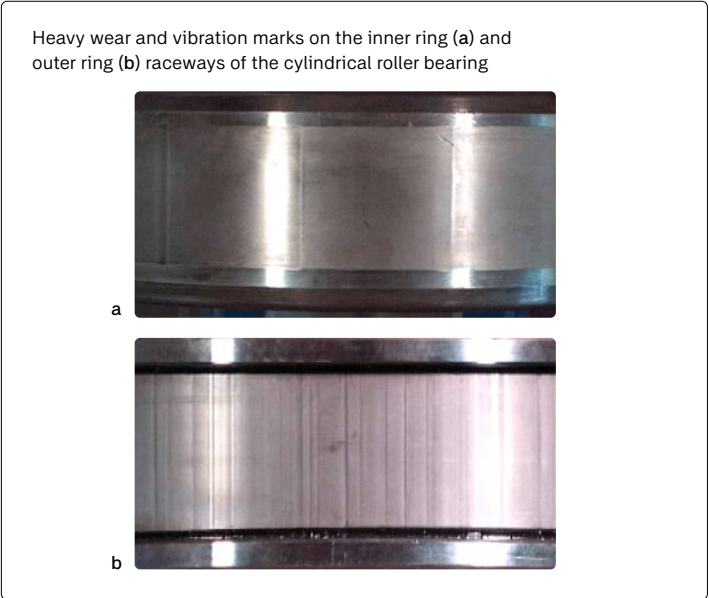
Fig. 5

When the bearing was cut, and a section put under a microscope, some interesting conclusions could be made:

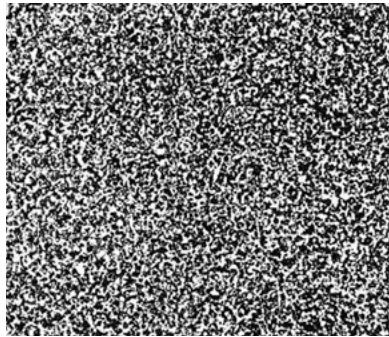
Fig. 6

The raceway surface showed microcraters that were the result of a damaging electrical current passing through the bearing (current leakage) (figs. 6 and 7).

The Primary failure mode is clearly current leakage erosion (ISO 5.4.3) caused by inadequate electrical grounding.

The inner ring raceway surface under 150x magnification showing a very large number of microcraters

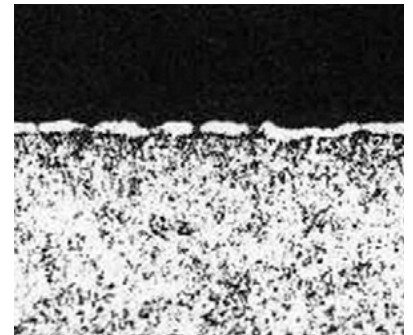
Fig. 7

Cross section of the inner ring under 500x magnification

The thin, light strip on top (underneath the black space) is the raceway surface. This is material that was rehardened due to the heat developed in the contact area. Below the light area, there is a thin, dark strip that had been annealed. The lower part is the steel with normal hardness.

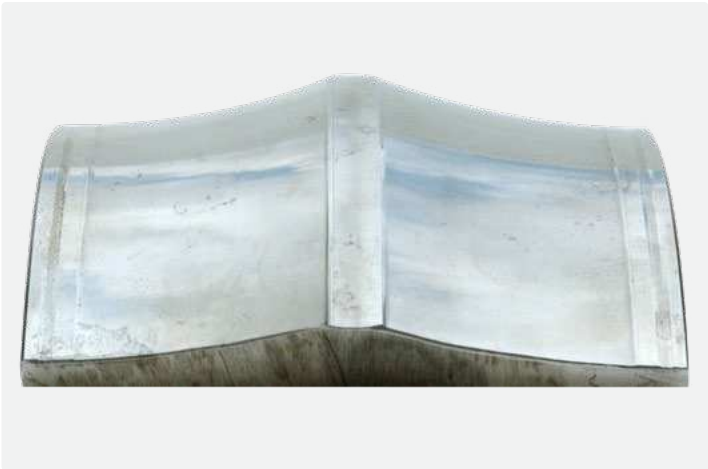
Fig. 8

The raceways showed severe abrasive wear. On both raceways, the cages had cut a groove at the edge of the raceway, indicating that the cages were making contact with the raceways. The raceways were dull and grey in colour (fig. 8).

Inner ring: Heavy abrasive wear on the raceways and a circumferential groove at both raceway edges

The customer improved the sealing arrangement and reduced lubrication intervals.

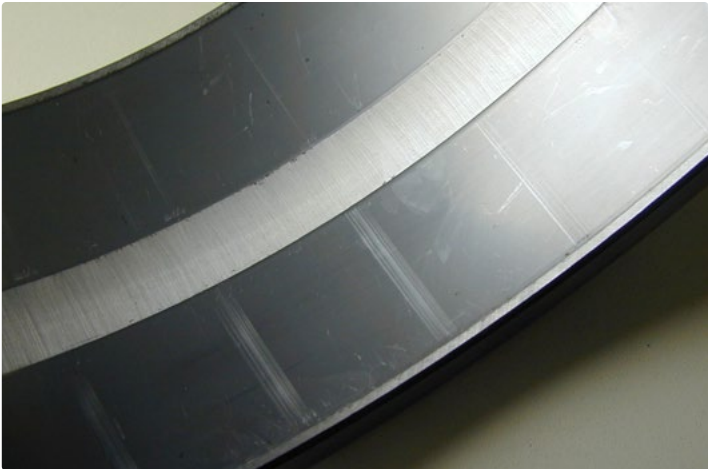
Fig. 9

The raceways showed heavy abrasive wear, and were dull and grey in colour (fig. 9). There were also transverse smearing marks (at roller spacing) from dismantling.

Outer ring: Heavy abrasive wear on the raceways and transverse smearing marks

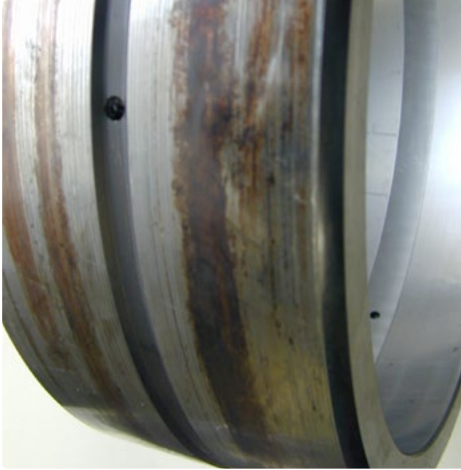
Fig. 10

Severe fretting corrosion was visible on the outside surface (fig. 10), which was the result of ring creep movements under heavy load and uneven ring support.

Outer ring: Fretting corrosion on the outside surface

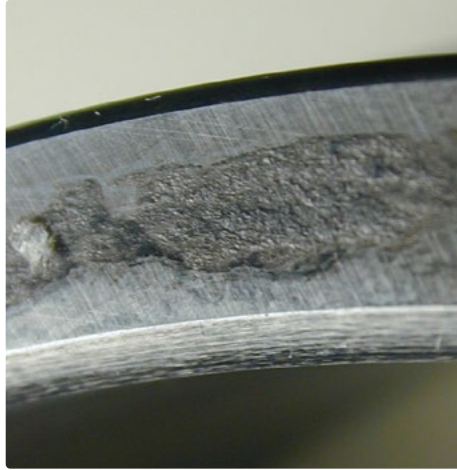
Fig. 11

The side faces of the outer ring also showed fretting corrosion (fig. 11), which further confirms ring creep.

Outer ring: Fretting corrosion on the side face

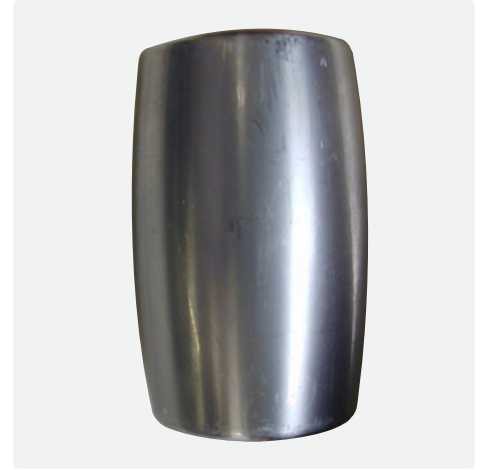
Fig. 12

The rollers were dull and grey in colour. Smearing marks from dismantling were visible (fig. 12).

Roller: Dull and grey colour

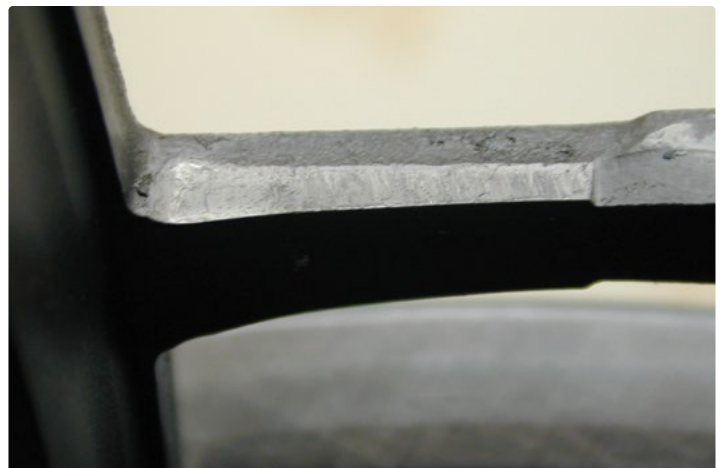
Fig. 13

The pockets of the window-type cages exhibited abrasive wear. The cage bars were worn substantially (fig. 13).

Cage: Pocket wear

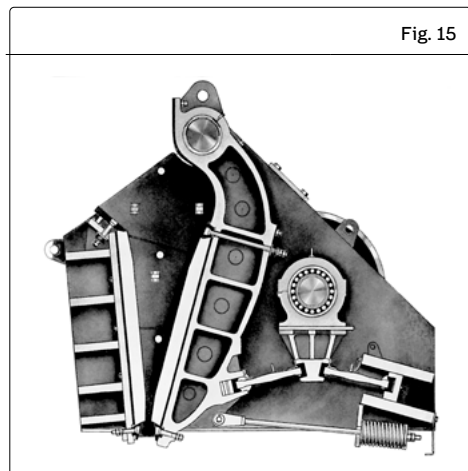
Fig. 15

Principle of a double-toggle jaw crusher

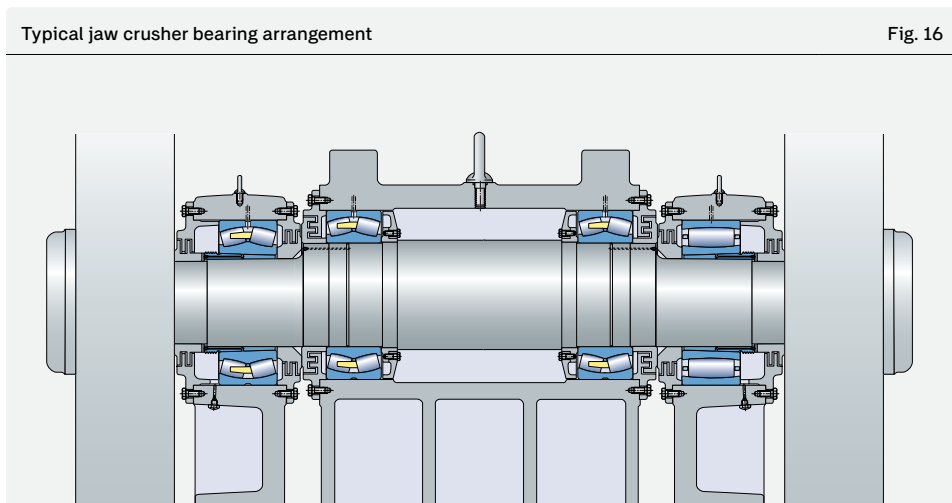
Fig. 16

Typical jaw crusher bearing arrangement

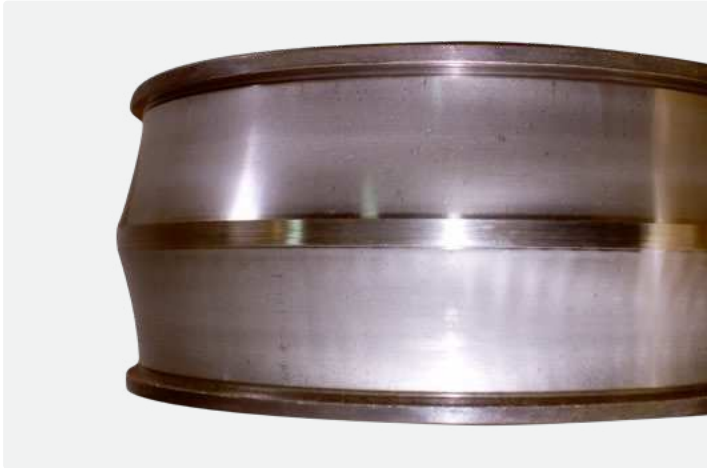
Fig. 17

There was heavy abrasive wear on the raceways (fig. 17). No other marks were visible.

The cause of the abrasive wear is inadequate lubrication and the vibration.

Inner ring: Abrasive wear on the raceways

1. Evaluate the lubrication and the maintenance relubrication schedule. SKF recommends the SKF LGEP 2 grease for this application.
2. Locate the course/cause of the vibration during operation.
3. Check the housing seat. Repair if needed.

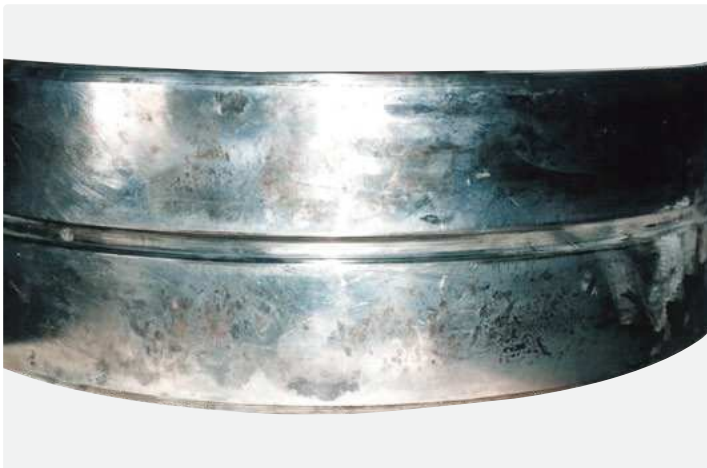
Fig. 19

There was heavy fretting corrosion on the outside surface corresponding to the load zone (fig. 19).

Outer ring: Heavy fretting corrosion in the load zone of the outside surface
