**SKF**

# **BEARING DAMAGE AND FAILURE ANALYSIS**

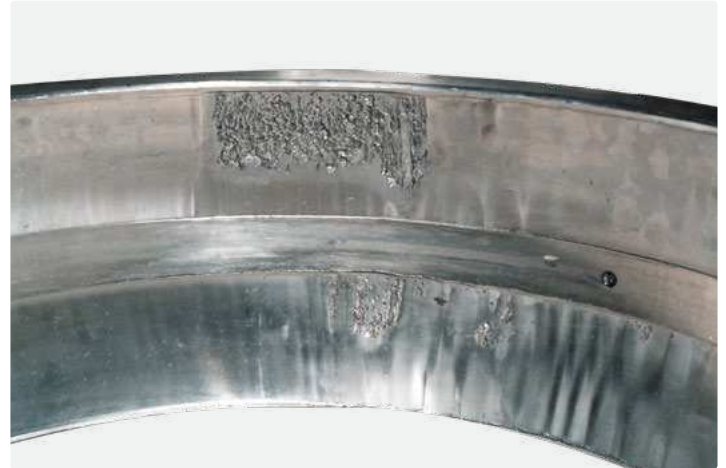
Fig. 18

There was heavy spalling on the raceways in a small area of the load zone. There were heavy vibration marks over a large part of the load zone (fig. 18).

Outer ring: Load zone spalls and vibration marks on the raceways, at the bottom of the ring

1. Evaluate the lubrication and the maintenance relubrication schedule. SKF recommends the SKF LGEP 2 grease for this application.
2. Locate the course/cause of the vibration during operation.
3. Check the housing seat. Repair if needed.

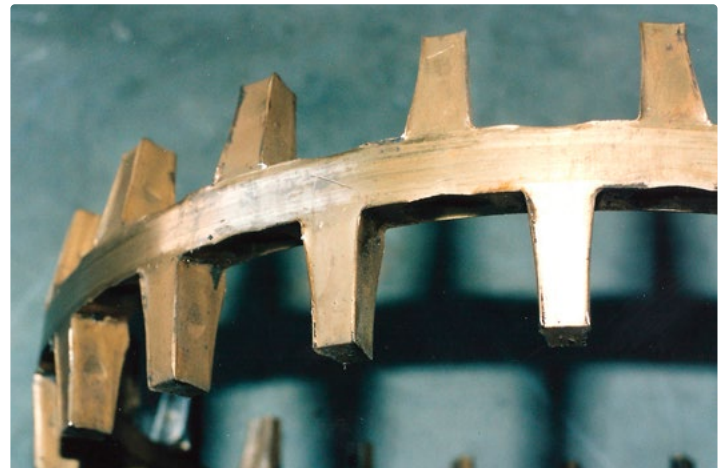
Fig. 20

The cage pockets exhibited heavy and irregular wear (fig. 20).

Cage: Heavy pocket wear
